# TECHNICAL SERVICE BULLETIN

Technical Service Bulletin: 410-1316

# TECHNICAL SERVICE BULLETIN 410-1316 REMEDY INSTRUCTIONS

Make(s): COLUMBUS RIVER RANCH Model(s): CMF390RL & CMF392MB Model Year(s): 2021	Repair Code: SB-510-13-00-004009 Allotted Time: .55 HRS. Inspection Code: N/A Allotted Time: N/A
	Concern: The black tank flush feature is plumbed incorrectly, which will not allow flushing of the black tank.	Photo(s) Required: NO Prior Authorization Required: NO Part(s) Number: N/A Part(s) Return: N/A

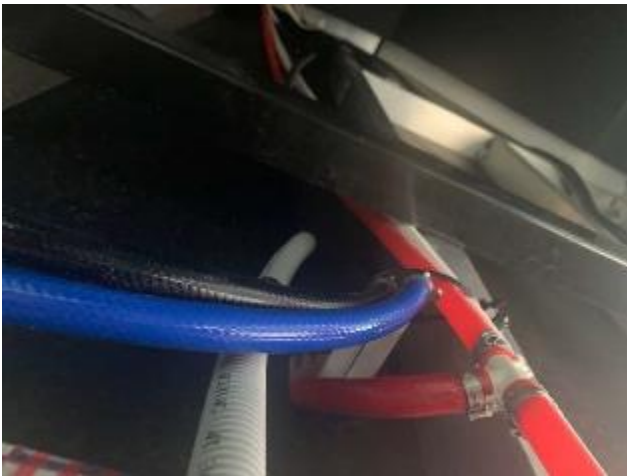
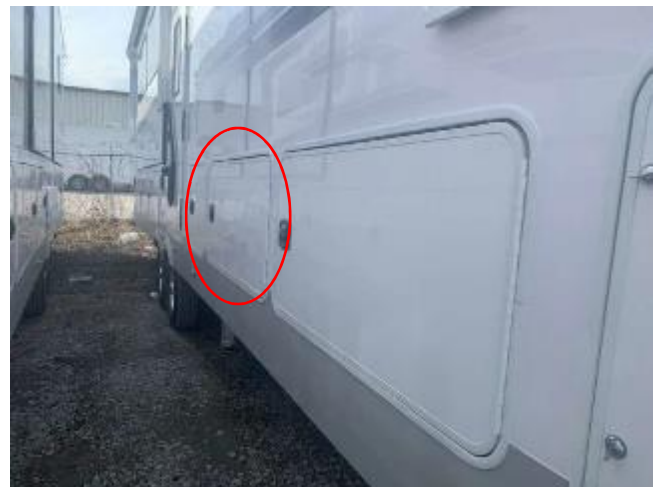
PHOTOS BELOW FOR REFERENCE.

The black tank flush may have been plumbed backwards.

STEP 2: SWITCH THE BLUE WATER HOSE AND BLACK WATER SEWER FLUSH HOSES ON THE VACUUM BREAKER THAT IS LOCATED AT THE EXIT POINT UNDER THE FLOOR;

STEP 3: TEST THE FLOW OF WATER TO ENSURE THE BLACK TANK FLUSH NOW PROPERLY WORKS.
