GROUP ELE	MODEL 2022MY Carnival (KA4) w/RSE
	NUMBER 236	DATE March 2021

TECHNICAL SERVICE BULLETIN

SUBJECT: SERVICE ACTION: RSE S/W UPDATE FOR WRONG LANGUAGE DISPLAY W/BLUETOOTH® SOUND SYNC (SA470)

This bulletin provides the procedure to update the Rear Seat Entertainment (RSE) software on some 2022MYCarnival (KA4) vehicles produced from January 4, 2021 through February 26, 2021, which may incorrectly display a Spanish phrase when tapping the Bluetooth® Sound Sync button. To correct this concern, perform the head unit software update procedure outlined in this bulletin to the vehicles. Before conducting the procedure, verify that the vehicle is included in the list of affected VINs.

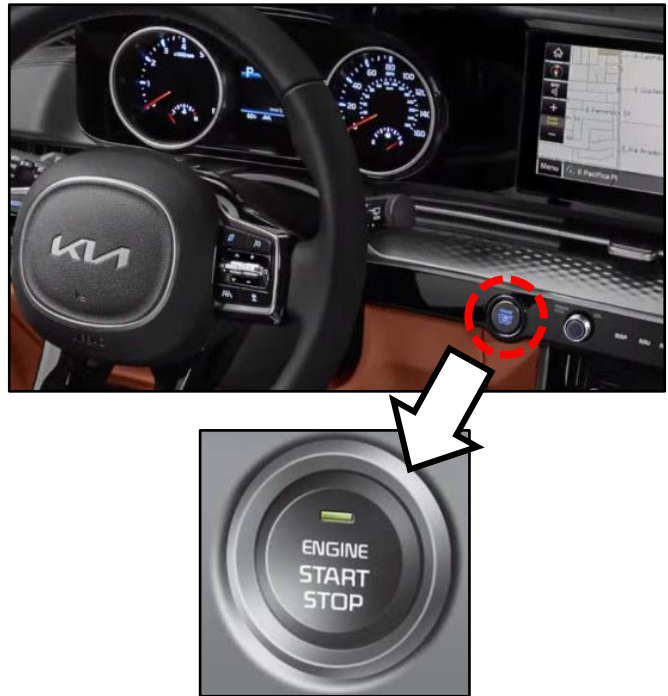
- 1. Press the 'Start' button to turn ignition 'ON'.

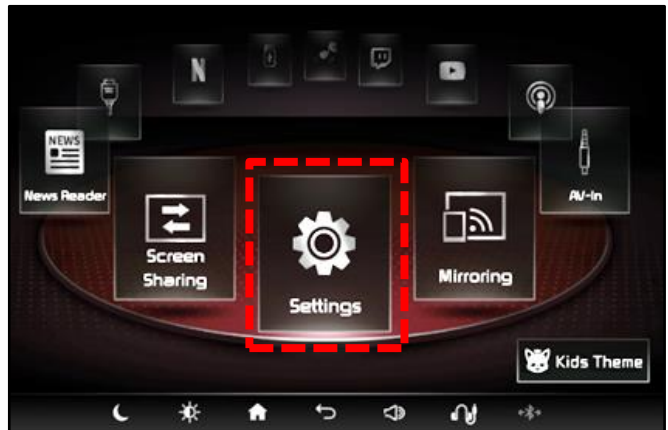
- 2. Press '**Settings**' on the Rear Seat Entertainment (RSE) unit.

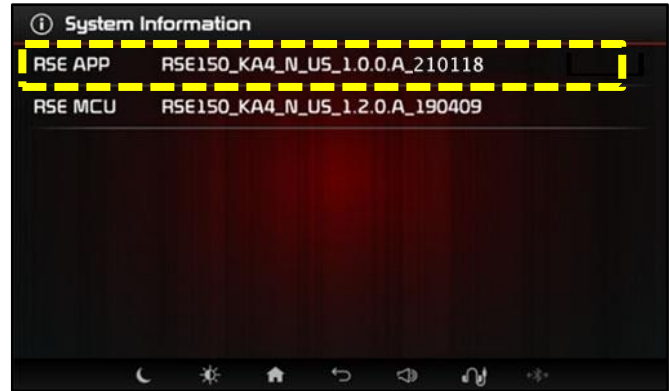
- 4a. Check the ‘**RSE APP**’ software version.
- 4b. Verify that an earlier software version is currently installed.

Note: Refer to the “Software Version” table below.

If the SW version is older than the “New Version” in the table below, proceed with the update.

Software Version (SW Ver.)	
Current Version (Before Update)	New Version (After Update)
RSE150_KA4_N_US_1.0.0.A_210118	RSE150_KA4_N_US_1.0.0.A_210302

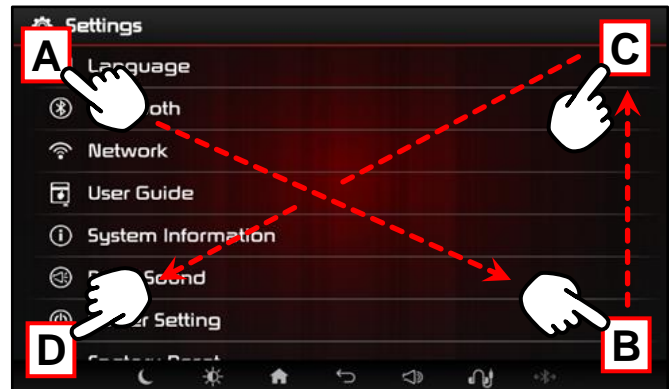
- 6. On the ‘**Settings**’ screen, enter the Engineering Mode by pressing the screen in the locations shown in the following order: **A** → **B** → **C** → **D**.

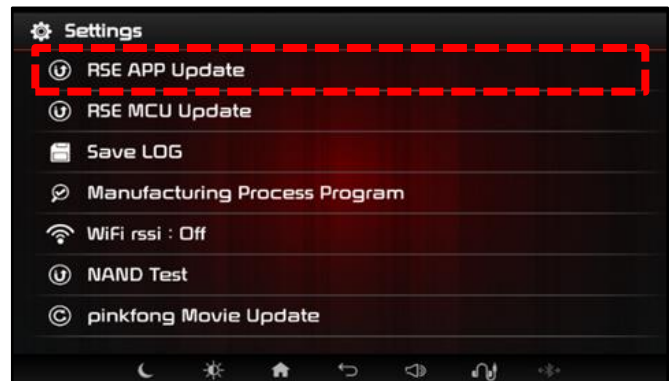
- 7. Press ‘**RSE APP Update**’.

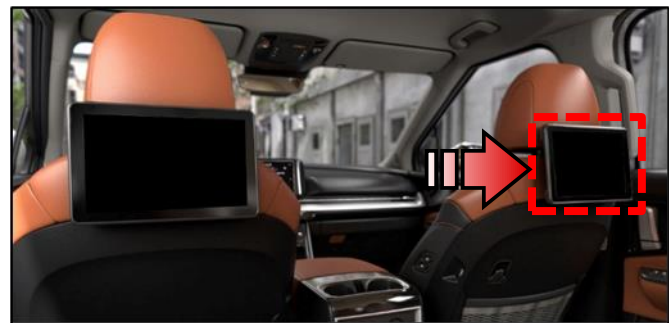
- While the LH side RSE unit is updating, insert the second USB drive into the USB port of the **RH** side RSE unit.

Follow steps 6, 7, and 8 above for the RH side RSE unit.

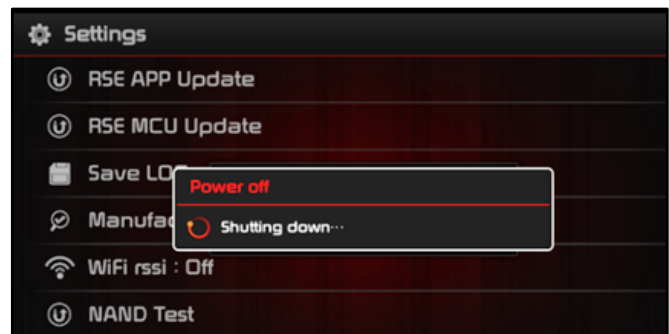
- After updating for a short time, the RSE unit will shut down automatically. **This is normal.**

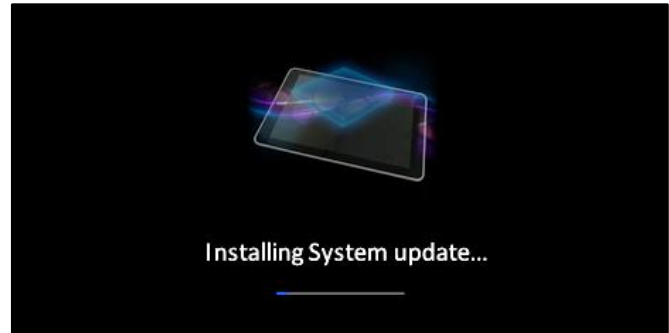
12. During the update, the RSE unit(s) will automatically reboot several times.

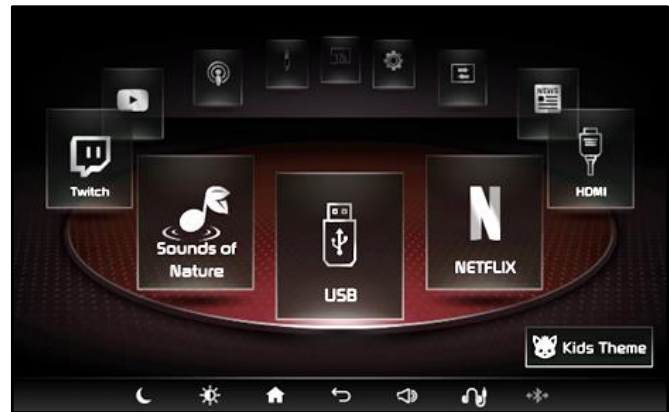
12. After the system update is complete, the RSE unit will reboot again.

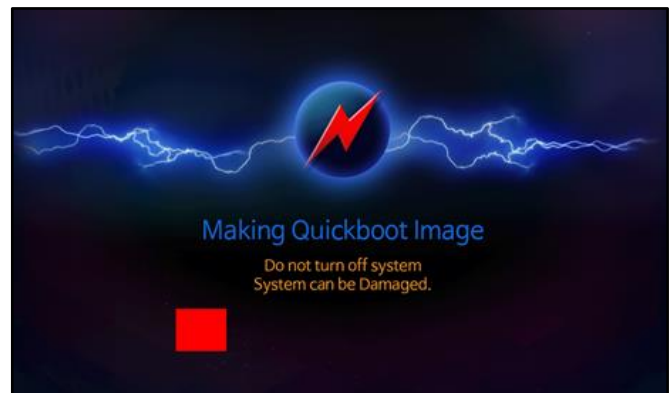
13. After the final rebooting, the RSE unit will automatically make a Quickboot Image.

Do not remove the USB flash drive yet.

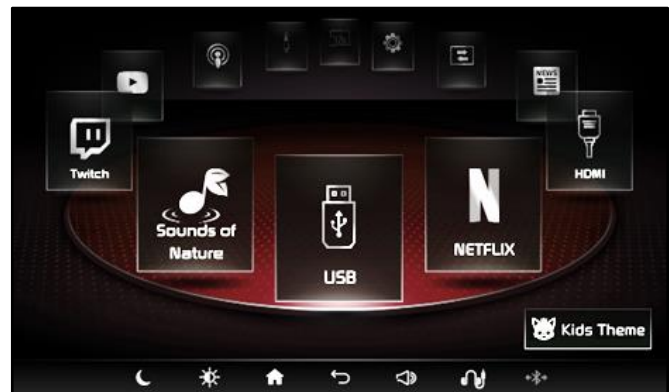
14. When the update is completed, the Home screen appears.

Note: The entire update process takes about 7 minutes to complete.

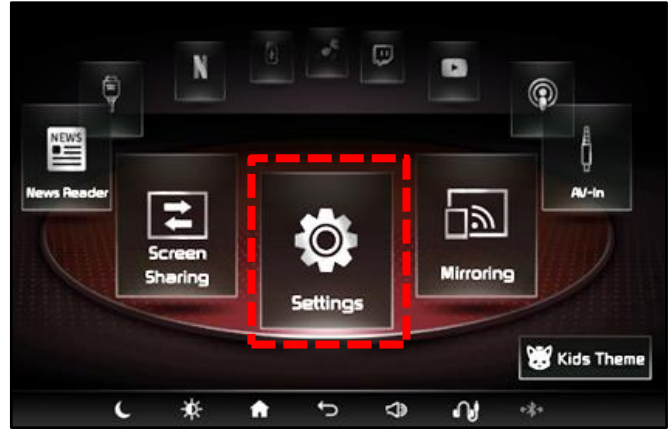
- Press **'Settings'** on the head unit.

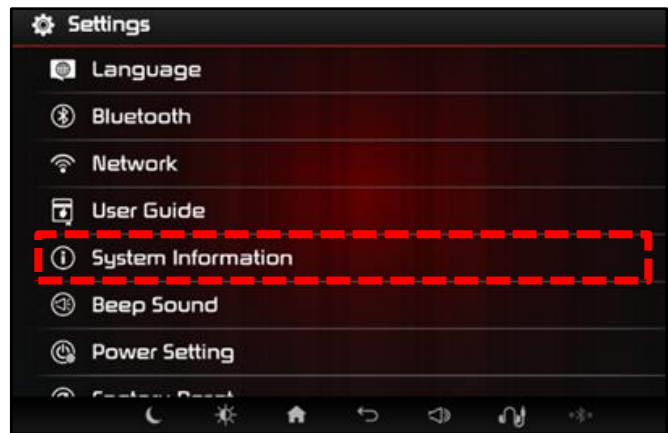
- Press **'System Information'**.

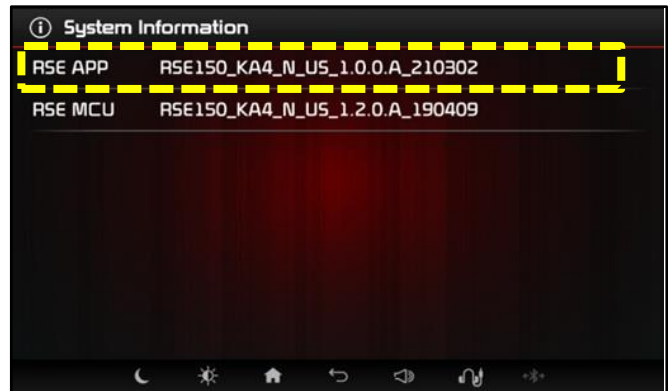
- Check the **'RSE APP'** software version and confirm it matches the "New Version" in the "Software Version" table on page 3.

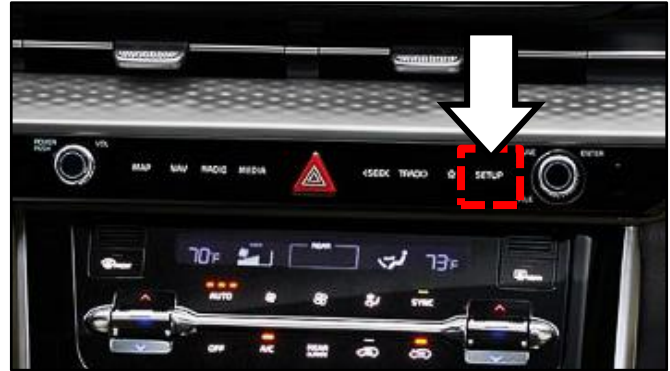
1. On the AVN head unit, press the **'SETUP'** button.

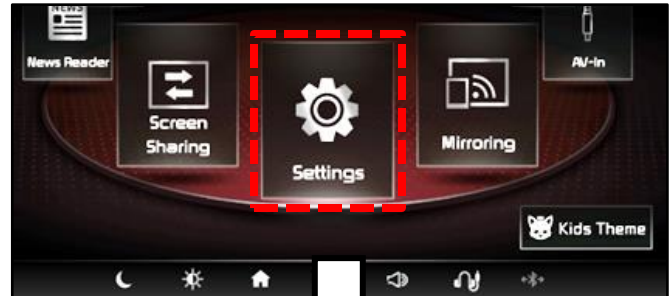
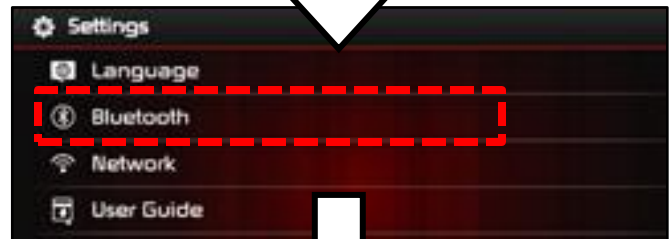
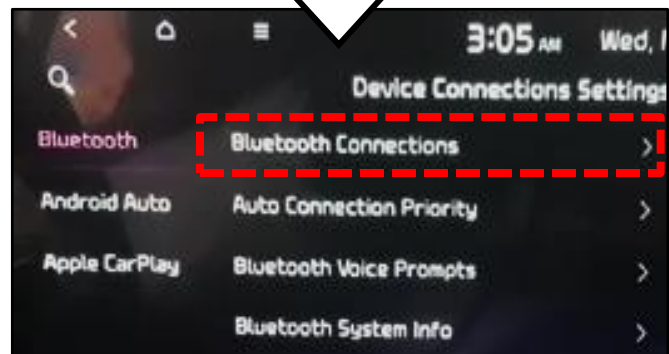
6. Reconnect the Bluetooth connection of both RSE monitors to the AVN head unit.

On each monitor:

- Press '**Settings**'.
- Press '**Bluetooth**'.
- Press '**Bluetooth Connections**'.
- Complete connection as directed.
