#### Seat Cover Staining / Discoloration

20 – 21MY Defender

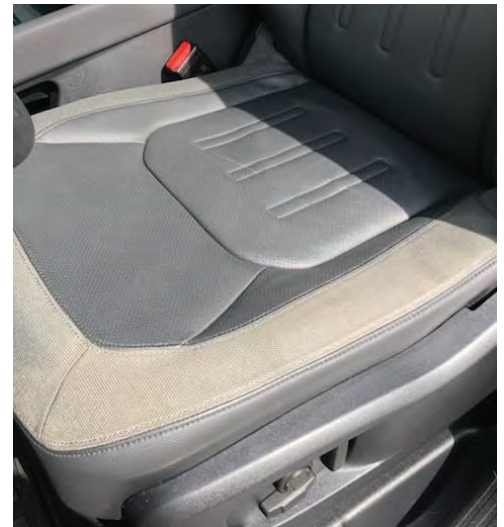
- A customer may report that the seat cover is becoming stained or discolored.

- This may be caused by a numerous different factors. One of them being incorrect amount of fabric treatment applied during manufacturing.

- A special seat cover cleaning procedure has been developed to address this concern.
- TSB JLRTB02070NAS1 has been published to address this concern.
- Should a customer express a concern, please refer to this TSB and make sure that the instructions are fully followed.
