TOYOTA MOTOR
NORTH AMERICA

CUSTOMER SUPPORT PROGRAM 20TE04

Certain 2019 - 2021 Model Year RAV4 HV
Coverage for Vehicle Refueling Performance

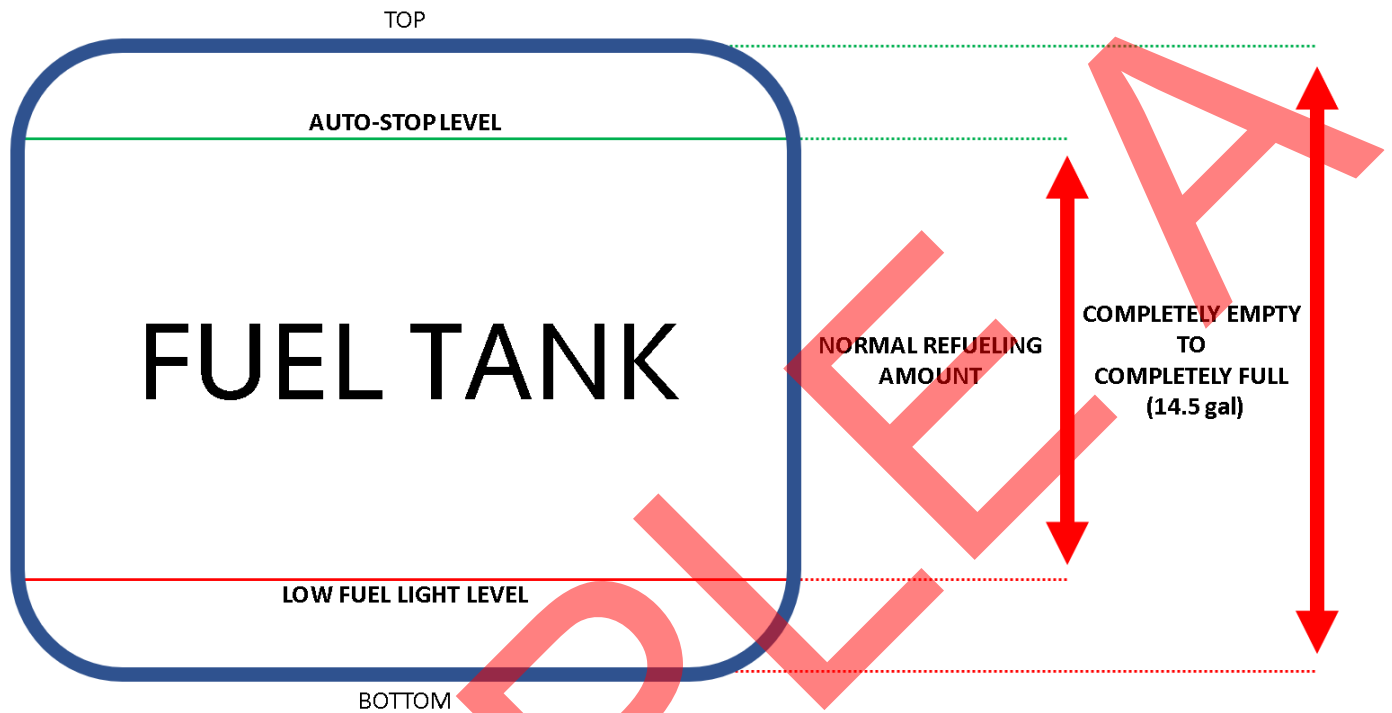
A6: The image below provides a visualization of the normal amount of fuel that is dispensed during refueling when the low fuel light is on until the auto-stop activates in the fuel pump nozzle. Note that the refueling amount is less than the total tank capacity of 14.5 gallons as stated in the Owner's Manual.

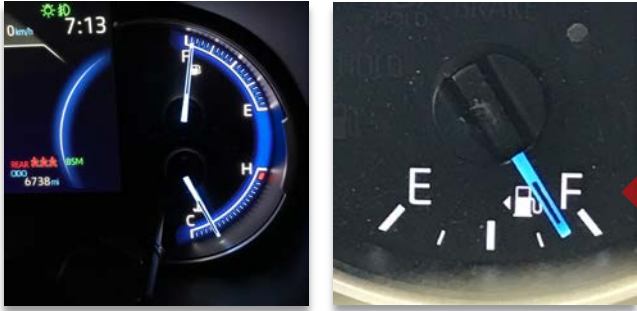
Condition	Fuel Gauge Less than Full	Total Fuel Dispensed is Less than Expected
Description	After refueling until the fuel nozzle automatically stops, the fuel gauge needle does not rise to the F line.

Amount of fuel dispensed into the tank during each refueling is less than expected.
How to Determine if Condition is Present	Refuel the vehicle until the fuel nozzle automatically stops. Observe the position of the fuel gauge needle. If the needle does not reach F as shown above, the condition may be present.	Wait until the next point in which the low fuel level light illuminates, then refuel the vehicle until the fuel nozzle automatically stops. If the refueling amount is less than 9.8 gallons, the condition may be present. If the refueling amount is 9.8 gallons or more, the vehicle's condition is normal, please refer to the FAQ included with this letter for more detail.

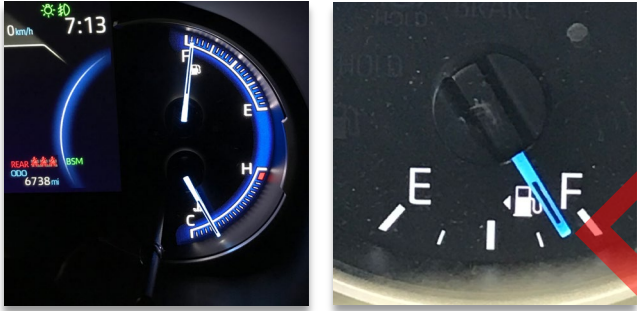
Condition	Fuel Gauge Less than Full	Total Fuel Dispensed is Less than Expected
Description	After refueling until the fuel nozzle automatically stops, the fuel gauge needle does not rise to the F line.

Amount of fuel dispensed into the tank during each refueling is less than expected.
How to Determine if Condition is Present	Refuel the vehicle until the fuel nozzle automatically stops. Observe the position of the fuel gauge needle. If the needle does not reach F as shown above, the condition may be present.	Wait until the next point in which the low fuel level light illuminates, then refuel the vehicle until the fuel nozzle automatically stops. If the refueling amount is less than 9.8 gallons, the condition may be present. If the refueling amount is 9.8 gallons or more, the vehicle's condition is normal, please refer to the FAQ included with this letter for more detail.
