Y1A Taycan PCM Displays German Language Unexpectedly

Vehicles Affected

Models	Model Year	Model Type	VIN Range	Vehicle-Specific Equipment
Taycan	As of 2020 up to 2021	Y1A	N/A	N/A

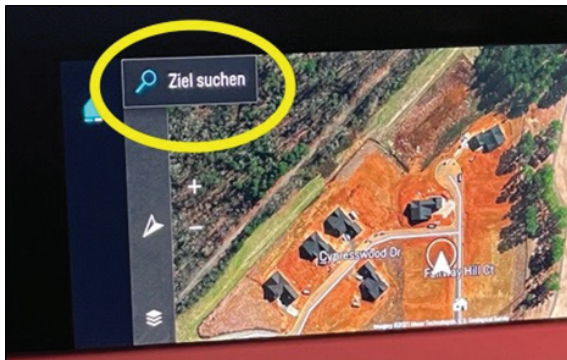
Figure 1

The customer reports that one or more of the PCM displays shows German language despite the customer not selecting German. (Please see figure 1.)

The workshop confirms this condition. Usually this condition occurs at startup.

The PCM tries to load text for all applications when the vehicle network wakes up after a full sleep. Sometimes, this load attempt occurs when the system is not yet fully ready. In this case, the PCM may have to load some of the text in the default language (German) and reattempt the text load later. If the customer looks at the display before it refreshes, there may be unexpected German text present.

This may occur at startup after the PCM central computer has been asleep.
(Generally, the PCM sleeps 15-30 minutes after vehicle shutoff).

Shortly after startup, the correct text will become available. The customer can wait for just a little while and then force a display refresh by changing screens.

There is no repair necessary. This is not a bug.
