## DINETTE TABLE PRODUCT IMPROVEMENT

| <b>Bulletin #(s):</b> | 21-014 | <b>Make(s):</b> | Jayco |
| <b>Job Code(s):</b> | N/A | <b>Model(s):</b> | Eagle HT TT |

| <b>Incident:</b> | Dinette table top tilting in bed position when pressure is added |

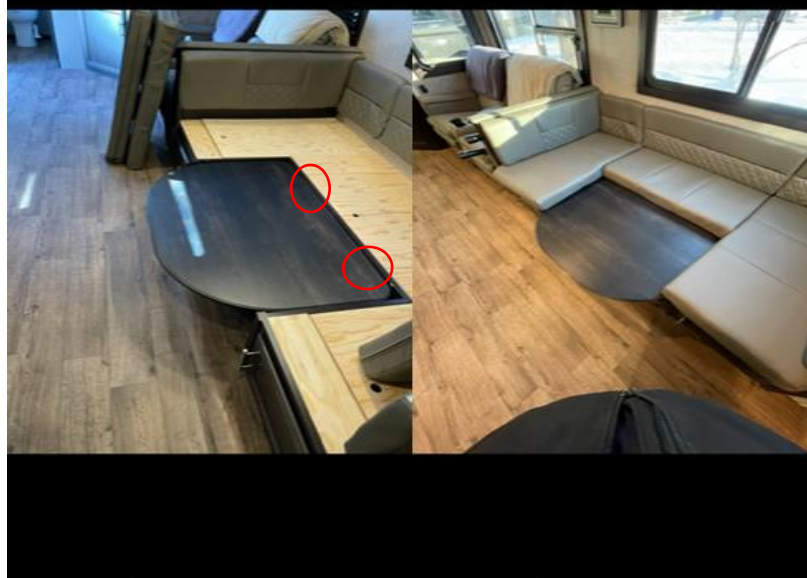
FIG 1

1. Fig 1 illustrates the Dinette Table in bed position. The red circles shows the location of the cleats under the table which will be removed in steps 2-5.

- Remove the two cleats shown in figure 1 and keep the 1 3/4" cabinet set fasteners.
- Install two L-brackets shown in fig 3 along with the cleat on the black plastic support with the 1 3/4" cabinet set fasteners. Do this process on the other side as well.

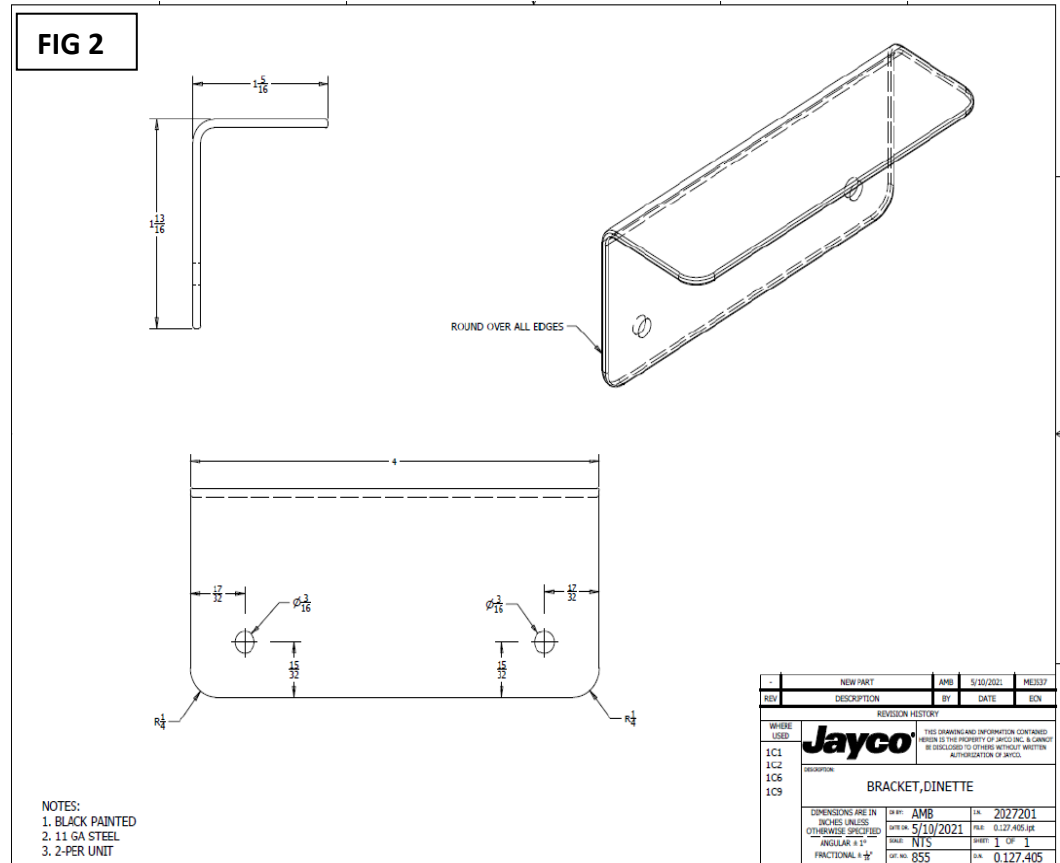
- Figure 2 shows the additional L-brackets that will be added to the cleats for additional strength.

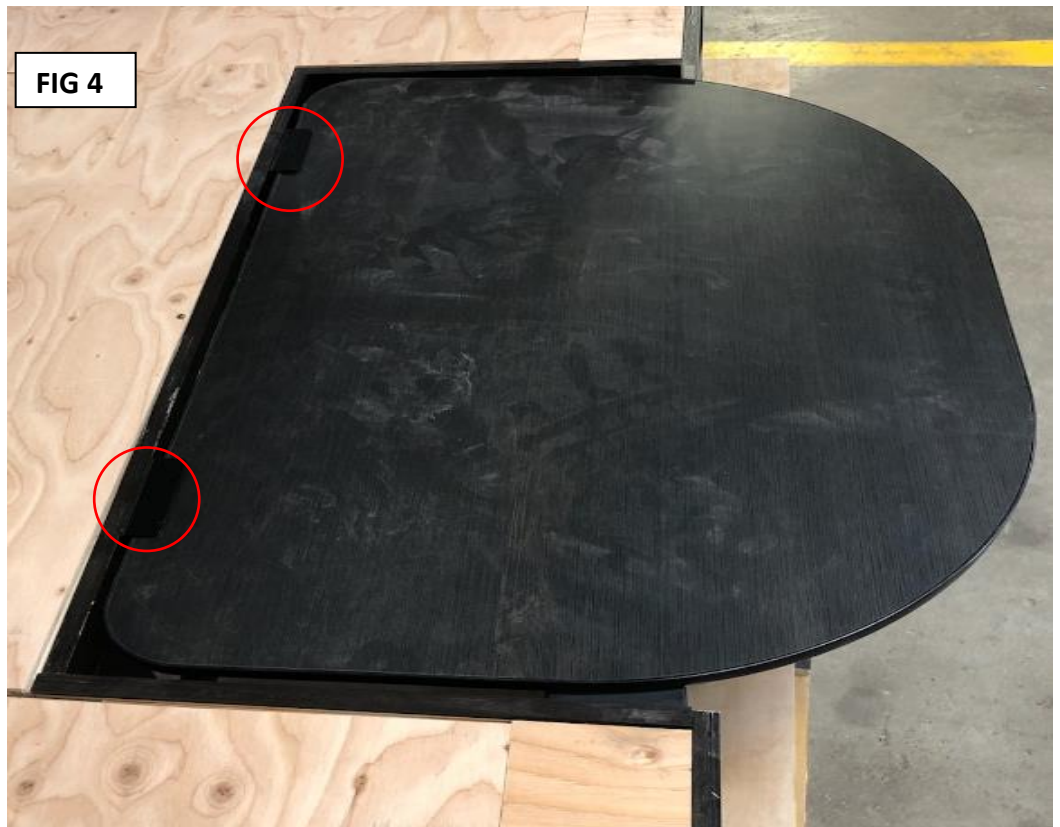
6. The improvement should look like Fig 4.
