## STAR ONLINE PUBLICATION

**Case Number:** S212300021

**Symptom/Vehicle Issue:** Buzz Or Rattle Noise From Floorboard Or Front Of Vehicle

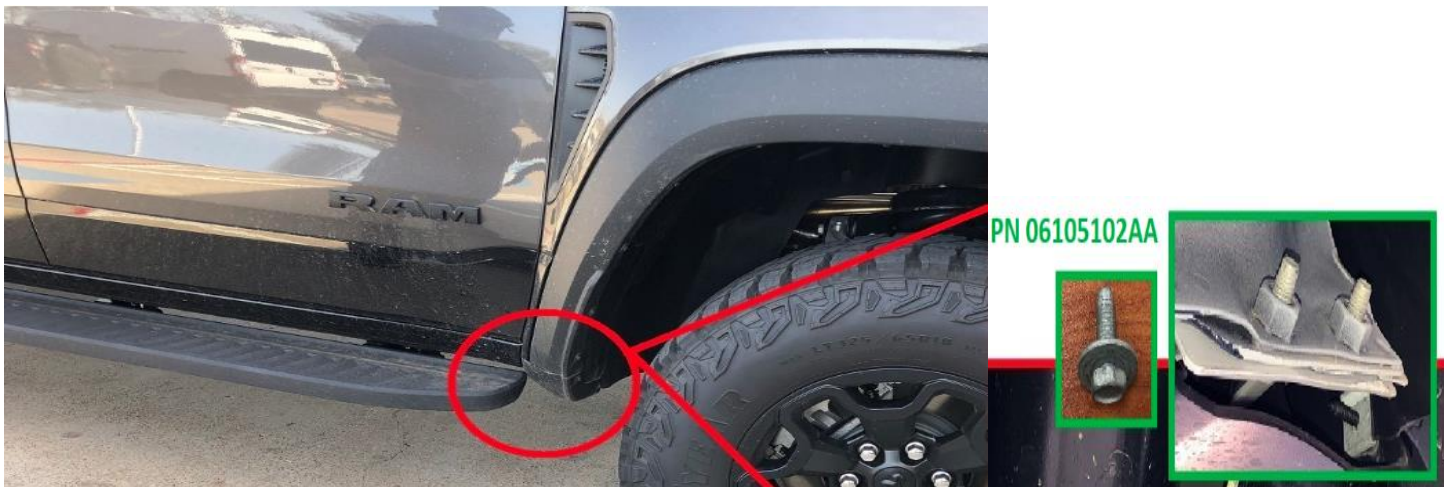
**Customer Complaint/Technician Observation:** Customer may describe intermittent buzz or rattle noise from floorboard or front of vehicle.

**Discussion:** Inspect front end components for installation and bolt torque. Verify install all A-Pillar to front fender fasteners are in place and tight. Install any missing A-Pillar to front fender fasteners, PN 06105102AA (M8x1.25x25.00 screws and washers). Then test drive to confirm noise has been resolved.
