Subject: REVISION - N202315730-01 - Service Update  
Wheel Casting with Exposed Porosity  
Revised Service Procedure

Models: 2020 - 2021 Chevrolet Corvette

### N202315730 Wheel Casting with Exposed Porosity

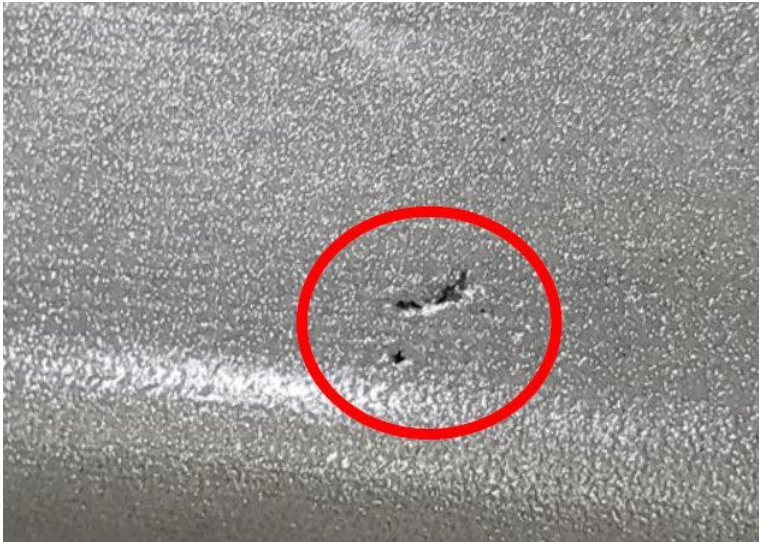
5754336

*The following photos show examples of the porosity condition covered by this bulletin.*

**Rim:**

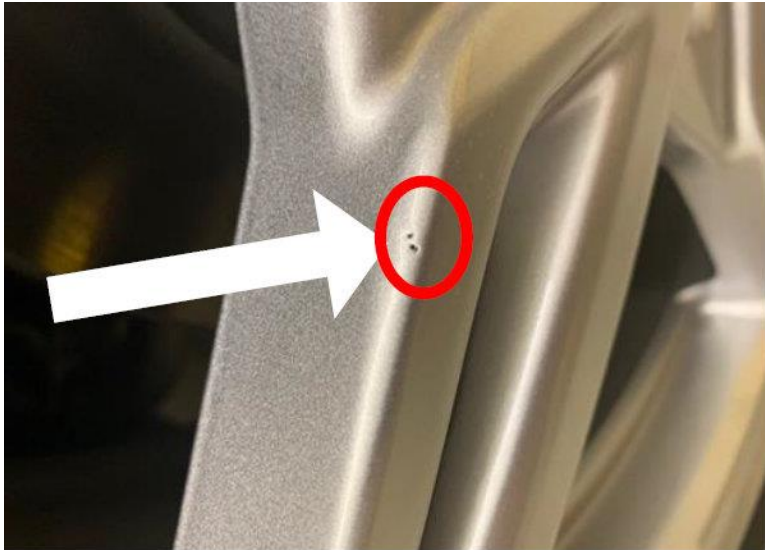
5754340

**Front Side of Spoke:**

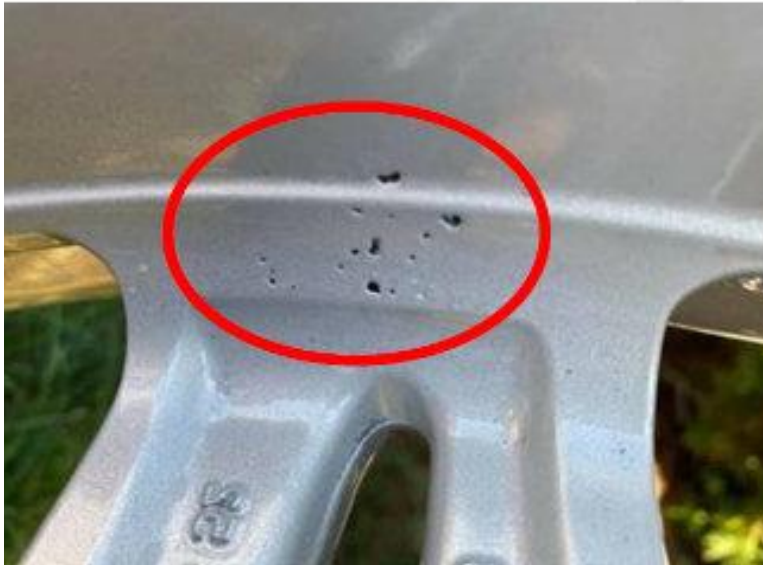
5754354

Back Side of Spoke near Rim:

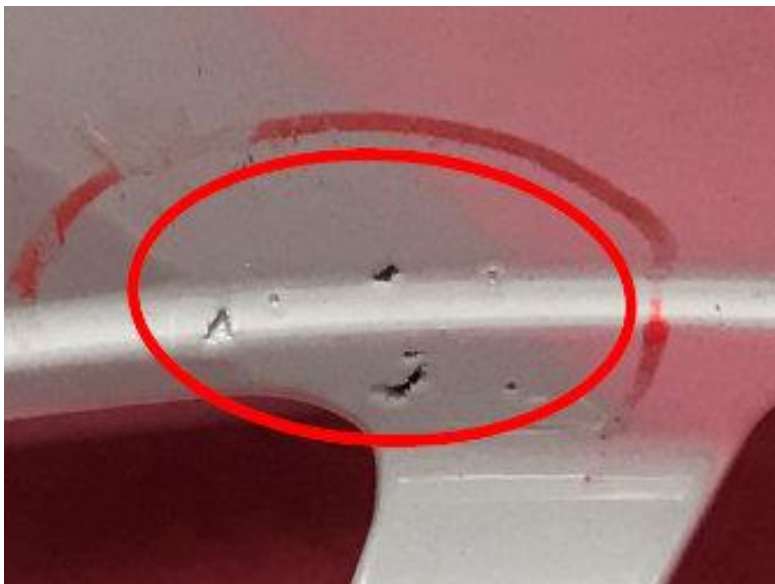
5754356

Back Side of Spoke near Rim:

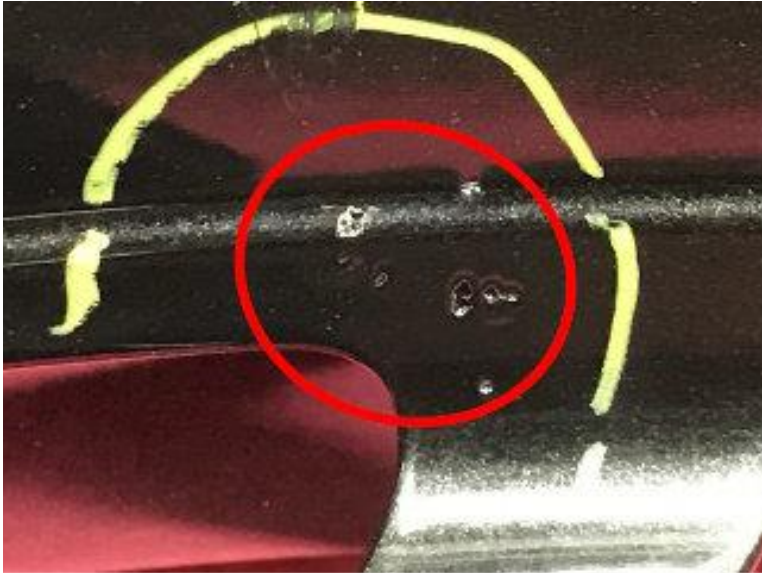
5754359

Back Side of Spoke:

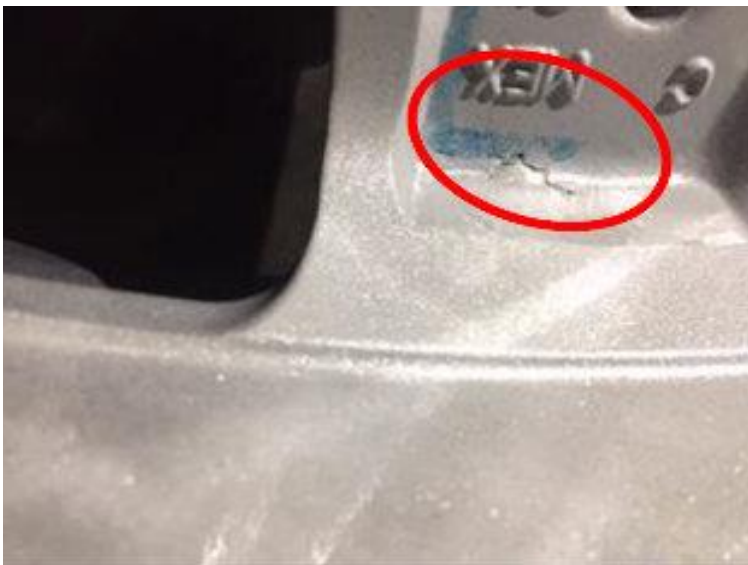
5754360

Back Side of Spoke:

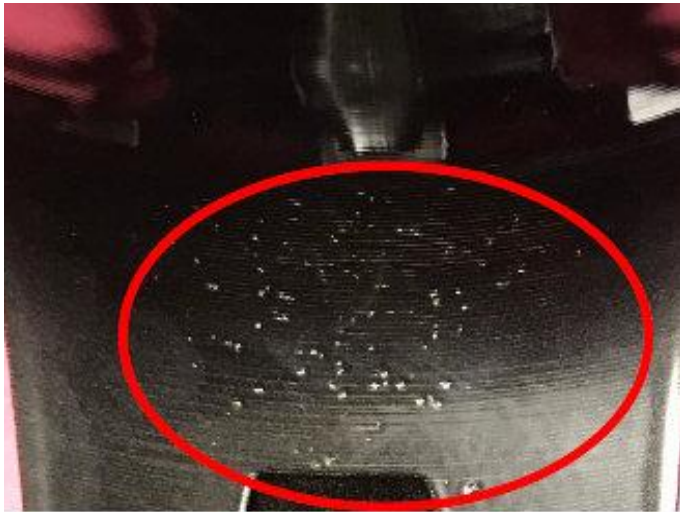
5754361

#### Back Side of Spoke near Hub:

**Note:** Each wheel must be individually and thoroughly inspected to avoid invalid submissions. Do NOT automatically replace all four wheels on the vehicle.

5. If any of the above conditions are found, initiate the Pre-Repair Authorization (PRA) process for a wheel replacement authorization:

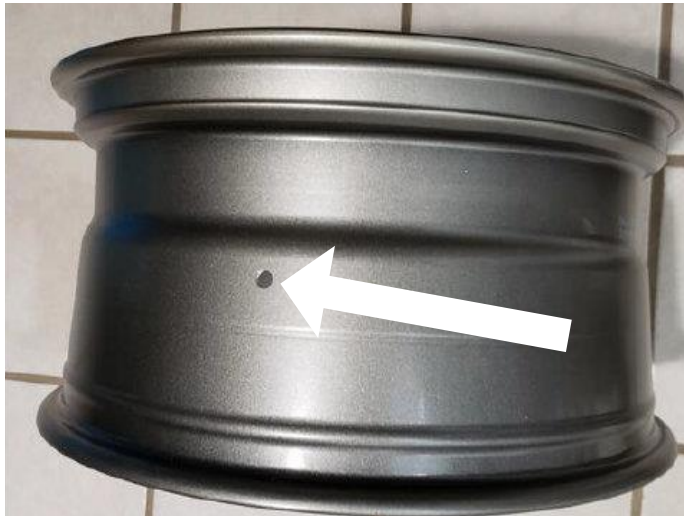
8. Once the new wheel replacement has been approved and the new wheel (or wheels) are installed on the vehicle, the removed wheel (or wheels) need to be properly disposed of.

- Drill a 13mm (1/2 in.) hole completely through the rim barrel of the wheel.
- See the Important statement preceding this step for proper wheel disposal instructions.
