# AfterSales BOL Technical Information

**MAS002624**  
(BOL 21-11)

## Door locking rod noisy

**Models:** M161 (All Model Years)

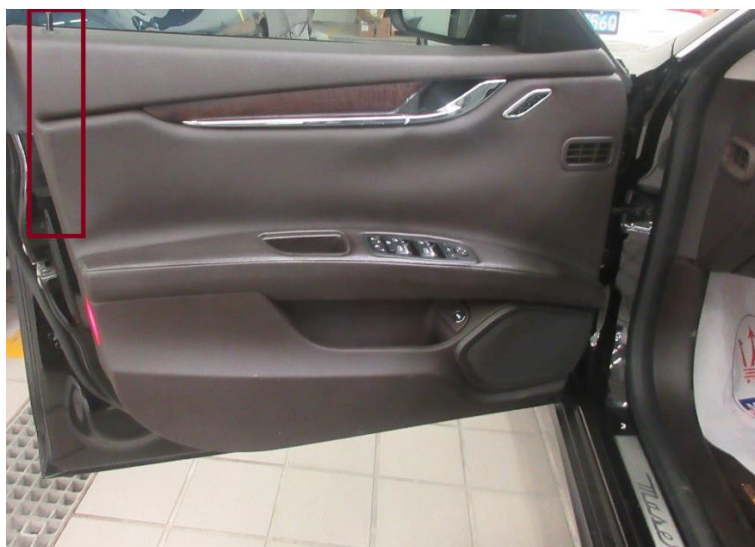
**Cause:** The source of the noise can be heard in the door locking rod area. (highlighted in Figure 1).

**Figure 1:** Area where the source of the noise is located.

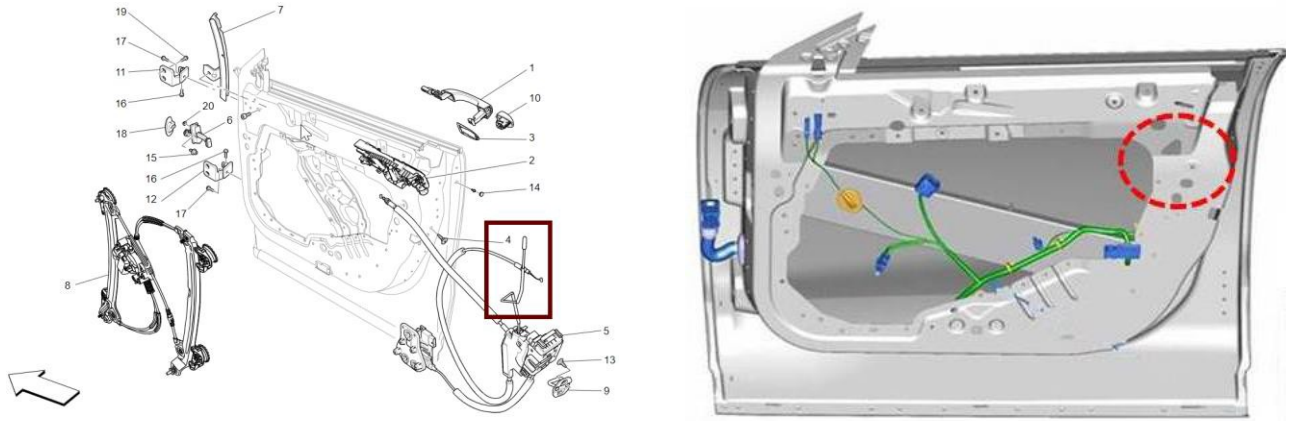
**Figure 2:** Door locking rod (left) and area of the possible interference with the door frame (right).

**Actions:** If the above complaint is received, proceed with the removal of the door panel to confirm the possible interference between the door frame of the affected door and the door locking rod, as shown in Figure 2.

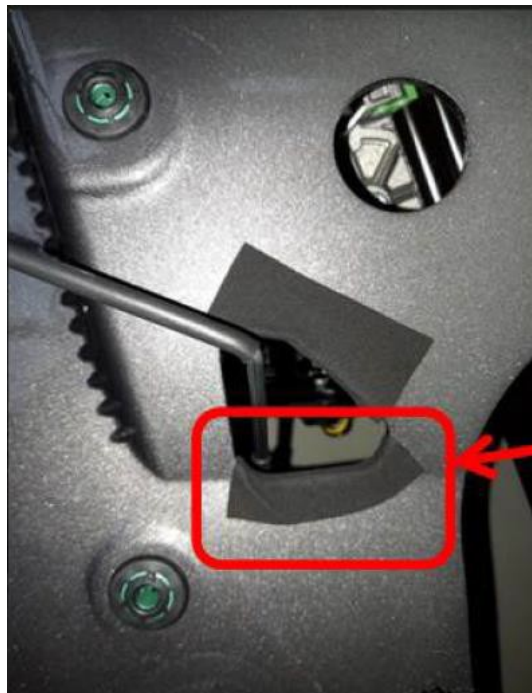
**Figure 3:** Application area of the anti-noise felt pad to solve the interference issue between the locking rod and the door frame.

If the interference is confirmed, apply two anti-noise felt pads, after having properly cleaned the area of the door frame where they are being applied (Figure 3). These felt pads are available as Spare Parts, Part Number 675000401.
