## Technical Bulletin 217

### 04.2021

**Item:** 217.1  
**Description:** Triumph Shift Assist  
**Model Affected:** Trident

**Item:** 217.2  
**Description:** Frame to Cylinder Head Left Hand Rear Mounting Bolt  
**Model Affected:** Trident

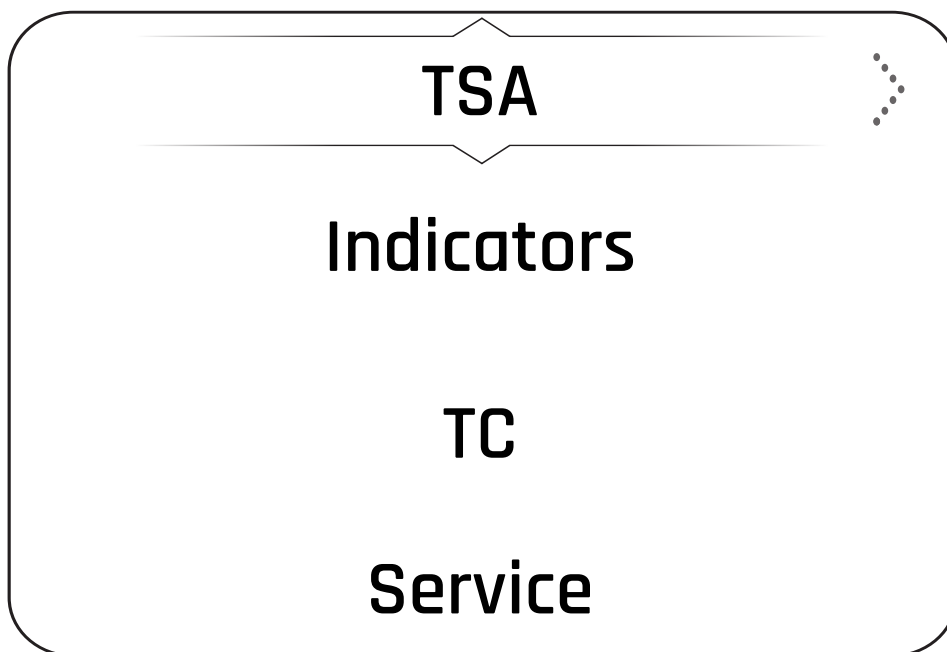
- From the Bike Setup menu, press the Up and Down buttons to select TSA.

It has come to our attention on the above model that if the battery has been disconnected/connected, the Triumph shift assist (TSA) will be disabled.

To enable the TSA, follow the procedure described below.

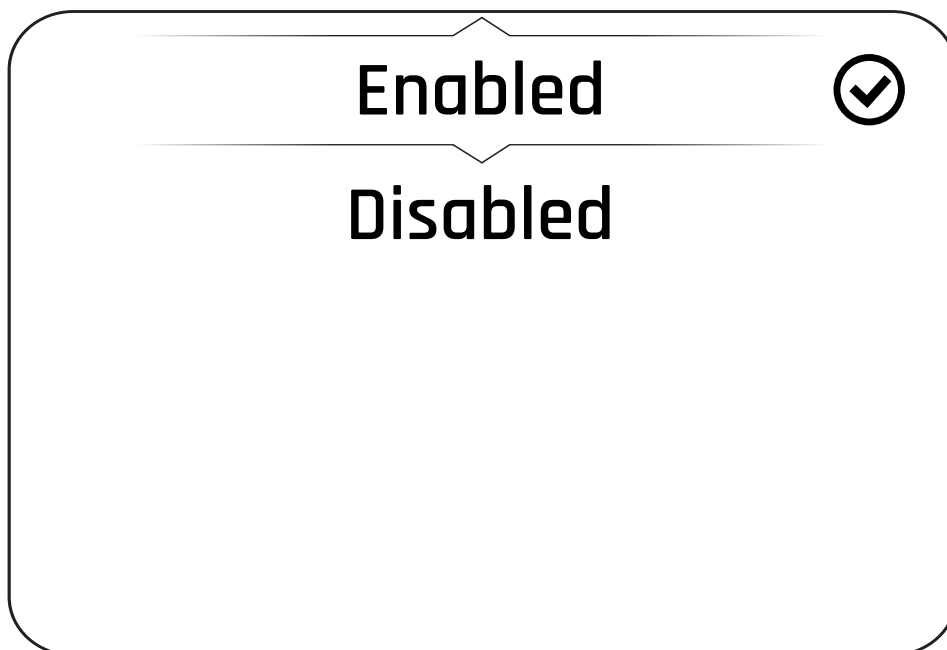
- Press the Right button to view the available options.

- Press the Up and Down buttons to select Enabled or Disabled.
- Press the Select button to confirm. A tick is shown to indicate the selected option.

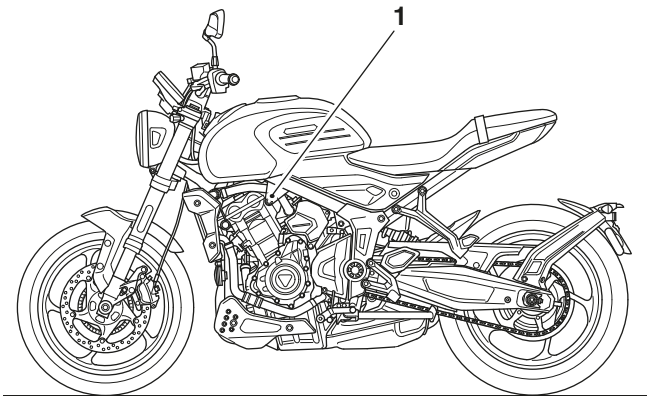
It has come to our attention on the above model that the frame to cylinder head left hand rear mounting bolt may damage the cylinder head threads when being removed or installed.  
When removing/installing the frame to cylinder head left hand mounting bolt power/air tools must not be used. Hand tools must only be used.  
Prior to installing the frame to cylinder head left hand rear mounting bolt, thoroughly clean the threaded part of the bolt and smear the first four threads with a proprietary copper based grease. The tightening sequence remains as described in the Service Manual.

**1. Left hand side rear frame to cylinder head bolt**
