SIB 34 04 14

Diagnosis of Compound Brake System Complaints in M Vehicles

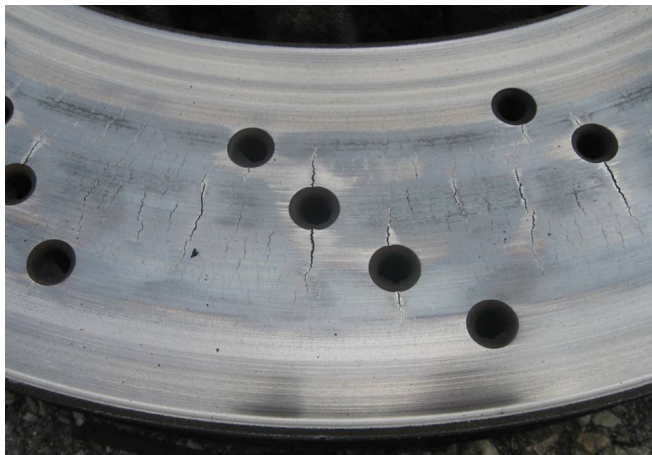
1. Visible cracks are caused by high thermal stresses during rapid heating and cooling of the brake discs. Braking from high speed with cold brake components (less than 212 degrees F) increases the likelihood of cracks to form. These hairline surface cracks are usually spread over the entire brake disc friction area, and have no negative influence on the durability or braking performance.

The rotors should not be replaced only for their appearance reasons.

When performing routine service on the brake system (pad replacement due to wear), the brake discs should be replaced if surface cracks are found to be greater than 13 mm, or if the brake disc thickness is below the minimum thickness.

Always replace brake discs in pairs (per axle). Install new brake pads when replacing discs. By doing this, the service life of the friction pad surface is increased, and an even material loss is ensured.

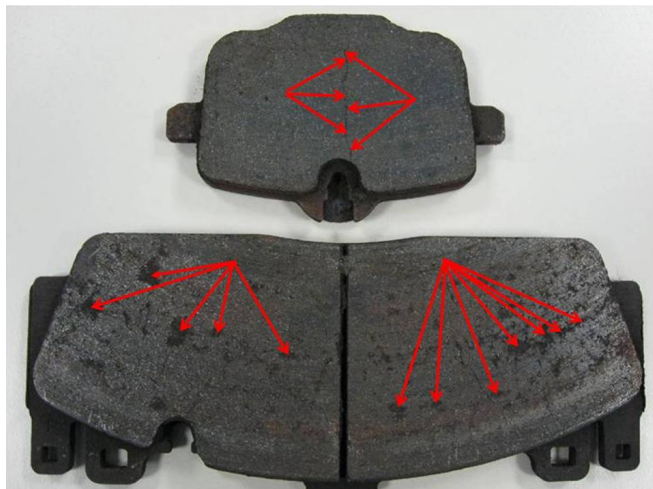
3. After high brake loads, running noises can be heard when applying the brakes, and may also be heard to a limited extent after the brakes are released (See the note in the Owner's Manual).

These noises are reduced during normal everyday operation, due to further erosion of the brake pad friction lining.

Visible surface cracks or crater-like recesses on the brake pad surface are caused by a minor difference in the material of the pad lining, which will decrease with further operation and should not be replaced due to their appearance.
