MODEL
2010MY Soul
w/MT

NUMBER
029

TECHNICAL SERVICE BULLETIN

SERVICE ACTION: SOUL MANUAL TRANSMISSION SHIFT SKIRT
(SA015)

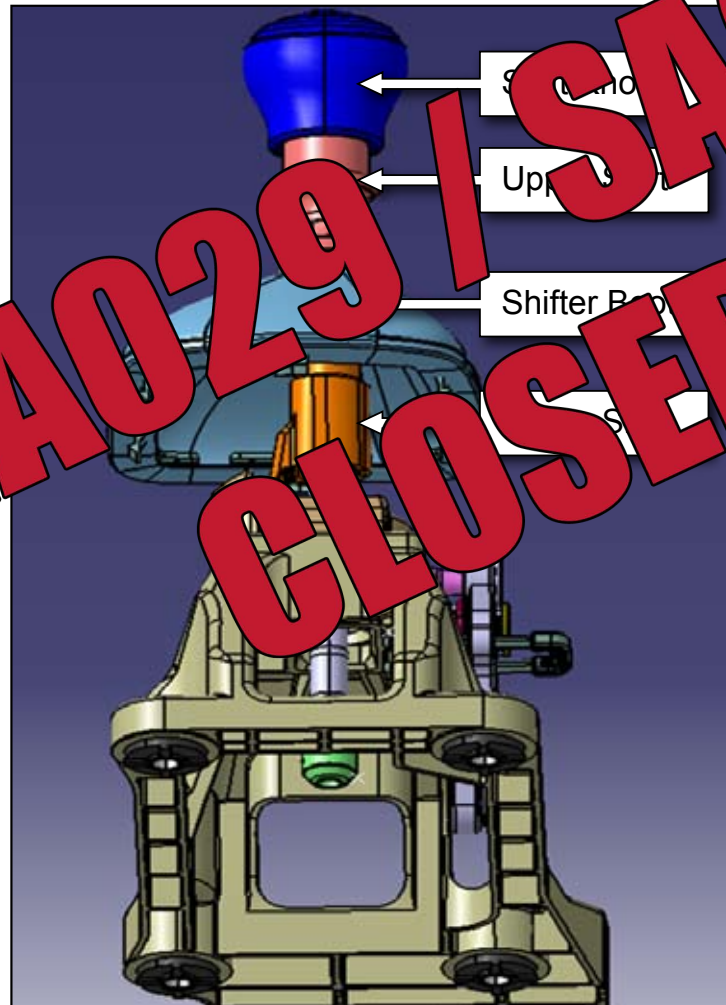
Shifter Assembly – Lower Skirt Replacement

This bulletin provides information related to Soul models produced from 1/8/2009 ~ 9/13/2009. Some Soul customers with manual transaxles may complain the vehicle maybe difficult to get into first (1st) gear when coming to a stop. To repair this concern replace the transmission gear shifter lower skirt, complete shifter assembly replacement is NOT necessary.
