Volvo Chassis - Stemco Hubcap Plug Will Not Stay In

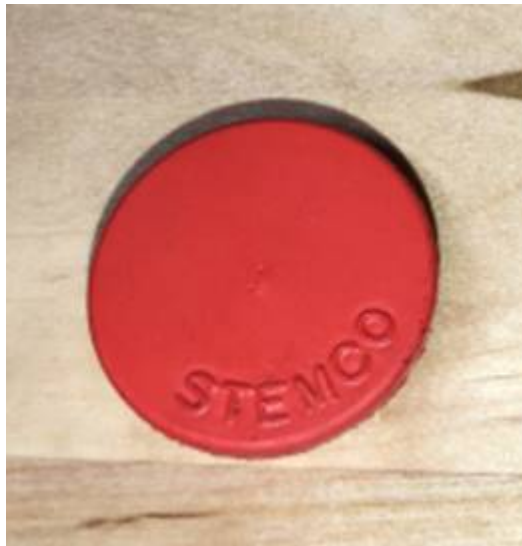
On Volvo model VN, VHD trucks built with hub cap 20421922 or using the 85105316 hub cap, the hub cap comes with a .7874 inch (20 mm) diameter plug that has a vent slit. The Volvo replacement part number for this plug is 92103-5001.

These hub caps can also be retrofitted to utilize a larger diameter plug that has better venting capability. Kit number 85105366 contains a replacement sight glass and a larger diameter 1.312 inch (33.3 mm) plug 1577627. This larger plug has a hole to vent instead of a slit and is less susceptible to popping out.

Note: The 1.312 diameter is measured at the end of the flare. The diameter at the neck is smaller.

Volvo	
	VN,VHD
Production Hub Cap P/N	20421922
Aftermarket Hub Cap P/N	85105316
Hub Cap Plug, Small P/N	92103-5001
Hub Cap Plug, Large P/N	1577627
Hub Cap Retrofit Kit, which includes Large plug	85105366
