Service Alert

**PASSENGER SEAT BELT WARNING LIGHT ON WITH NO FRONT
PASSENGER IN SEAT**

Service Alert No.: SA-042/21

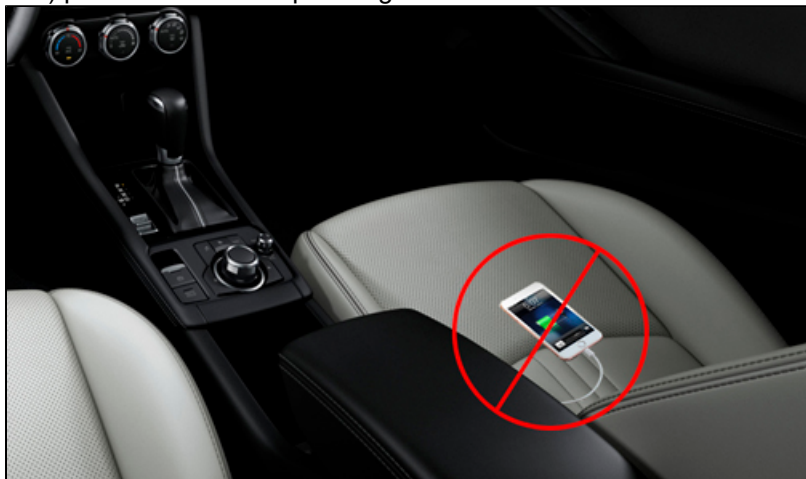
Some customers may complain that the passenger seat belt warning light is ON and the PASS AIRBAG OFF indicator light is OFF with no front passenger in the seat. This may be caused by an electrical device (smart phone, tablet, laptop, etc.) placed on the front passenger's seat.

NOTE: The PASS AIRBAG OFF indicator light does not turn on with this concern.

Advise the customer not to place electrical devices on the front passenger's seat.
