Type: Customer Satisfaction Campaign

MODEL: Revero GT and GS-6**TITLE: Vehicle Recovery Cap Retention Remedy****PURPOSE:** A service tip for loose a recovery cap on the front fascia.

MODEL: Revero GT and GS-6

TITLE: Vehicle Recovery Cap Retention Remedy

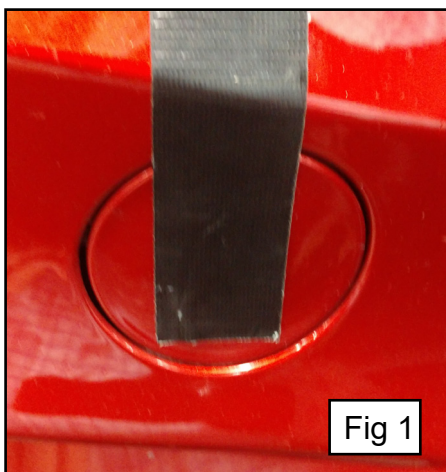
Place a temporary piece of tape as an anchor on the cap as shown in (Fig 1).

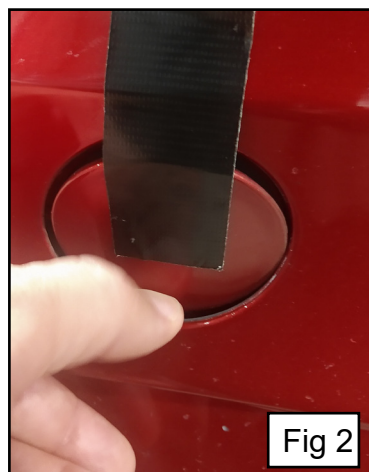
Apply pressure to the bottom portion of the cap to pop it out (Fig 2).

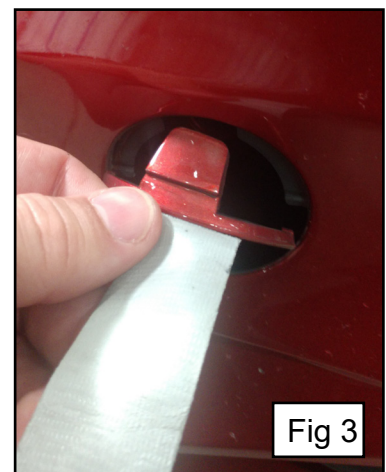
As the cap rotates (Fig 3) use the tape to assist in guiding the cap out to remove safely from the front fascia the remove the recovery cap.

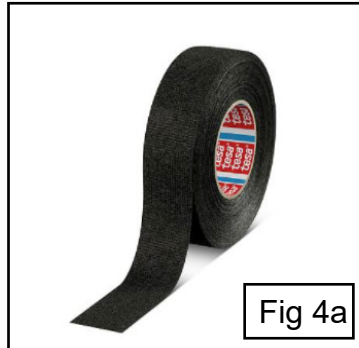
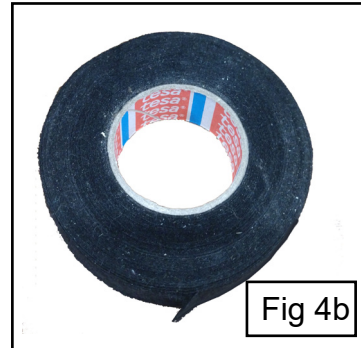
Source this locally, felt wire loom tape if none is available. This is available on-line and at most auto parts stores (Fig 4a and Fig 4b).

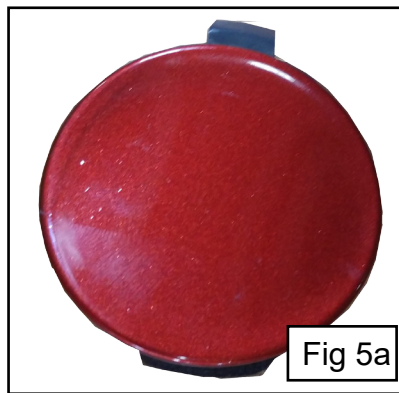
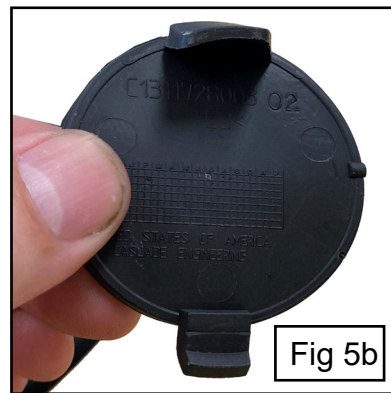
The existing or new cover (fig 5a and fig 5b) will now have the tabs wrapped with the felt tape.

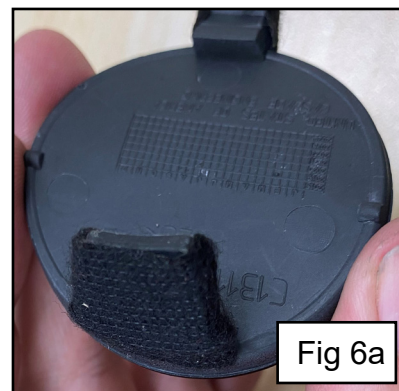
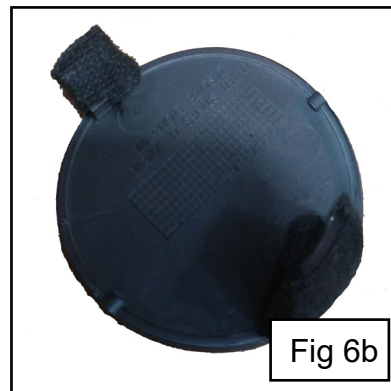
Cut small strips to wrap these tabs neatly providing one or two layers of the tape on each tab (fig 6a and fig 6b). This should not be too thick so as to cause too great an effort on installation. Installation is the reverse of removal.
