# SERVICE BULLETIN

Classification: AT19-002F	Reference: NTB19-040F	Date: June 14, 2021
------------------------------	--------------------------	------------------------

## DTC P0741/4/6, P0776, P0841, P0875, P0965, P2857/8/9, P17F0/1/2/4 AND/OR P285A STORED, AND MAY HAVE HESITATION AND/OR REDUCED POWER

**APPLIED VEHICLES:** 2018-2021 Kicks (P15)  
2020-2021 Versa Sedan (N18)

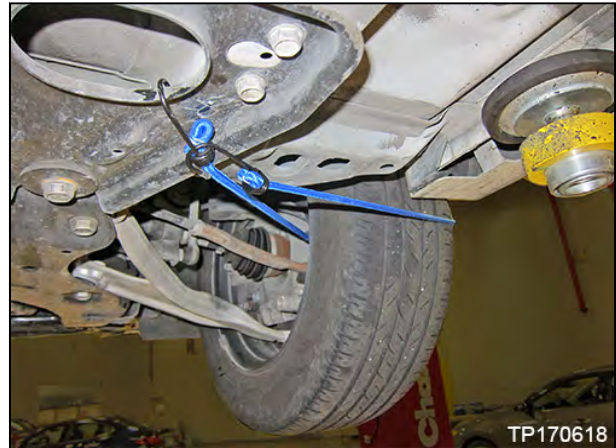
Figure 7

13. Secure the front right tire with a suitable strap.
  - This will assist in making the belt turn during the borescope belt inspection step.
14. Mark the front left tire with a suitable marking.
  - This will assure all 360° of the belt is inspected.

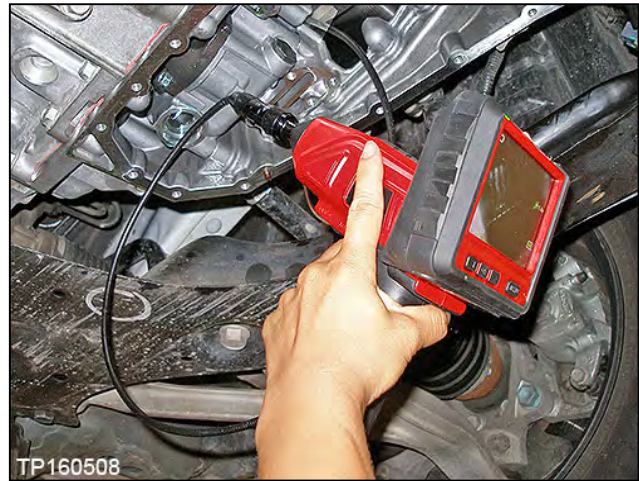
Figure 12

- c. Using the mark applied to the left front tire for reference, slowly and carefully rotate the front left tire one full turn in either direction to view all of the belt.
- Holding the borescope (camera flexible tube) with one hand allows rotation of the tire with the other hand (see Figure 12).

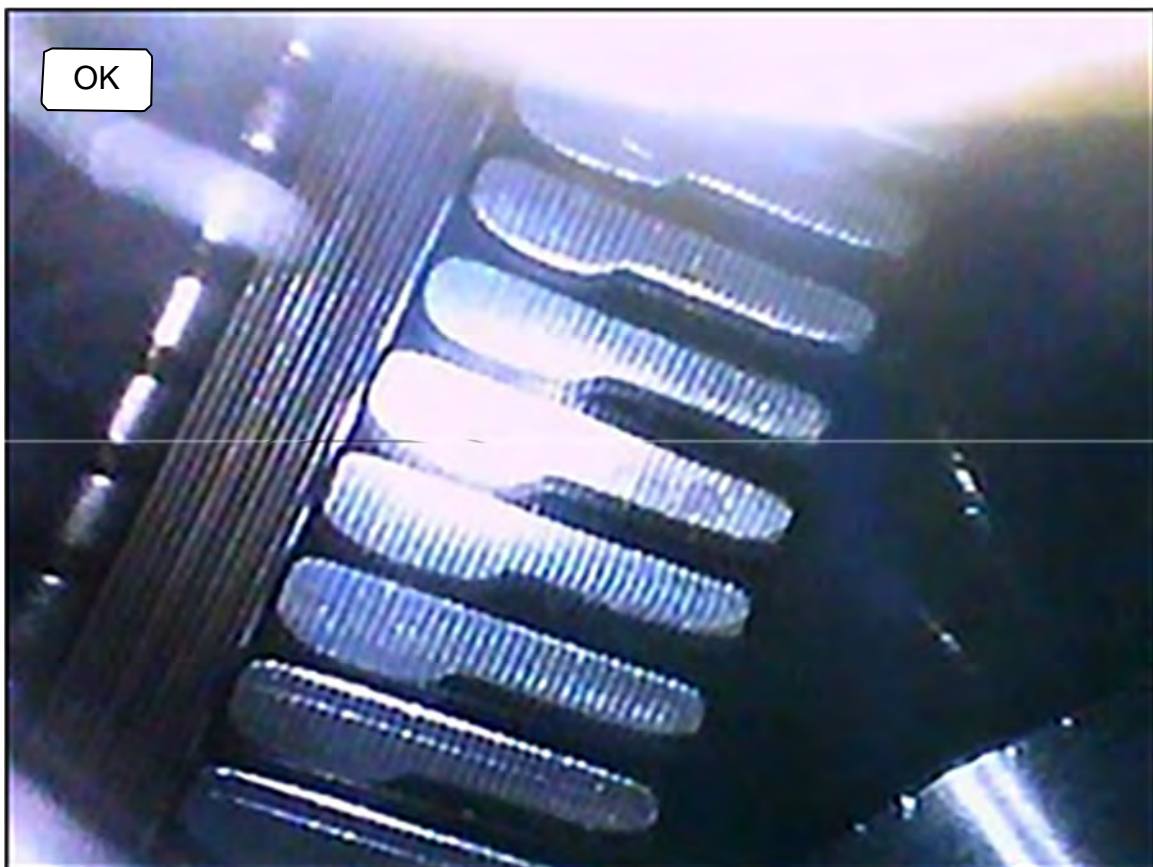
Pictures in Figure 16 and Figure 17 were taken with borescope J-51951.

21. Was belt damage found?
  - **NO:** Skip to step 31 and install a new control valve.  
**NOTE:** If no belt damage is present, only the control valve (valve body) will be replaced.
  - **YES:** Proceed to step 22.
22. Re-install the original (removed) control valve, oil pan gasket and oil pan, hand tight.

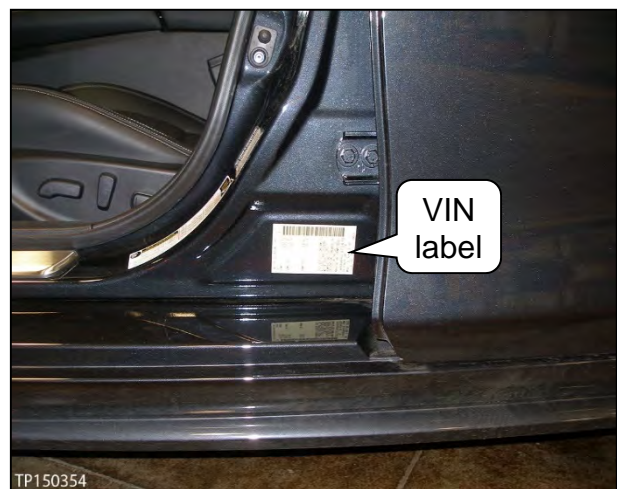
Figure 23

24. If CVT replacement is required based on the inspection results from steps 18 and 19, use borescope J-51951 to record a continuous video, 15 seconds or less, of the most severe evidence of belt slip and the VIN on the F.M.V.S.S. certification label (VIN label). See Figure 23.
