SS 3082-FTL2021 P4 New Cascadia Fuel Sending Unit Connector Loose

All P4 Vehicles

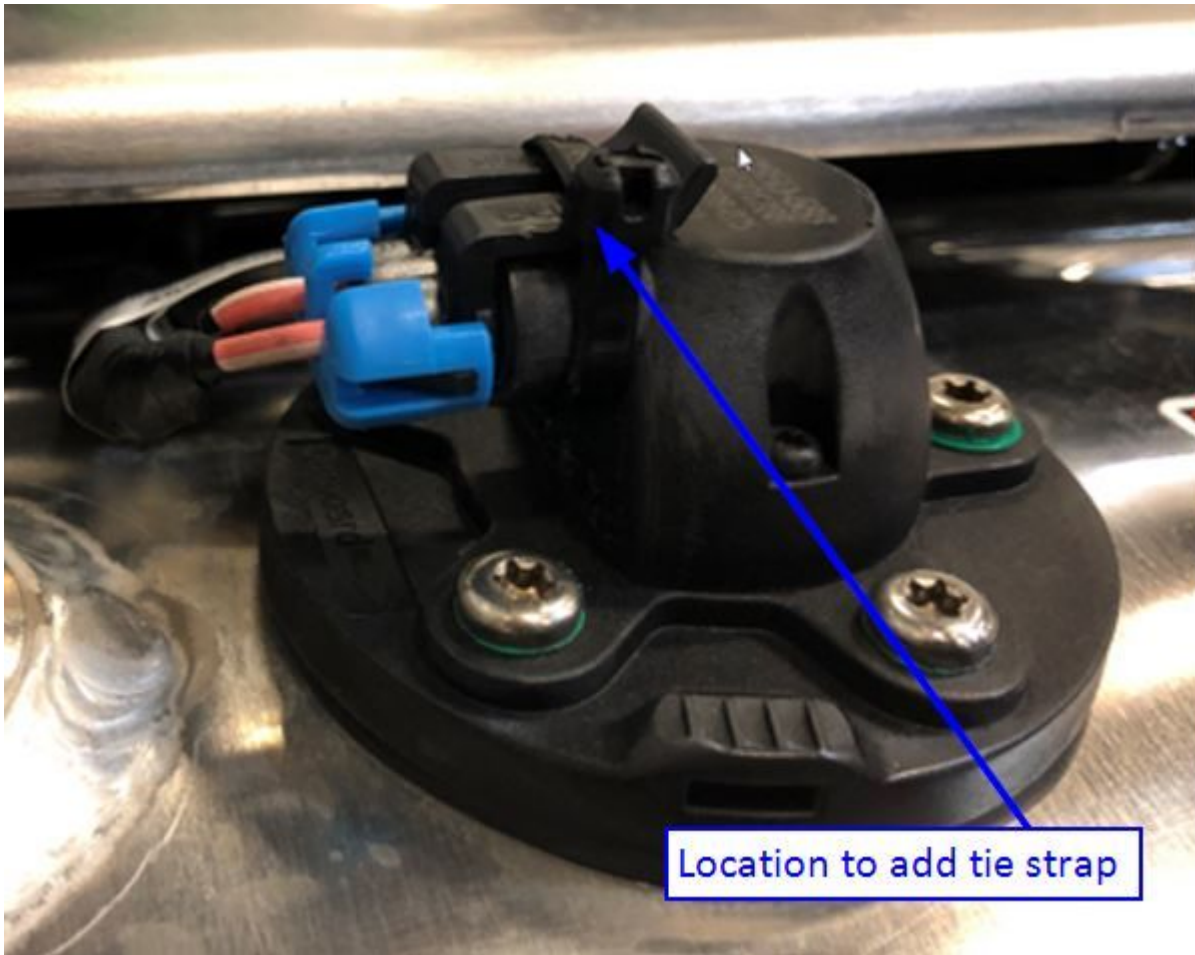
Figure 1

Fuel gauge reads empty.

Fuel sending connector detached/unplugged.

Tie strap fuel sending unit on the plug locking tab to prevent disconnection (See Figure 1)
