SIB 01 04 19

F48 FUEL TANK VENT/PURGE VALVE: LTD WARRANTY EXTENSION

2021-06-01

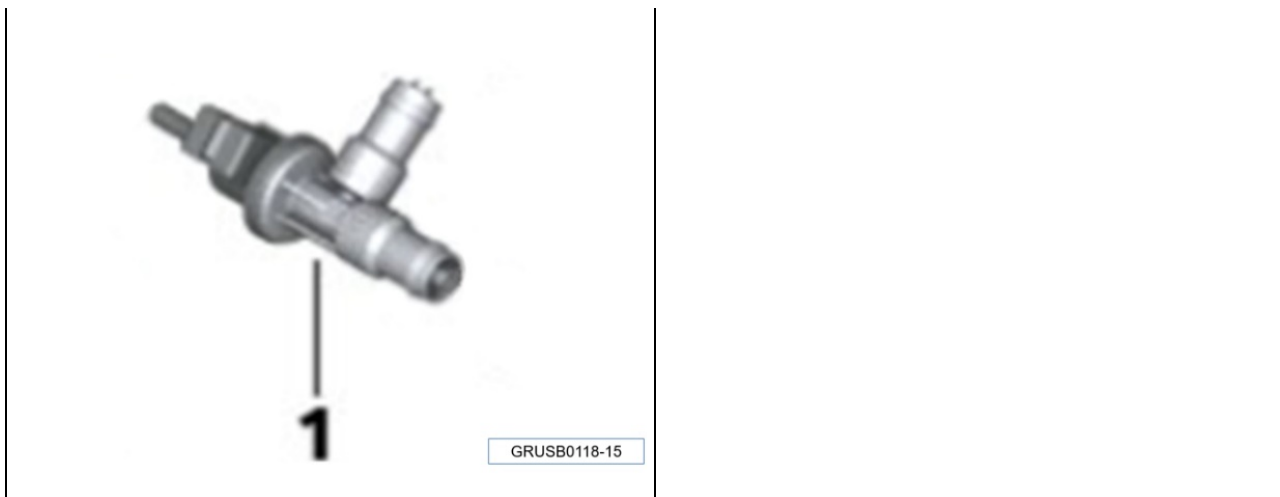
<p>For the eligible vehicles that are not covered under the State of California PZEV (SULEV) emission regulation, BMW of North America, LLC (BMW NA) is extending the limited warranty for the vehicles fuel tank vent (purge) valve (shown) to:</p> <ul style="list-style-type: none"> • 10 years/120,000 miles as determined by the vehicle's original in-service date
--	--

The fuel tank vent valve may be faulty.

Replace the fuel tank vent valve as instructed after performing ISTA diagnostics and the related test plans.
