GROUP	MODEL
General	See table below
NUMBER	DATE
PS656 (Rev 2, 08/24/2021)	March 2020

REAR OCCUPANT ALERT (ROA) WITH ULTRASONIC OPERATION

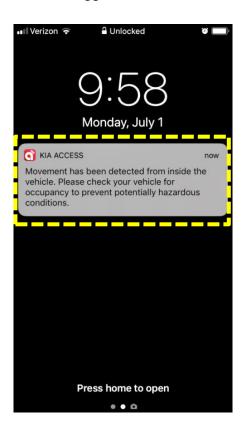
If the customer's Kia Access with UVO Link account is activated and notifications are enabled, they will receive the following phone notification when ROA is triggered.
