SIB 51 16 21

NOISE FROM THE CENTER CONSOLE GEAR SHIFT COVER

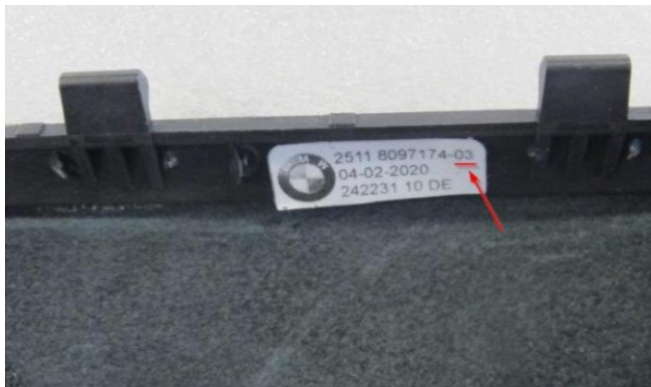
1. Inspect the shifter cover revision index number (AI).

2. If the index number is 03 as shown in the picture, replace shifter cover with revision 04, as per repair instructions **25 11 085**

3. If the index number is already at 04, do not replace shifter cover, and perform further diagnosis.
