Bulletin No.: PIP5813
Published date: 07/9/2021

PIP5813 Replacement Camshaft Information

Models

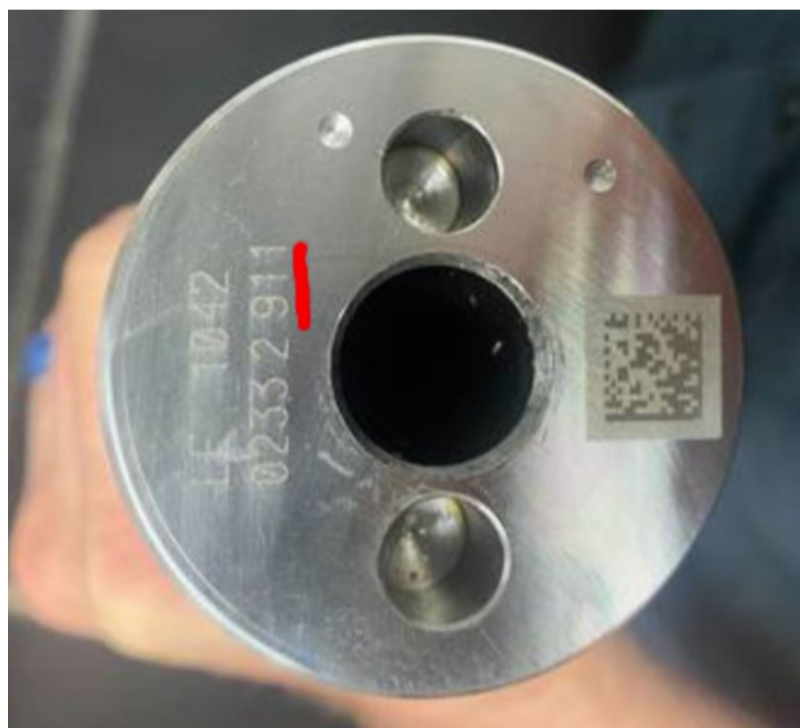
The camshaft below showing the 911 is for the L84 part number 12664911

Prior to installation, inspect the end of the camshaft, as the last 3 digits of the part number will be at this location (as seen below).

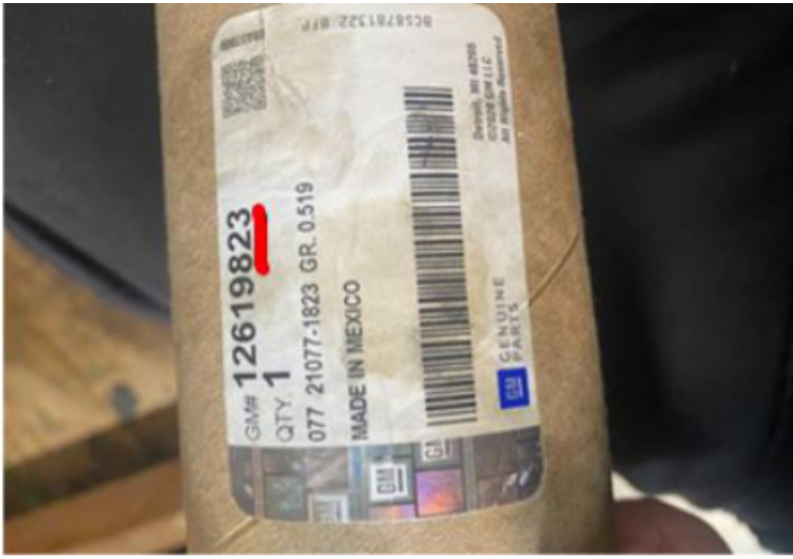
The label below shows the correct camshaft part number 12619823 for L83 the camshaft above should have 823 NOT 911 etched on the end.
