## **SPECIAL SERVICE CAMPAIGN 20LC02**

## FRONT INSIDE DOOR HANDLE MAY BECOME INOPERATIVE

#### CERTAIN 2016-2019 MODEL YEAR RX350 and RX450h

## **UPDATE 07/07/2021**

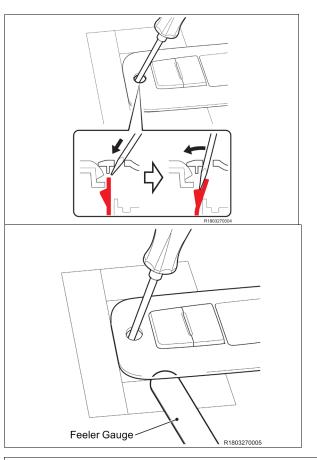
Using a ¼in drill bit, drill a hole into the window switch cover using the indents as a guide.

Use a slow speed on the drill to reduce the chances of the drill slipping off the window switch.

e) Using a small screwdriver, release the locking tab by inserting the screwdriver into the hole and prying the tab back.

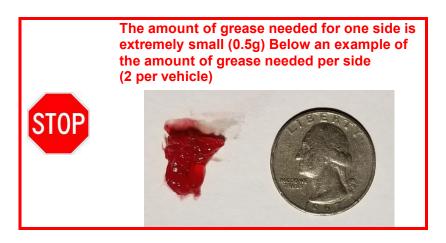
e) Apply the grease (Plus guard SG) to the positions shown in the illustration.

f) Move the lever several times to make sure it functions normally.
