## MOST Bus Network: Overview, Troubleshooting, and Repairs

Year	Model	Trim Level
2018 and later	Odyssey	ALL
2019 and later	Passport	ALL
2019 and later	Pilot	ALL

This job aid contains information on the MOST Bus Network and troubleshooting information for common problems.

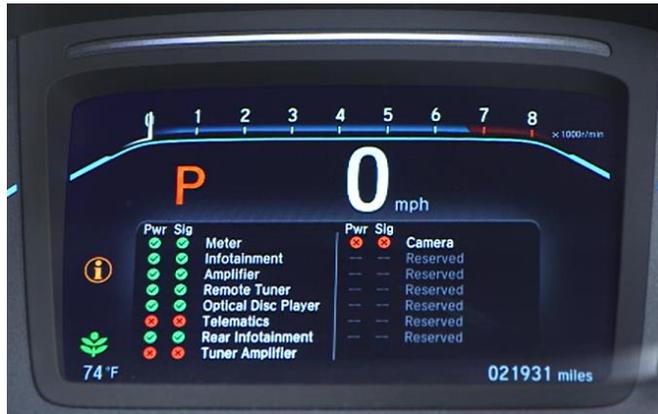
4. While displaying the settings screen, press and hold the **HANG-UP** button and then the **ENTER** button until the MOST bus diagnosis screen below is displayed.

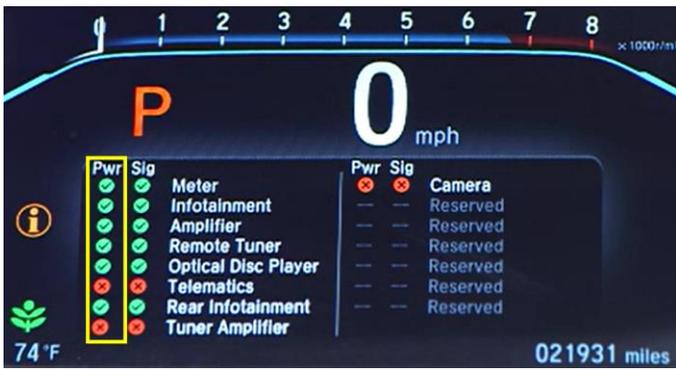
The **Pwr** (Power) column shows if each component is online or not.

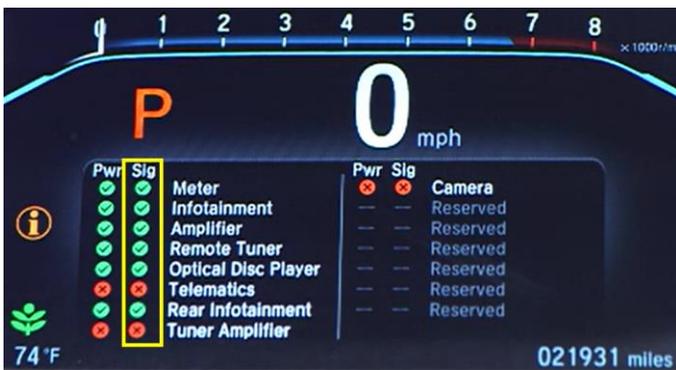
The **Sig** (Signal) column shows if the component is receiving a signal.

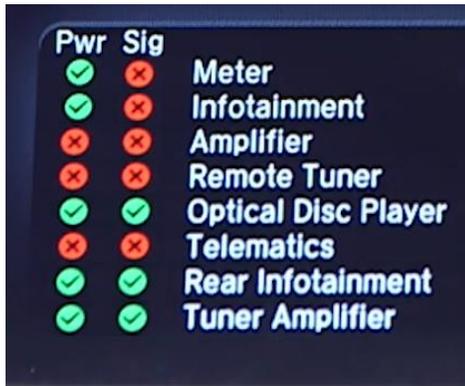
In this first example, the following components reported a power problem and signal problem or just a signal problem.

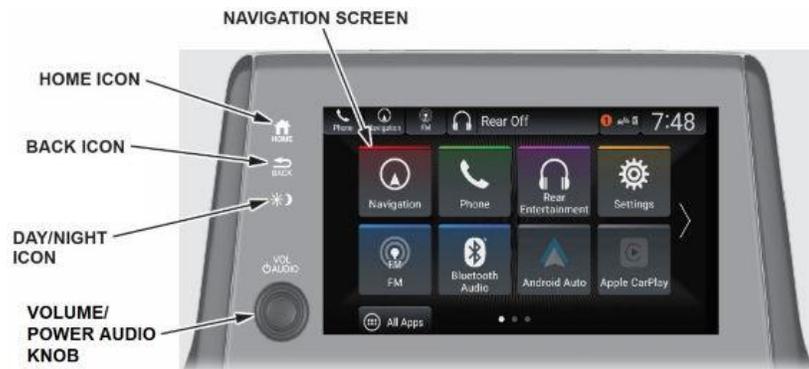
## ODYSSEY

1. Turn the vehicle to the ON mode.
2. Press and hold the VOL/Power AUDIO knob, **Day/Night** icon, and **HOME** icon at the same time. Hold these buttons until the Dealer Diagnostics menu screen appears.

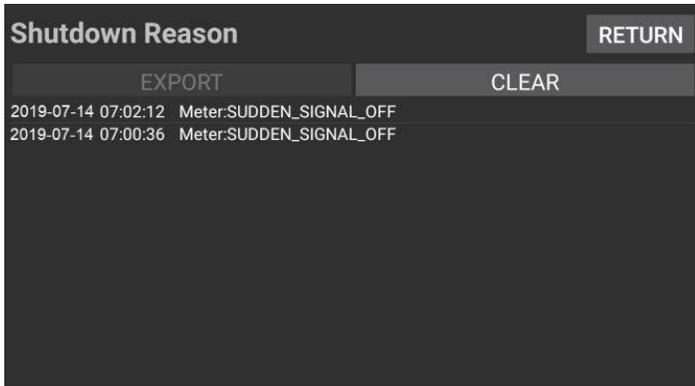
Look for the most recent event on the list. In the example below, the cause of the intermittent failure can be identified as **Meter:SUDDEN\_SIGNAL\_OFF**, dated 2019-07-14 with a time stamped 07:02:12. There was a complete loss of signal between the gauge control module and the previous transmitting component on the network.

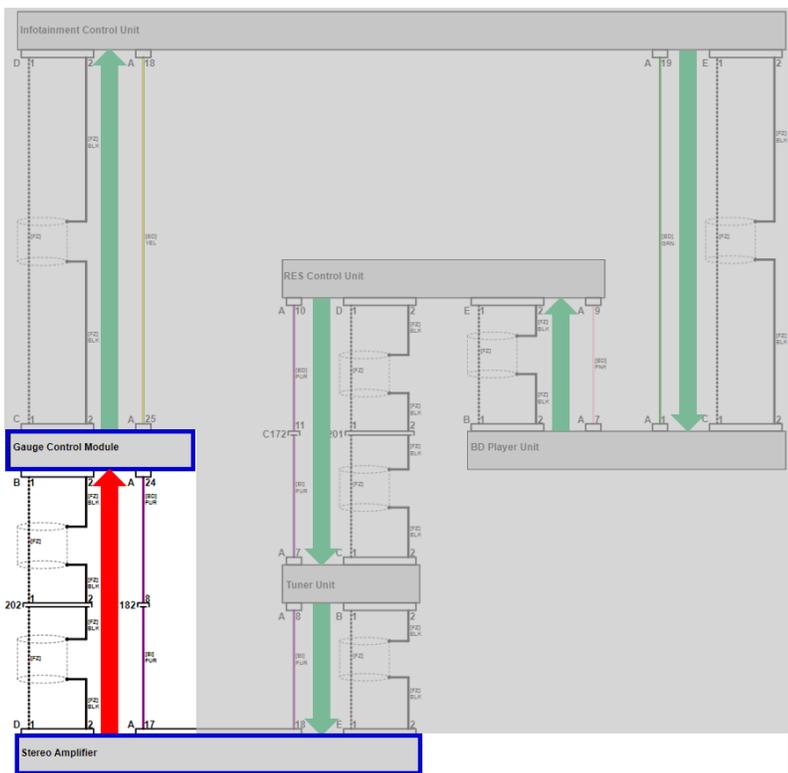
Similar to the MOST Electronic Control Line (ECL) Diagnostic Mode procedure, you must determine the network flow and the previous component to the reported failed component. In this case, the previous component to the gauge control module is the stereo amplifier, and troubleshooting will focus on the circuit between the two components.

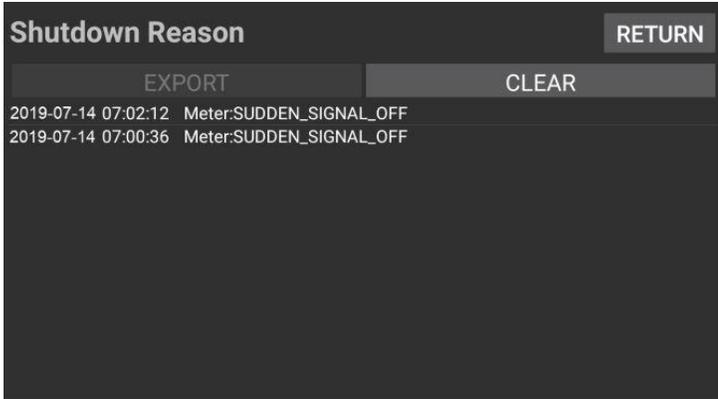
After repairs are completed to the network, be sure to clear the failure logs. This can only be done through the failure log screen by pressing the CLEAR button.

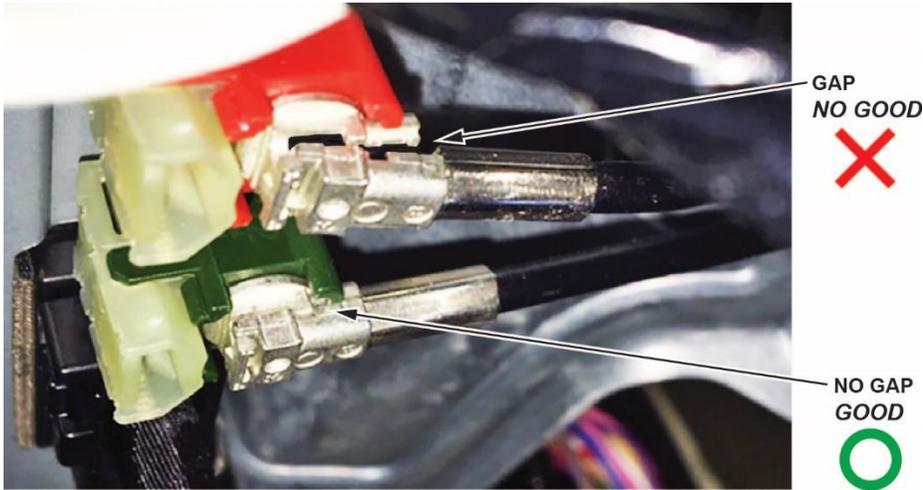
**Example 1**

The green connector sits correctly, perpendicular to the control unit, while the red connector sits at an angle caused by tension on the wire harness.

In both examples, the connector is considered damaged, and the wire harness must be replaced. These connectors **are not** repairable.

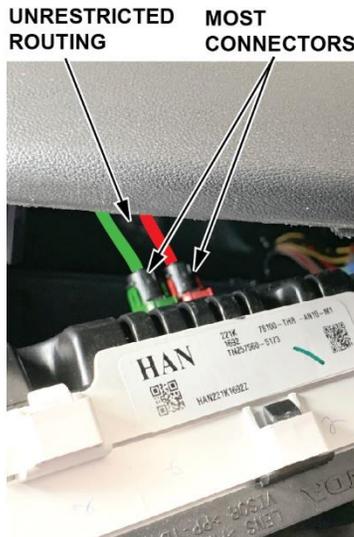
Below are more examples of incorrect harness mis-routing.

**✗ NO GOOD**

**○ GOOD**

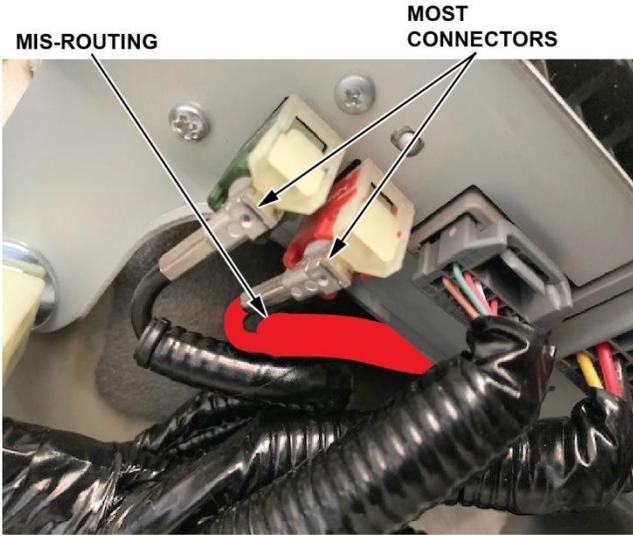
**X** NO GOOD

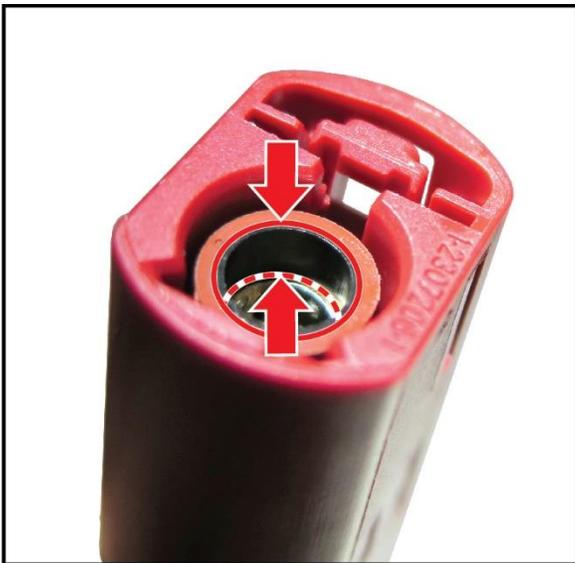
**Example 5**

The wire is not fully seated into the new terminal. The edge of the wire must sit with the edge of the updated terminal.

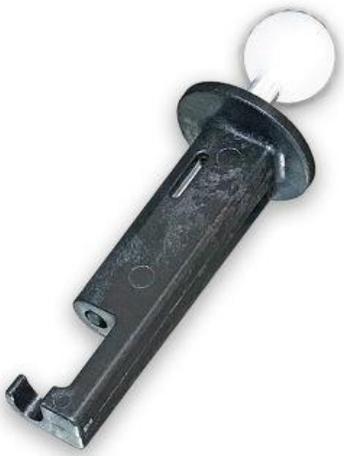
**90 DEGREE FAKRA A PULLER (T/N 07AAC-THRA100)**

NOTE: Use this tool for removing 90° connectors in tight areas such as the Odyssey RES Control Unit behind the glove box.

1. Install the puller.

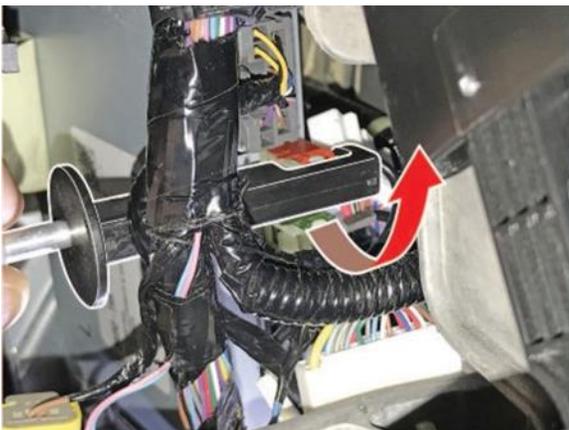
2. Rotate the puller.

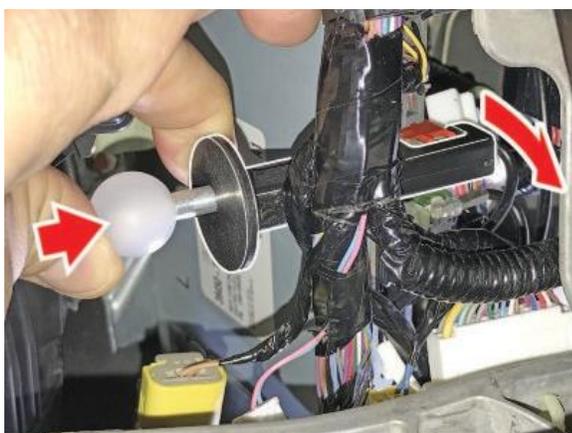
4. While holding down the ball, slide off the connector.
