## Mack Chassis - SNM16-031 US'14 (GHG) MP8 Two Piece Valve Cover (Corroded Screws)

**Bulletin:** SNM16-031  
**Date:** September 12, 2016  
**Valid to:** Until Further Notice  
**Replaces:** N/A  
**Action Required?** **Yes**

**Subject:** US'14 (GHG) MP8 Two Piece Valve Cover (Corroded Screws)

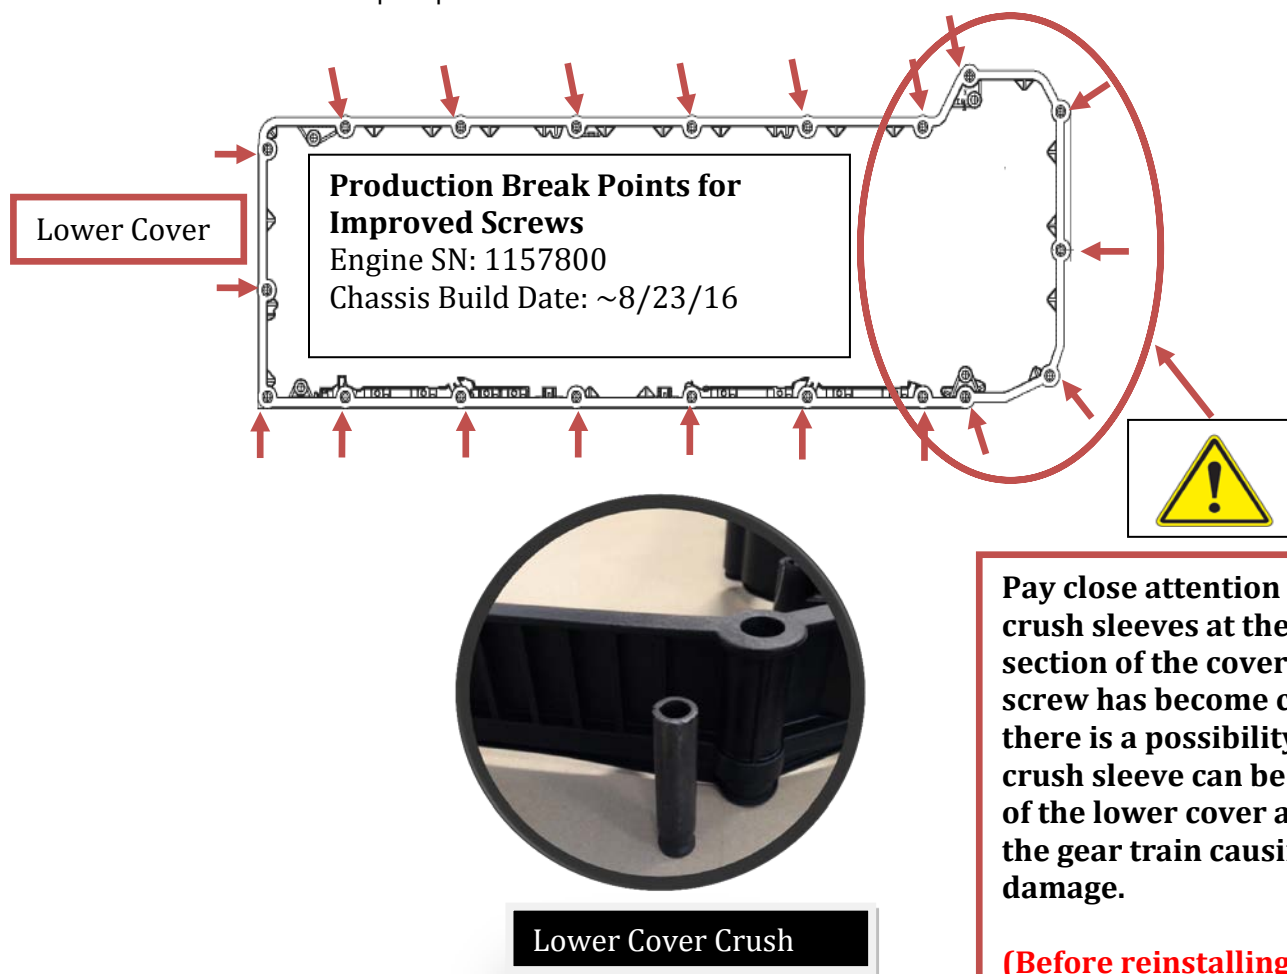
An improved screw (Part # 22806270) is being released to prevent corrosion on the stem of the screw and threads. If corrosion has occurred replacement of all screws is required. If you encounter a screw that has corroded or seized, make sure the crush sleeve inserts in the lower cover remain secure during repairs. **Failure to confirm that all sleeves remain in lower cover could lead to engine damage.** The crush sleeves are not offered as a spare part at this time, however we are in the process of getting sleeves released as a spare part.
