## FIELD SERVICE CAMPAIGN – 21107

14 September 2021

Air Filter Minder Gauge Replacement

International® HX® Series trucks with Cummins X15 engine only

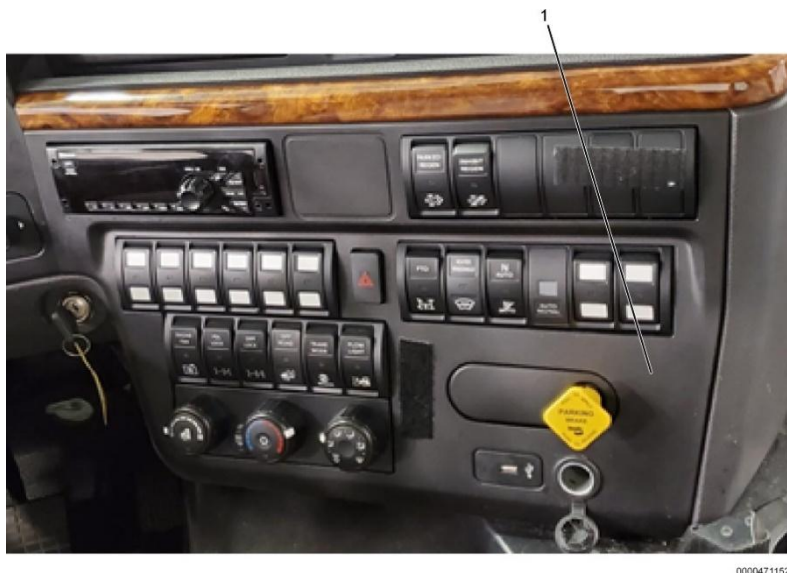
**Figure 1. Center Dash Bezel**

1. Center dash bezel

6. Disengage and remove center dash bezel (Figure 1, Item 1).

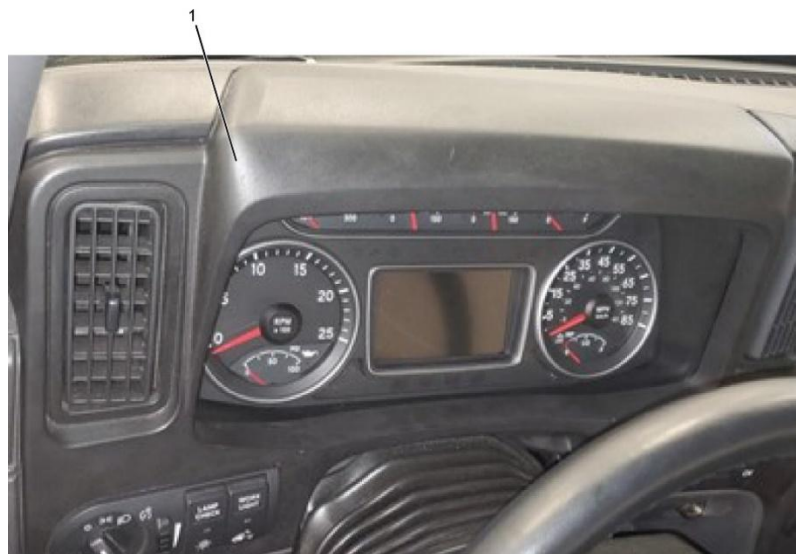
**Figure 2. Instrument Cluster Bezel**

1. Instrument cluster bezel
7. Disengage and reposition instrument cluster bezel (Figure 2, Item 1) slightly away from instrument panel.
8. Disconnect headlight and cluster switches. Then remove instrument cluster bezel.

16. Position auxiliary gauge bezel to instrument panel and install previously removed bolt. Tighten bolt securely.
17. Connect headlight and cluster switches to instrument cluster bezel (Figure 2, Item 1).

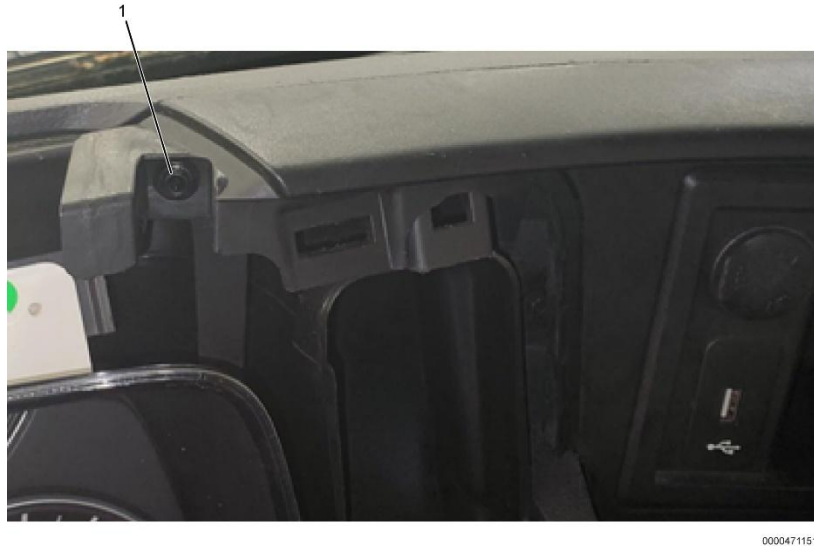
**Figure 3. Auxiliary Gauge Bezel Bolt**

1. Auxiliary gauge trim bezel bolt
9. Remove auxiliary gauge trim bezel bolt (Figure 3, Item 1). Save bolt for reinstallation.
10. Reposition auxiliary gauge trim bezel to access gauge connectors.
