SERVICE BULLETIN

NUMBER: 09-74-21R

SUBJECT: Cleaning Procedure for Carbon Deposit Removal to Address Engine Misfire DTCs, Black Smoke from the Exhaust, Lack of Power, Knocking (Ping) and / or Rough Idle Concerns

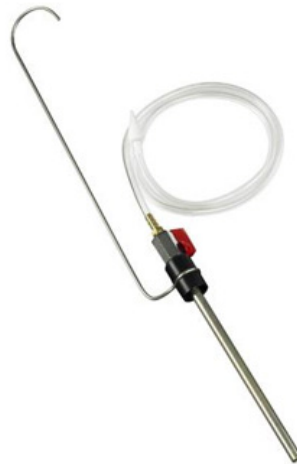
Use tool **SOA868V9430** with this black, long-neck style bottle only.

New tool **SOA868V9432** is to be used with these new shorter clear or black bottles only.

- The new (shorter) bottle contains the same amount of P.E.A. product (6.76 oz.) but utilizes the newer version (**SOA868V9432**) of the applicator tool which has a shorter siphon tube designed to work in conjunction with the new bottle.
- Be sure to use the correct tool for the corresponding bottle style. The siphon tube on the original (long-style) tool is approximately **7 5/8"** long while the new version for use with the shorter bottles measures **6 3/8"**.
- The end of the siphon tube on the tool should not contact the bottom of the bottle. If it does, the old tool is being used with the new style bottle.
- If the tool does not extract all the contents of the bottle, the new tool may have been used with the old bottle.
- Each retailer has been automatically shipped ONE of the new (shorter siphon tube) applicator tools at no charge.

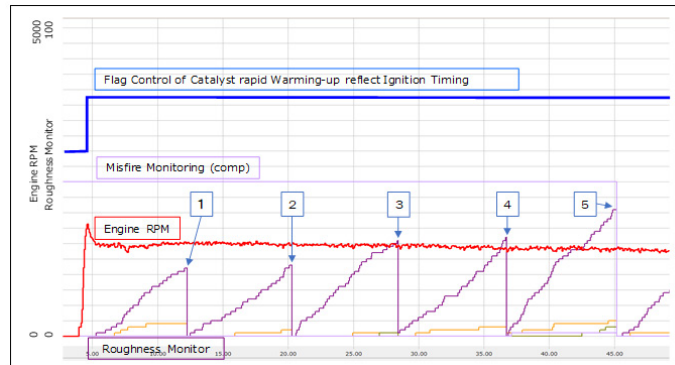
EXAMPLE 1:

- Flag control of Catalyst Rapid Warming-up reflect Ignition Timing
- Misfire Monitoring (comp)
- Engine RPM
- Roughness Counters #1, #2, #3 and #4.
- The roughness counter rises and resets (drops sharply) repeatedly which is the reason the signals form triangles. Read the peak values of each triangle on all cylinders until the “Misfire Monitoring (comp)” changes to “0” then, add all the values to get a “total” value. A **TOTAL** count of **34 or less** is to be considered acceptable.

Cylinder:	Peak 1	Peak 2	Peak 3	Peak 4	Peak 5	Total:
#1 (Orange)	4	2	1	3	5	169
#2 (Blue)	0	0	1	0	3	
#3 (Purple)	22	23	31	32	41	
#4 (Green)	0	0	0	0	1

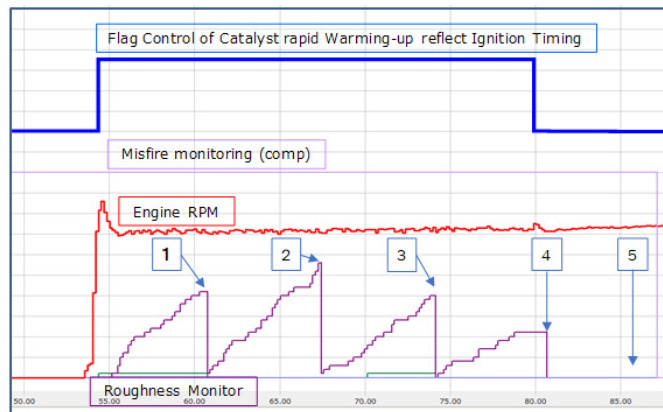
EXAMPLE 2:

Cylinder:	Peak 1	Peak 2	Peak 3	Peak 4	Peak 5	Total:
#1 (Orange)	0	0	0	0	0	82
#2 (Blue)	1	0	1	0	1	
#3 (purple)	21	28	20	11	0	
#4 (Green)	0	0	0	0	0

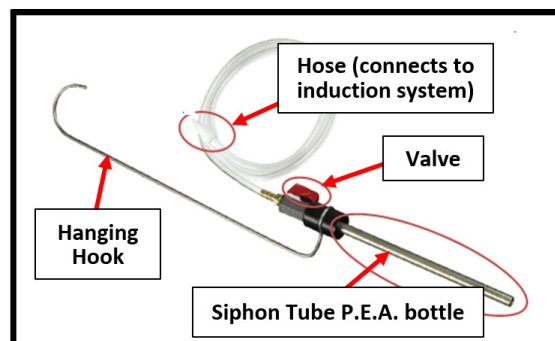
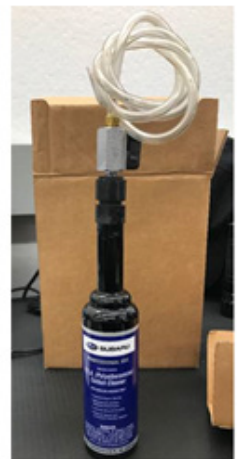
- **STEP 3 (all models):** Pour **ONE** full bottle of P.E.A. carbon cleaner into the vehicle's **FULL** fuel tank. **REMINDER:** The fuel tank **MUST** be **FULL**.
- **STEP 4:** With the valve **CLOSED** as shown below, remove the cap and thread the applicator tool onto the P.E.A. bottle. During use, try to keep the bottle vertical to insure all the contents are consumed.

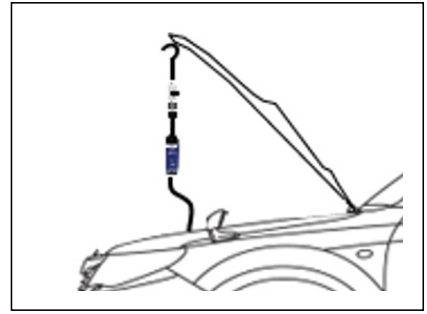
- **STEP 5:** Use the hanging hook to hold the assembled applicator tool on the hood striker as shown here.

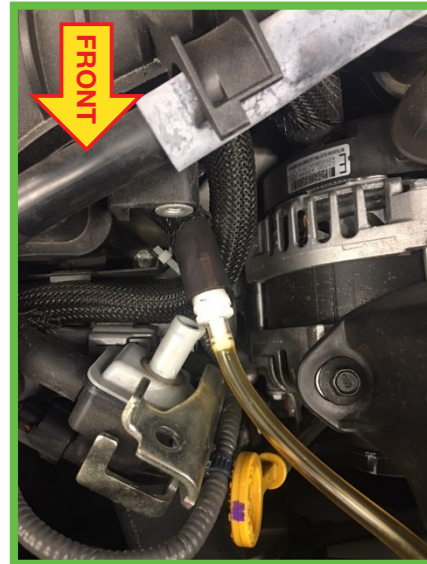
2.4 DIT

- **STEP 6:** Remove the purge hose and connect the hose from the applicator tool. Refer to the images below for the hose locations.

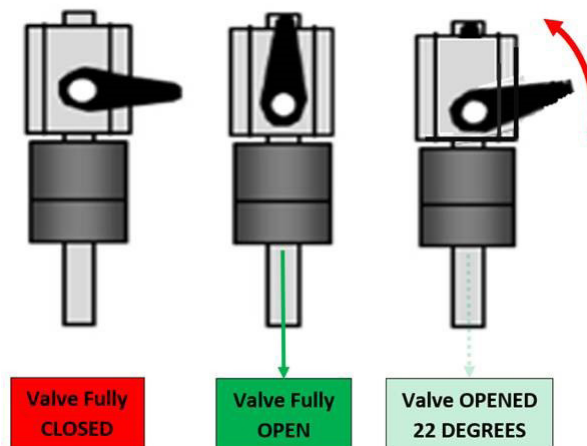
Step 7b) Open the valve on the applicator tool carefully and adjust to approximately 22 degrees from closed. Use the illustration below for reference. At that flow rate, it should take about 1 hour to empty the 6.76 oz. bottle. **IMPORTANT:** This flow rate is critical. Some trial and error (e.g. put the intake supply hose into a CLEAN container and experiment as needed to determine the proper opening position of the valve to achieve the required flow rate). Return any used P.E.A. to the supply bottle.
