Spyder 2021 1330 Engine With Low Compression - 139334

We have some reports of Spyder MY21 (built after January 2021) with no start due to low compression.

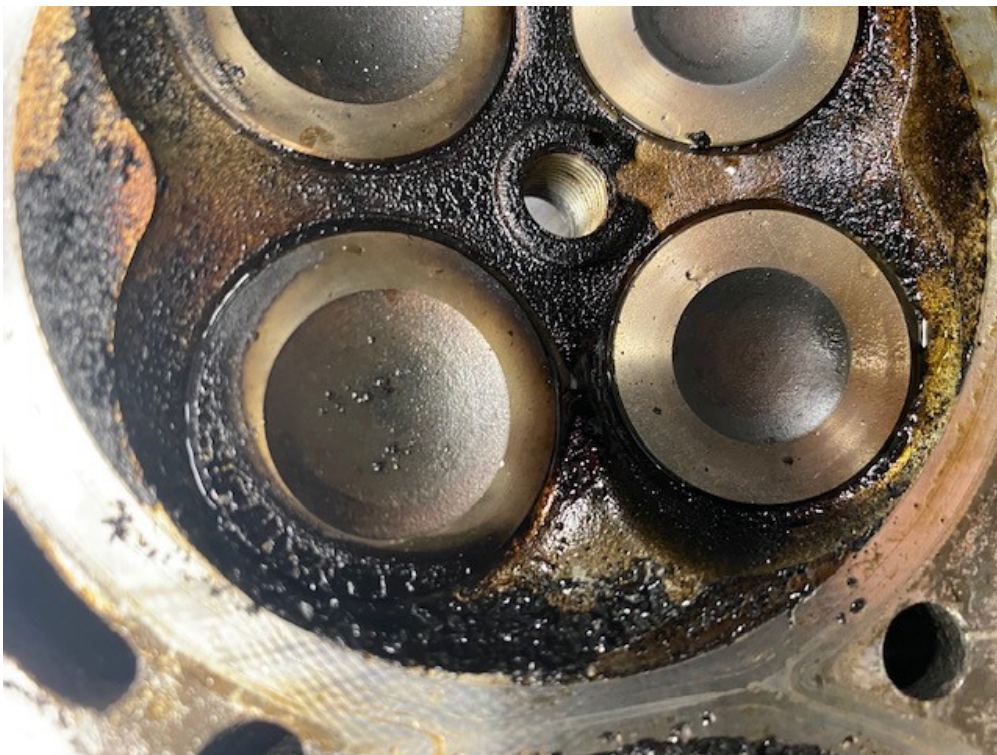
The engine won't start due to low compression (+- 80 PSI) and a major leak down (+-90%). The root cause found is carbon buildup in the combustion chamber probably caused by worn-out rings.

Some of you might notice a slower cranking and, no spark & injection pulse, this is normal with a low compression issue and an engine without a camshaft sensor.

Remove the spark plugs and fuel rail (injector). Use carburetor and carbon cleaner product and spray it generously in the combustion chamber and in the fuel rail injector hole. Remove the 14mm Allen nut on the engine side and turn the engine a little. Spray cleaner again and wait +- 30 min (follow cleaner guidance). After the waiting time, use an air gun and blow all 3 cylinders to remove all cleaner excess. Re-install spark plugs and injectors. Start the engine and let it warmed up. Replace the oil.
