## Technical product information

| <b>Topic</b> | Transmission communication DTC's (Numerous) - W12 engine |

### New Continental GT and New Continental GTC - W12 engine

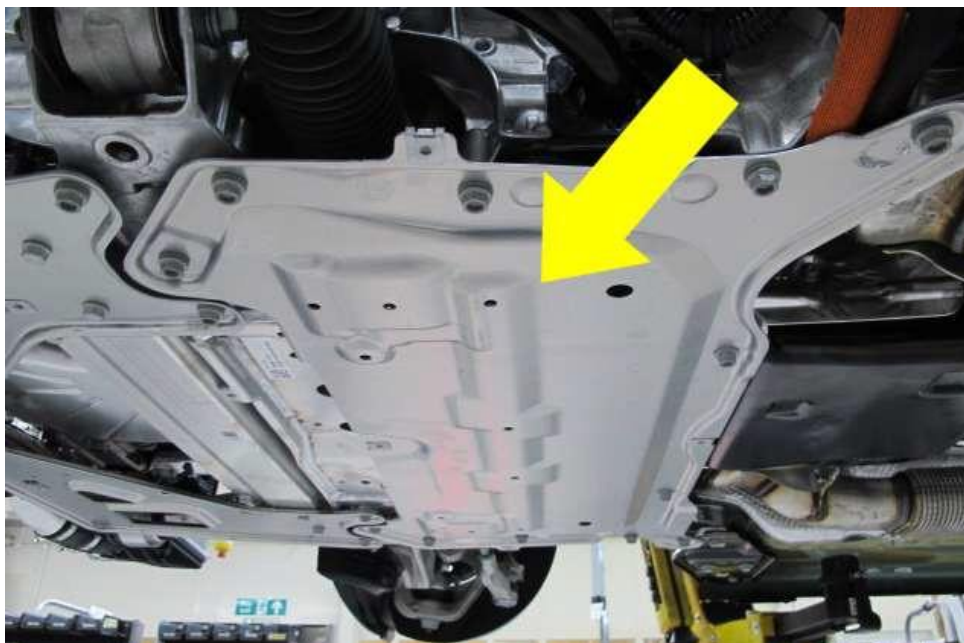
Figure 3

3) Remove the rear subframe support – Rep.Gr 40 (Figure 3)

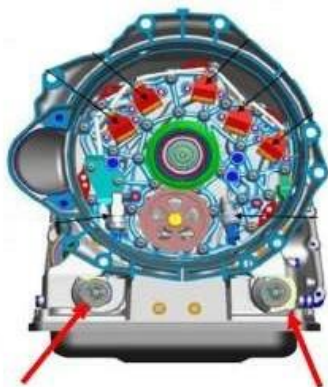
Figure 4

4) Disconnect the connections (Figure 4 - Arrows) from the Mechatronic unit for dual clutch gearbox -J743-

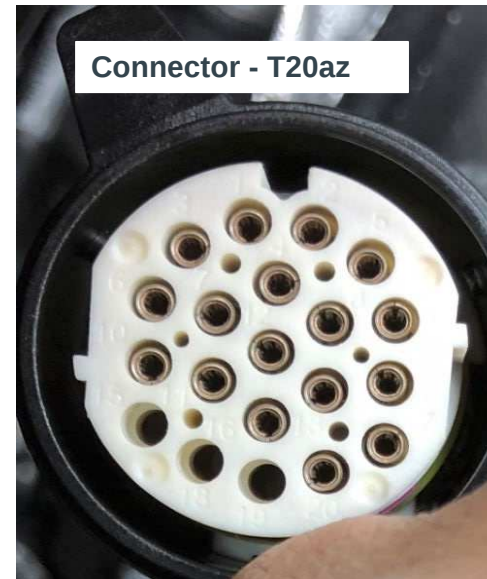
| Connector T58ag | | Power supply | Resistance |

| Connector T20az | | | Resistance |
