## Technical product information

<b>Topic</b>	DTC's stored for all cylinders on Bank 1 or all cylinders on Bank 2 - W12 TSI engine derivative
<b>Market area</b>	Russische Föderation (5RU),Australia E04 Bentley rest Asia and Australia (6E04),China 796 VW Import Comp. Ltd (Vico), Beijing (6796),Germany E02 Bentley rest Europe (6E02),Japan E03 Bentley Japan (6E03),Korea, (South) E08 Bentley South Korea (6E08),United Arab Emirates E06 Bentley Middle East and Africa (6E06),United Kingdom E01 Bentley UK (6E01),United States E05 Bentley USA and rest America (6E05)
<b>Brand</b>	Bentley
<b>Transaction No.</b>	2062626/2
<b>Level</b>	EH
<b>Status</b>	Approval
<b>Release date</b>

### Bentayga, New Flying Spur, New Continental GT&GTC - W12 TSI

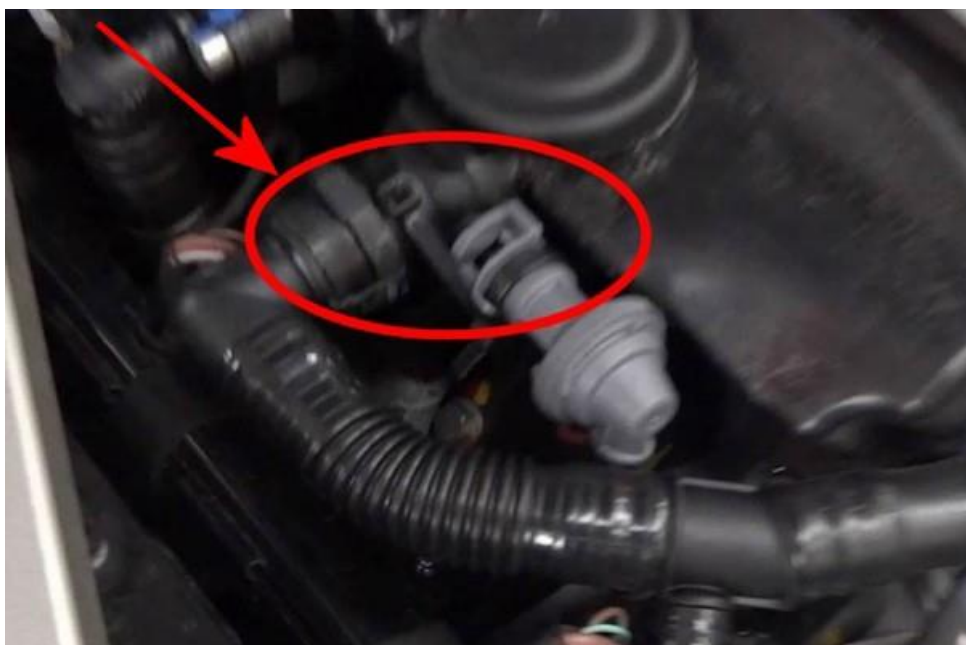
1) Referring to Figure 1 - Check the oil separator and adjoining pipework for any damage

*NOTE: The cable tie attached to the grey joint is the damaged area, in this particular scenario a cable tie was fitted to aid diagnosis*

2) In the event the oil separator and/or adjoining pipework is damaged and/or broken - Referring to the applicable Rep.Gr - Replace the oil separator and applicable pipework
