## TECHNICAL SERVICE BULLETIN

WSB-03: Blocked Air Return

**WSB-03:** Wayfarer Blocked Furnace Air Return

**Models Involved:** 2020-2022 25RW, 25TW, 25SW, 25LW built between 06/29/2020 and 07/23/2021

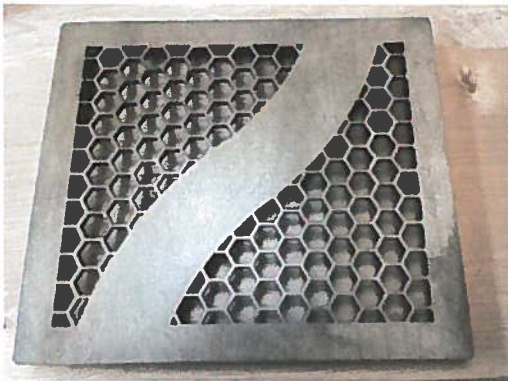
- A. Remove air return insert from the furnace return air opening located directly in front of the furnace by removing the 4 screws, one from each corner of the vent cover.

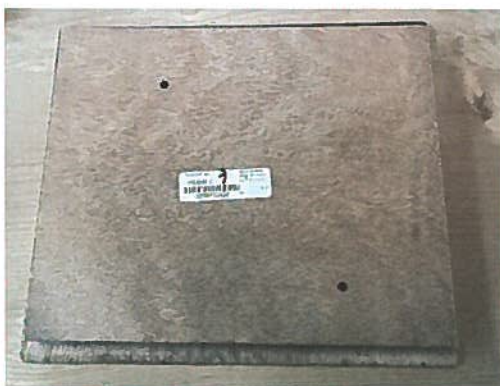
- B. Place air return insert face down to expose the two screws located on the backside of the assembly.

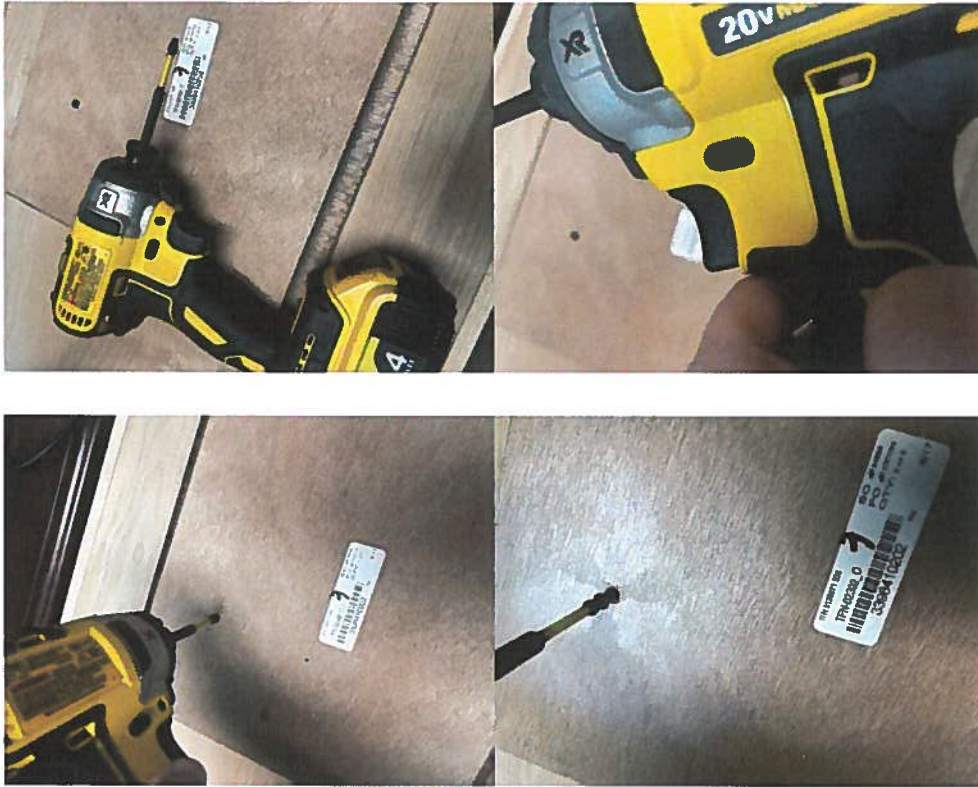
- C. Remove the two screws from the back panel on the Air Return Insert in a counterclockwise direction.

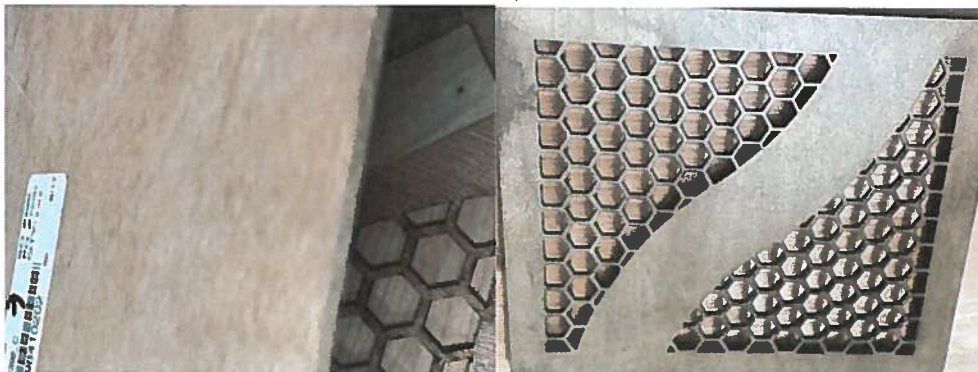
- D. Once both screws are removed, remove the panel.
