# Technical Journal

**AC evaporator repair, additional parts needed**

REF NO:  
**TJ 35912.3.1**

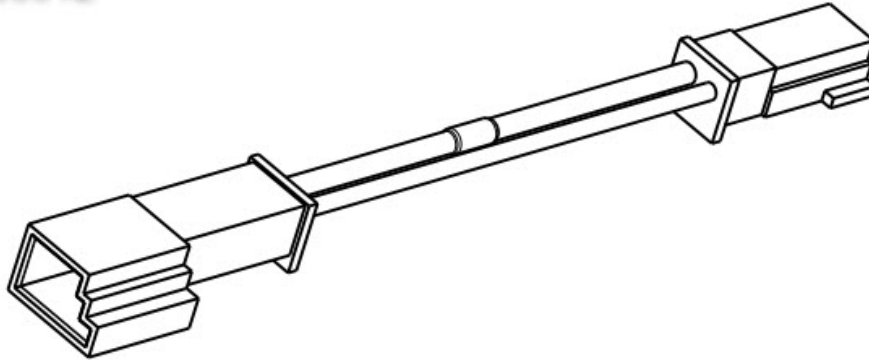
| File Name | File Size |
|---|---|
| TJ 35912 2.PNG | 0.0476 MB |

When replacing the AC evaporator according to VST OP Number: 87402-2, also install Resistor (in-line jumper cable) P/N 32241228 (see picture 2) according to the method with VCC ID VCC-517278-1.
