SPYDER RT 2021 Storage Panel Rework Needed - 139442

These 2 rear storage panels will need some minor rework if replaced on MY21 RT.

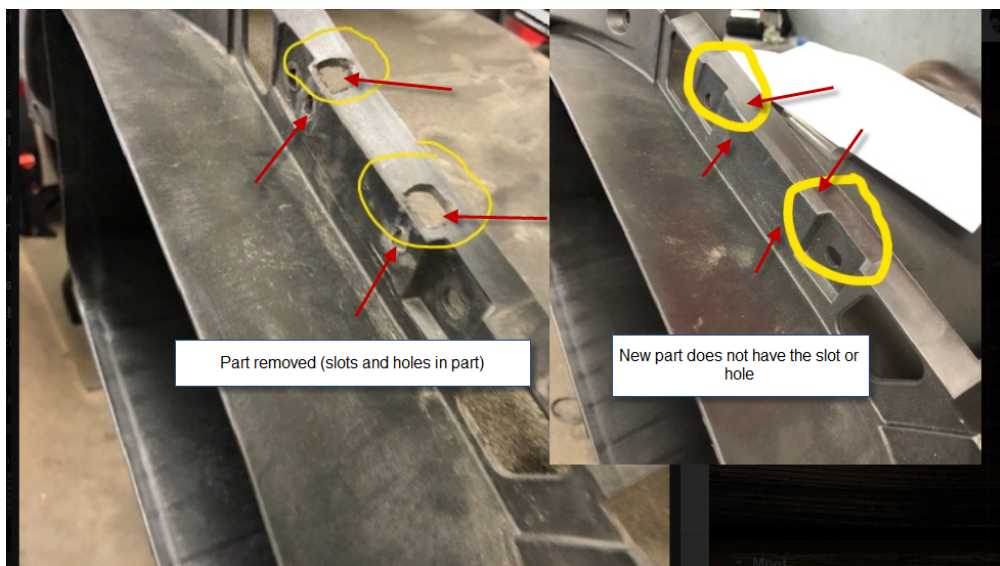
If ever you have to replace a rear saddlebag 708303846 or 708303847, some minor rework will be necessary. Two holes are missing for the retaining clamps.

The templates to rework the rear storage box according to the production vehicle are attached below.

Print to scale (1:1), cut the outlines, and align details on the part to locate the area to modify.
