Technical Service Bulletin

Topic	New Continental GT and GTC - Front Passenger Safety Belt Presenter Does Not Deploy
Market area	United States E05 Bentley USA and rest America (6E05)
Brand	Bentley
Transaction No.	2058512/6
Level	EH
Status	Released for publishing

New Continental GT and GTC

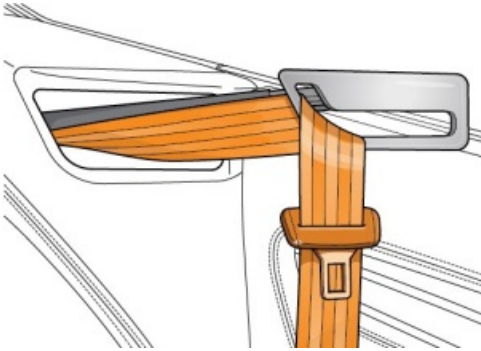
Front Passenger Safety Belt Presenter does not deploy when expected.

Check for Diagnostic Trouble Codes (DTC's) relating to the Front Passenger Safety Belt Presenter, if DTC's are not evident conduct the following process.

Note: There are various situations in which the Front Driver and Passenger Safety Belt Presenters will deploy. This TPI is specifically designed to only check and prove the functionality of the Front Passenger Safety Belt Presenter. Conduct this specific test process as follows.

- Ensure the vehicle is unoccupied, Driver and Passenger doors are closed, vehicle unlocked and the ignition switched "off".
- Open Driver's door and sit in Driver's seat.
- Close Driver's door.
- Driver's Safety Belt Presenter will deploy.
- Switch "on" vehicle ignition.
- Have a second person open the Passenger door.
- Have the second person sit in the Passenger seat.
- Close Passenger door.
- Passenger Safety Belt Presenter deploys.
