## Technical Service Bulletin

**21-ST-002H**

**Elantra (ADA)**

**SUBJECT:** C-MDPS WORM SHAFT BEARING NOISE

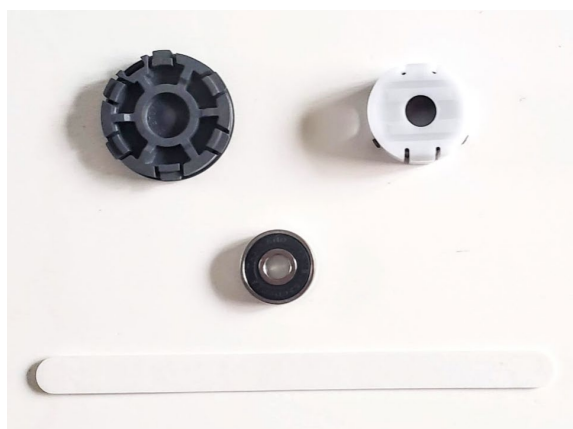
**Description:** Certain vehicles may develop a bearing noise within the Motor Driven Power Steering (MDPS) column worm shaft assembly. If bearing noise is heard, follow the procedure in this bulletin to replace the worm shaft bearing.

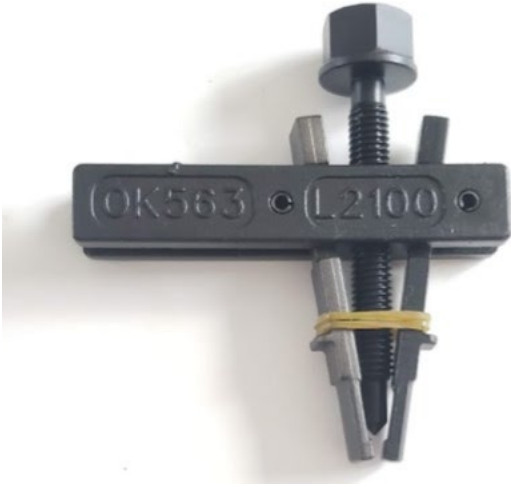
| PART NAME | PART NUMBER | PHOTO |
|---|---|---|
| MDPS SMALL BEARING REMOVAL TOOL | 0K563-L2100FF | |

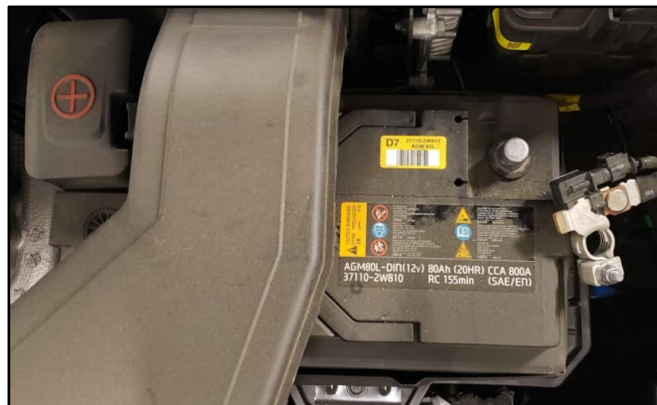
3. Ensure the wheels are straight and the steering wheel is level.
4. Record the customer's AM, FM, and SXM radio preset stations.
5. Disconnect the negative (-) battery terminal.

Wait at least **3 minutes** before proceeding to ensure voltage is bled off.

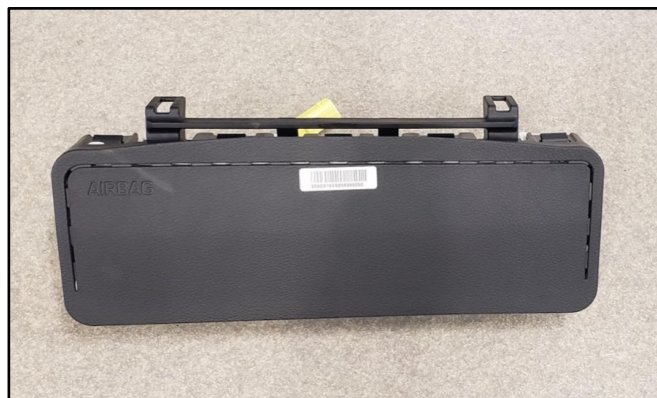
6. Removal of the MDPS assembly is not required to replace the small bearing located in the MDPS steering column and housing. Several parts might need to be removed to gain access to the small bearing.

If equipped, carefully remove the driver's knee airbag following the procedures in the applicable shop manual.

The airbag may accidentally be deployed and possibly cause physical injury. After removing the knee airbag module, position airbag with the cover facing upward.

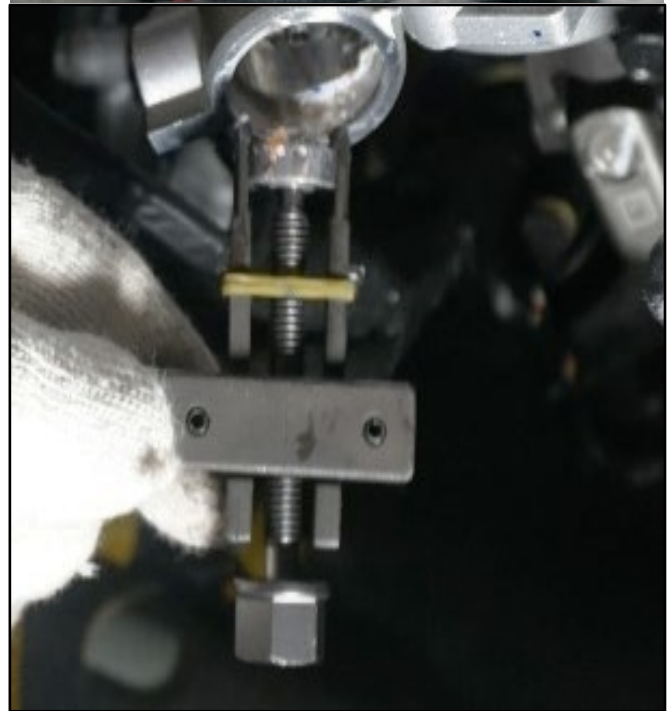
13. Use the MDPS small bearing removal tool, to remove and discard the bearing.

1. Insert the ends (a) of the tool into the MDPS housing to grasp the outer race of the bearing.
2. Slowly turn the threaded rod (b) until the tip (c) reaches the center of the bearing and worm shaft.
3. Continue to turn the rod slowly until the bearing is pulled off the worm shaft.

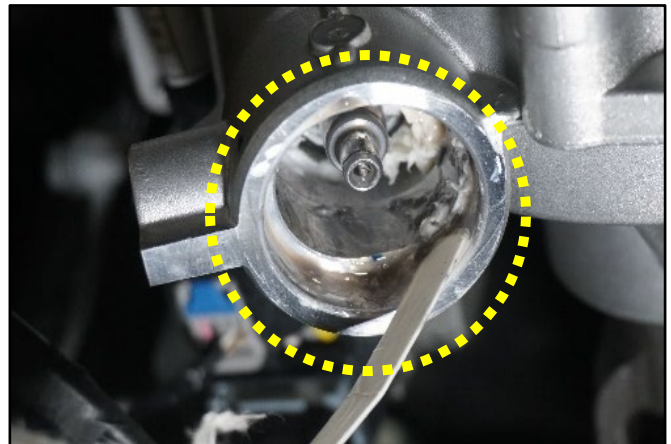
14. Use the supplied paper stick to remove the excess grease.

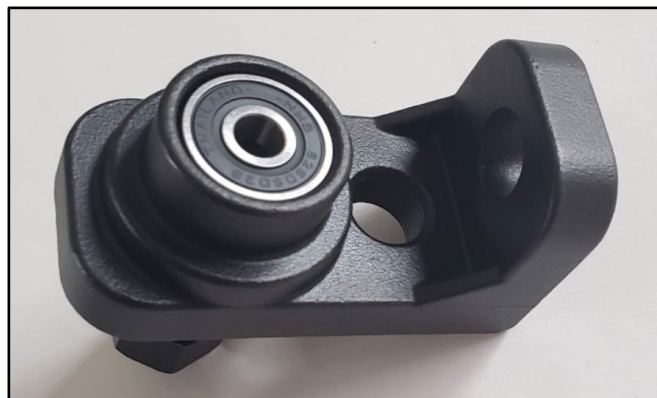
16. Insert the new, small bearing into the bearing holder.

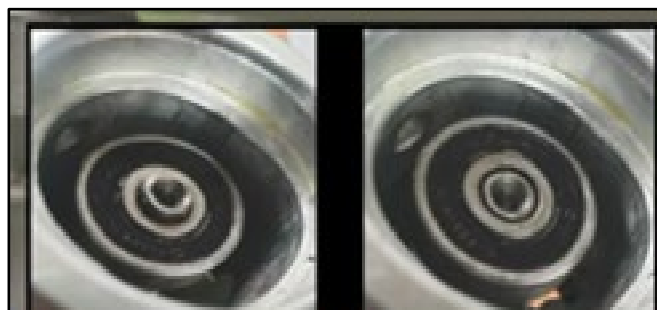
Ensure the bearing is fully seated and the end of the worm shaft is protruding approximately 1.2mm (0.047 inch).

**OK**  
Bearing is seated properly. The end of the worm shaft is protruding.

**Not OK**  
Bearing is not seated properly. The end of the worm shaft is flush with the bearing.

If the bearing did not seat as shown in the photo, increase the torque setting on the torque wrench and continue to slowly seat the bearing.

If the bearing is removed during this procedure, do not reinstall the bearing as it might be damaged and cause a noise. A new bearing must be used.
