PRODUCT CAMPAIGN BULLETIN

APPLICABILITY: 2018-2019MY Legacy and Outback 2.5L and 3.6L NUMBER: WRG-21R 2020MY Legacy and Outback 2.5L and 2.4L (Turbo) DATE: 08/24/21 2018-2020MY Impreza **REVISED:** 11/10/21 2019-2020MY Ascent NHTSA ID : 21V587 2018MY Forester (Turbo) 2018-2019MY WRX 2018-2019MY BRZ

SUBJECT: **Fuel Pump Impeller Failure**

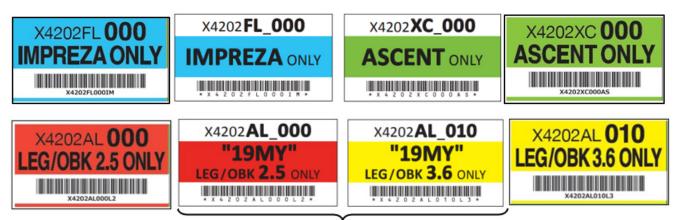
These labels show only "19MY", but the parts are also applicable to 2018MY.

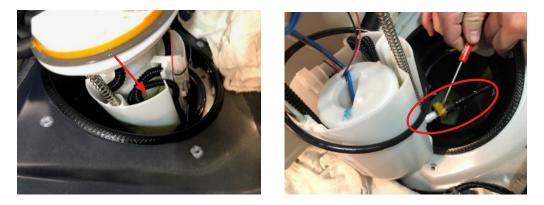
IMPORTANT: After the pump assembly is removed, **ALWAYS** install the applicable fuel tank cap (plug) as shown below or, cover the fuel tank opening with shop cloths or a fender cover (or an equivalent) to keep fuel odors from accumulating inside the cabin. These tools are not required

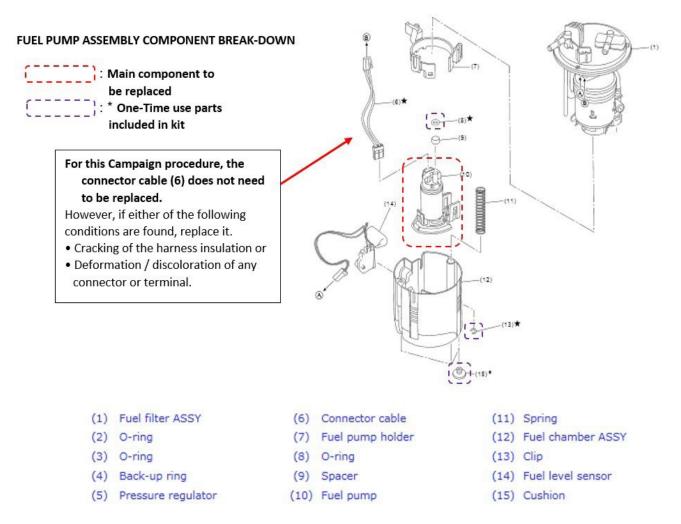
*The 3 rubber cushions (15) on the bottom of the fuel chamber and included in the kit must be replaced as they are 1-time use.

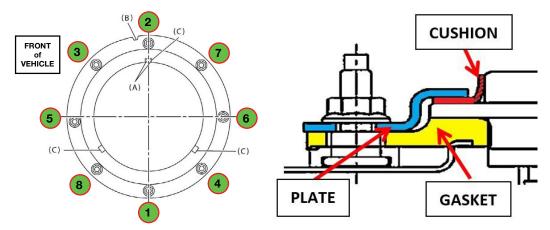
- **CRITICAL:** Lightly hand tighten all nuts in the sequence shown below. Complete tightening of the 8 retaining nuts to the specified torque: **4.4 Nm**, **(3.2 ft. lbs. or 38 inch- pounds)** following the sequence shown below. **NEVER** use air or electric powered tools to tighten these nuts as the studs may be damaged.

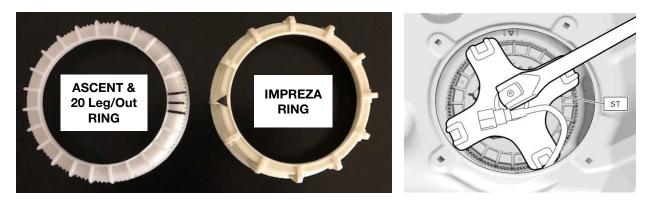
Ascent Ring Nut Markings:

Inspect the new ring nut and identify the set of 3 "teeth" close together as shown above.
 NOTE: The center or middle line (GREEN tooth) must be aligned with the triangle Δ mark in the middle of the thread starting point hash marks as shown below. Also, there is another Δ mark on the top of the fuel pump (Indexing Arrow) to be used as a reference for making sure the pump is properly indexed inside the tank. See Appendix B starting on pg. 60 for more information and a video on this CRITICAL step.

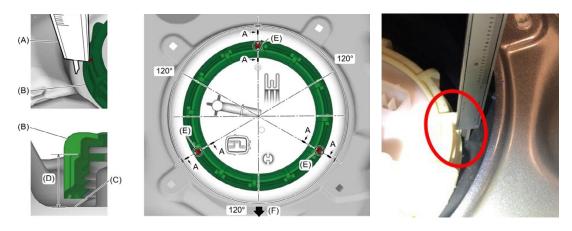
12. CRITICAL: Using a caliper with depth gauge, measure the dimension in 3 positions between the top of the ring nut and the top of fuel tank as shown in the illustration and photo (inset) below. The difference between the three measurements cannot exceed ± 1.5 mm or .060 inch.

• If the difference between any of the three measurements exceeds ± 1.5 mm or .060 inch, loosen and

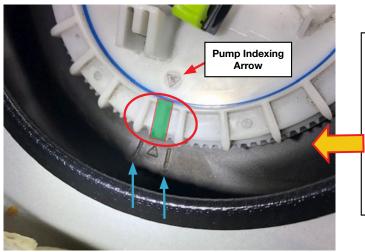
IMPORTANT: This photo shows the NEW ring nut and (Blue) seal plate included in the kit already in place. The ASCENT ring nut thread starting point is identified by the 3 "teeth" close together (RED circled). Align the center (Green) tooth (position mark) with the triangle Δ mark between the molded-in hash marks on the tank (Blue arrows).

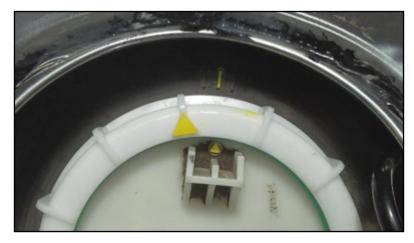
Using special tool #42099CA000, torque the ring nut to 85Nm (62.7 ft-lbs.).

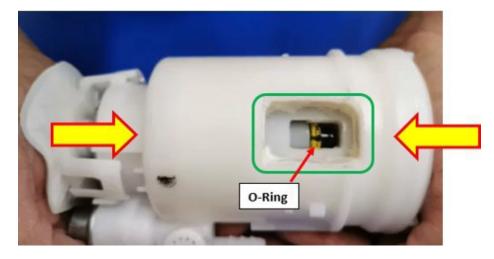
CRITICAL TIP: Align and press the new fuel pump **FIRMLY**, **SQUARELY** and **STRAIGHT** into the filter housing in ONE smooth, continuous motion.

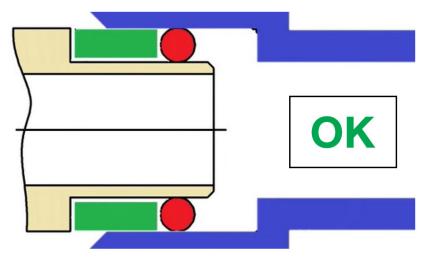
The **RED** circles represent a cross-section of the o-ring.

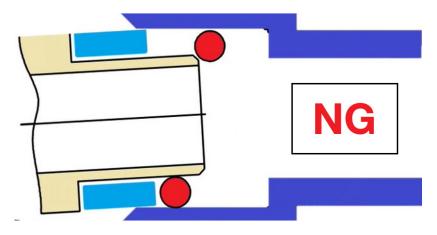
Here, the new fuel pump is being pressed into the filter housing bore at an angle which will likely result in the outlet tube butting against the shoulder of the bore the o-ring seals against followed by repeat attempts which often end up with the o-ring becoming dislodged.
