## **Volvo Chassis - Equipped With An Automated Manual Transmission ( AMT, I-Shift ) - Reverse / Back-Up Lights Inoperative, No Diagnostic Trouble Codes (DTC), No Issues With Circuit, Additional Check - US10 And US13 Emissions, Model Years 2011 To 2014**

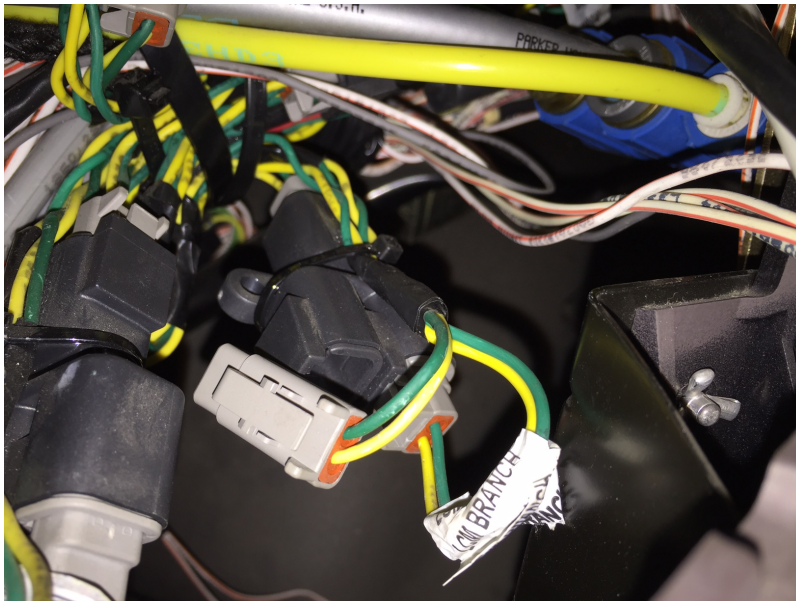
Ensure that all three connections are clean and tight. An example of an unplugged connector is shown below. Note that the example below did not set any fault codes pointing directly to a particular circuit or component and because it was the data link that was unplugged, the reverse light circuit was found free of faults.

If all diagnostic steps for the conditions above lead to No Fault Found (NFF), an additional item to check are the data link connections to the LCM. There are three Tee (3-way) connectors for the J1587 And J1939 data links located in the dash: Two of the connectors supply the LCM and the third leads to another branch.
