139/21 ENU AMB7

### AMB7 - Replacing Axle Carrier Side Section (Recall Campaign)

Model Line: Boxster (981)

Cayman (981)

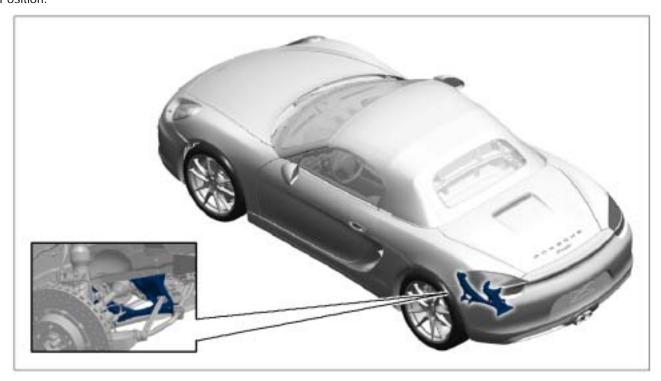
Installation Position:

Installation place of rear-axle carrier side section shown on the Boxster (981)

Action required: Replace axle carrier side sections.

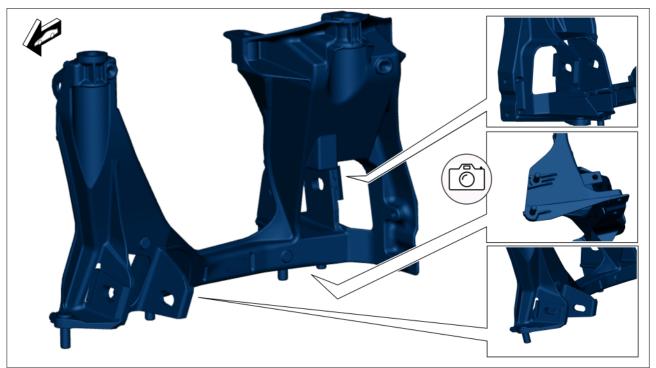
Photo documentation of rear-axle carrier side section

- 7.1 Take photos of the jacking points on the rear-axle carrier side section at the left and right shown in ⇒ Photo documentation of rear-axle carrier side section Picture-.
- 7.2 Upload the **pictures** to the PCCS quality line with the relevant **inscription** on the affected side, e.g. **Component left\_VIN\_Fig 1**.
- 8 Enter the campaign in the Warranty and Maintenance booklet.
