Document ID: IK0800080

Title: J1939 Data Link Troubleshooting

Applies To: All Models with 250k Baud Data Link (Black 9-Pin Diagnostic Connector); Overview information for 500k Baud Data Link

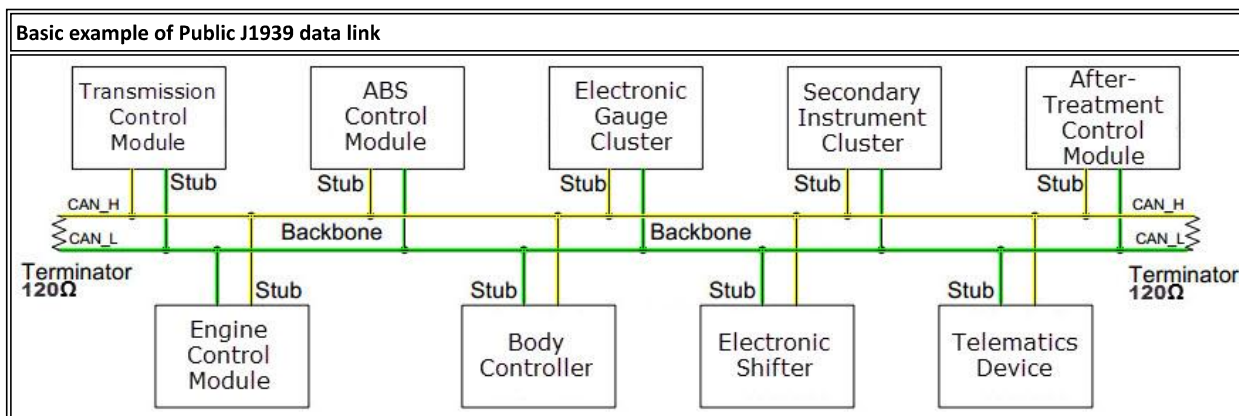
- The troubleshooting cards give a good overview of the data link. This will help show you the backbone of the data link (main data link wiring between 1st terminating resistor to 2nd terminating resistor) and the stubs of the data link (wiring from the backbone to each possible module)

- The J1939 Splice Adapters (1024, 1025, 1026) are part of the backbone of the data link (The backbone will come in on 2 terminals and leave on 2 different terminals). The wiring from the connector to each module is a stub.
 - o 2007 - [HPV \(medium duty\) 1939 Troubleshooting Card](#)
 - o 2007 - [CE / BE Bus 1939 Troubleshooting Card](#)

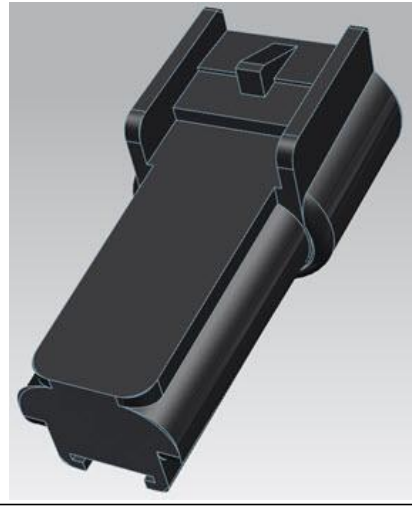
Connector: 1667741C1 Terminal: 1661875C1
Terminating Resistor (2-Pin Connector)	120 ohm resistor: 3769112C91	Connector: 3683465C1

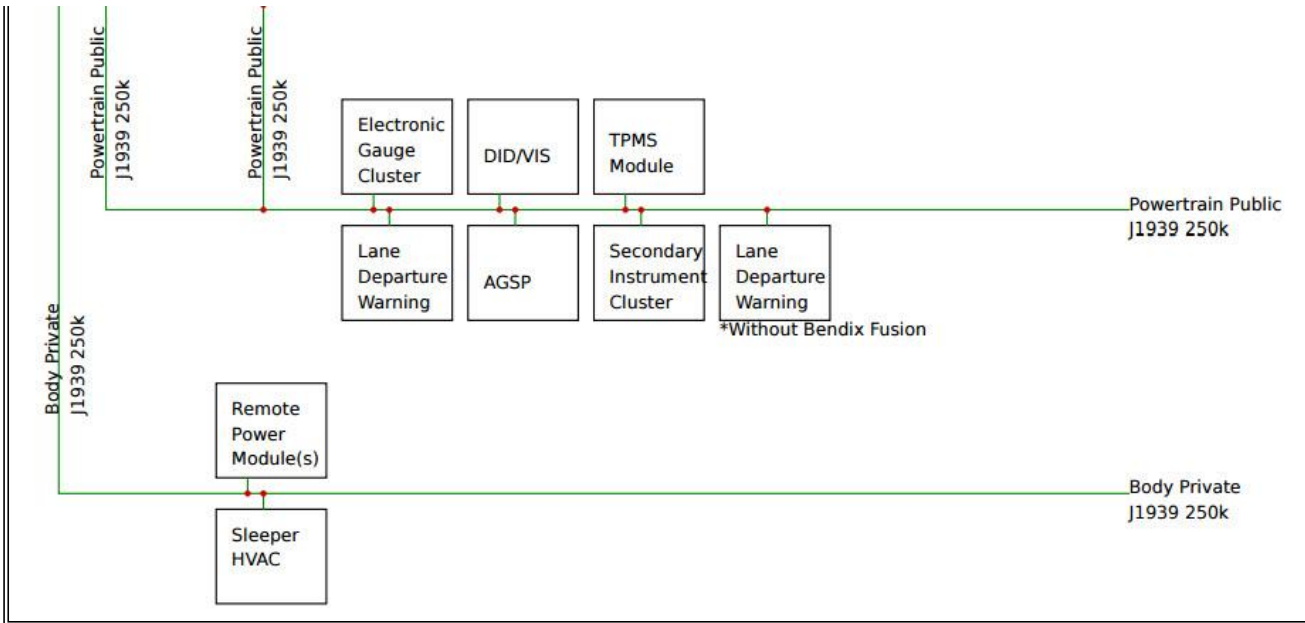
500k Baud Vehicle Architecture - Phase 1

This can be properly identified by looking in the components tab of the vehicle and looking for a GREEN 9-Pin connector and feature:
