## STAR ONLINE PUBLICATION

**Case Number:** S2108000272

**Symptom/Vehicle Issue:** Check Engine Light Is On. DTC's P0070 And P0073 Are Active For The Ambient Air Temperature Sensor

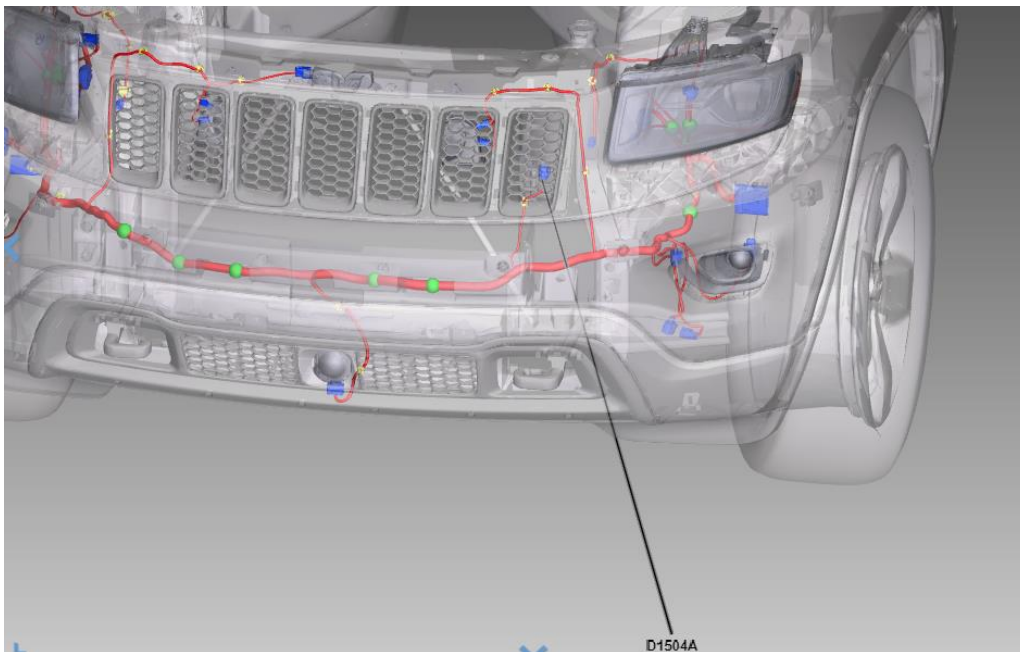
**Discussion:** The check engine light may be illuminated. Upon scanning the vehicle you may find multiple DTC's set for the ambient air temperature circuit including P0070 and P0073.

**Repair:** The Ambient Air Temperature sensor may not have been fully seated. Inspect the D1504A AAT sensor connector behind the left grill. Disconnect and reconnect the connector to confirm it is fully seated.

**Verification:** Clear the DTC's and verify they no longer return and the CEL is no longer illuminated. Confirm the ambient temperature sensor is reading correctly.
