SIB 31 01 21

SERVICE ACTION: FRONT AXLE SUPPORT WEDGE

This Service Information Bulletin (Revision 1) replaces SI B31 01 21 **dated March 2021**.

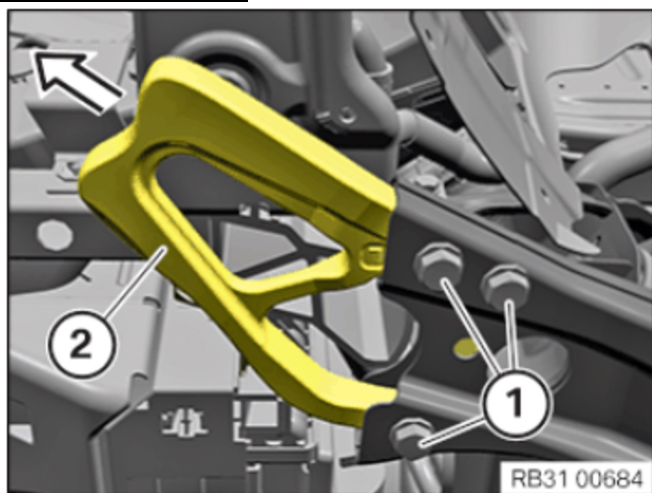
Install the left and right wedges (2) to the front axle.

Install the left crash wedge as per REP 31 10 035.
Install the right crash wedge as per REP 31 10 036.
