SIB 46 05 21

SERVICE ACTION: OPTIONAL ACCESSORY FOOTRESTS

2021-11-03

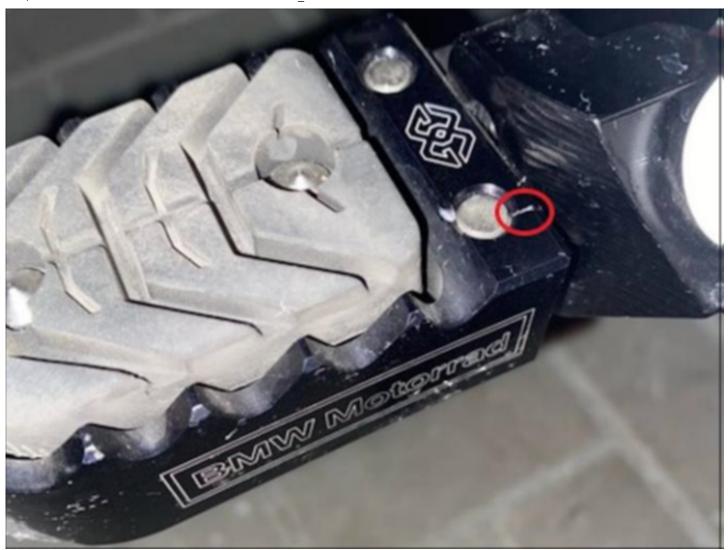
Stress corrosion cracks may occur on the studs of certain milled footrests from the BMW Motorrad special accessories catalog for the GS models. The following part numbers are affected:

- 77 25 2 452 958 Footrest adjustable, left, black solid
- 77 25 2 452 960 Footrest adjustable, right, black solid
- 77 25 2 465 256 Set of footrests adjustable, black solid

This Service Action only applies to certain Accessory Milled Footrests, part numbers are listed above. Check if the bike has these specific accessories; if they do not, no action is required. Customer vehicles coming in must be actively inspected for affected footrests that must be exchanged.

In the affected vehicles, the installed accessory footrests adjustable black solid must be exchanged with accessory footrests Shadow (Option 719).

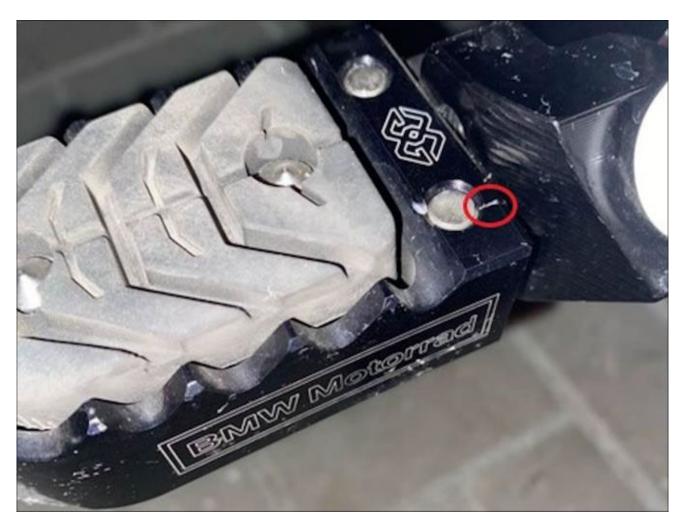
Stress corrosion cracks may occur on the studs of certain milled footrests from the BMW Motorrad special accessories catalog for the GS models. The following part numbers are affected:

- 77 25 2 452 958 Footrest adjustable, left, black solid
- 77 25 2 452 960 Footrest adjustable, right, black solid
- 77 25 2 465 256 Set of footrests adjustable, black solid

This Service Action only applies to certain Accessory Milled Footrests, part numbers are listed above. Check if the bike has these specific accessories; if they do not, no action is required. Customer vehicles coming in must be actively inspected for affected footrests that must be exchanged.

In the affected vehicles, the installed accessory footrests adjustable black solid must be exchanged with accessory footrests Shadow (Option 719).
