# Service Bulletin

Bulletin No.: 21-NA-264

**Subject:** Liftgate Actuator Showing a Leaking Residue on Strut

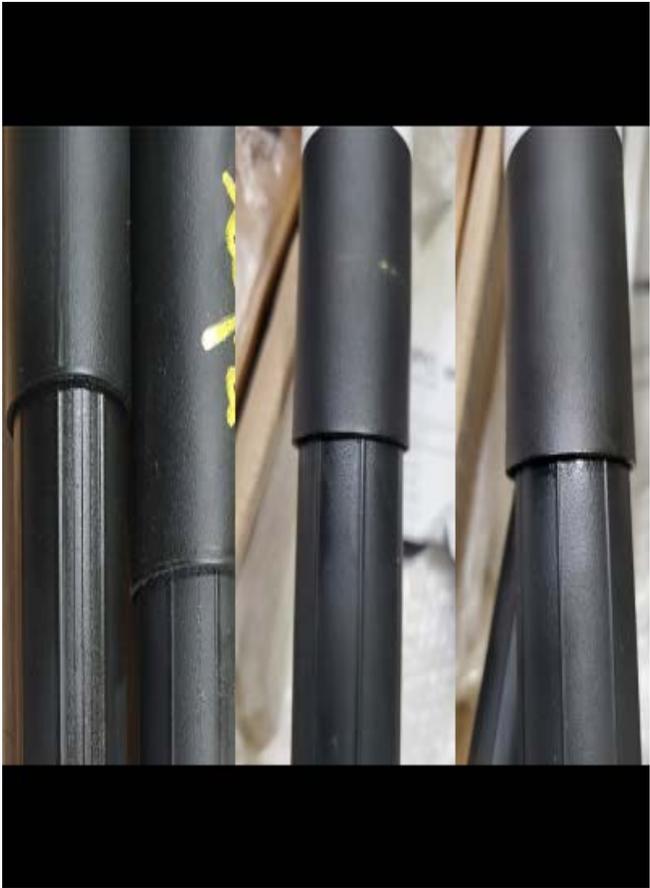
| <b>Cause</b> | <p>The cause of the condition may be a specific issue in which typically extra padded grease is used for the boot, to reduce noise from movement. This in some cases can be confused with a leak from a type of hydraulic fluid that assists with the pressure of the actuator. <b>This is not the case.</b> The struts do not contain any fluid for its mechanical functionality. There are no concerns with the part functionality from this residue of grease. This is extra grease that has found its way out from added pressure on the boot.</p> |

| <p>Open the liftgate to access the strut (1), then grease can be wiped away with a damp cloth and dried appropriately.</p> | |
