SIB 01 11 21

2021-11-09

F16 (N55) FUEL DELIVERY UNIT W/IN-TANK PUMP LTD WTY EXT-15 YEARS/150,000 MILES

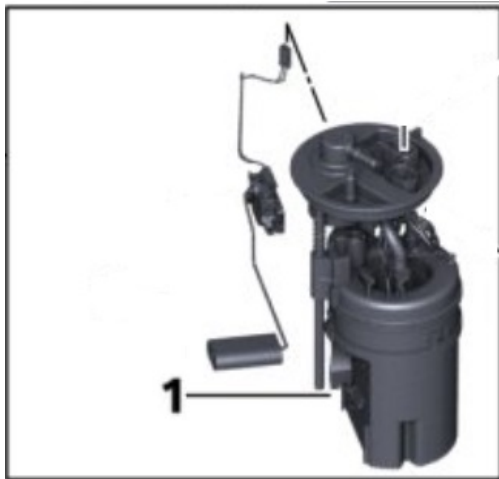
For the eligible vehicles and for the issue described below, BMW of North America, LLC (BMW NA) is extending the limited warranty for the vehicle's fuel **delivery unit with in-tank pump (item # 1, shown, for fuel delivery issues)** to:

Due to multiple conditions that may occur under certain driving conditions, the in-tank fuel pump may stop operating. Consequently, the fuse may also trip in the fuel pump control unit (EKP). As a result, this can cause the engine stop and not restart due to insufficient fuel supply.

If a vehicle listed above arrives at your center with the issue described above, perform diagnosis (fuel pressure related), and when applicable, replace the delivery unit with in-tank pump.
