## Grounding Bus Bar (Cloverleaf, Grounding Star, Four Point Ground Stud) On Frame Rail; Inspection To Be Performed For Power And Ground, Data Link DTCs - US10 And Newer Emissions, Model Year 2011 And Newer

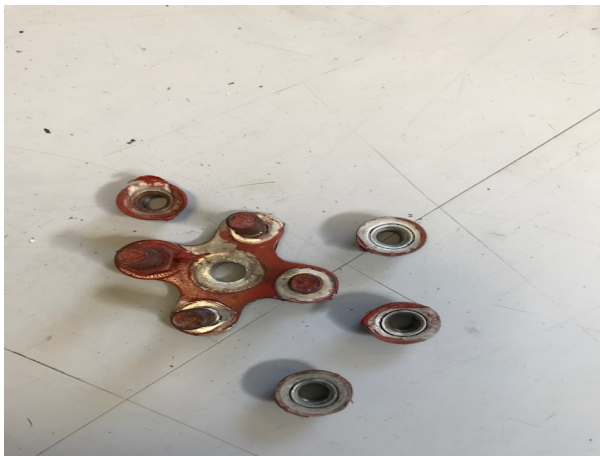
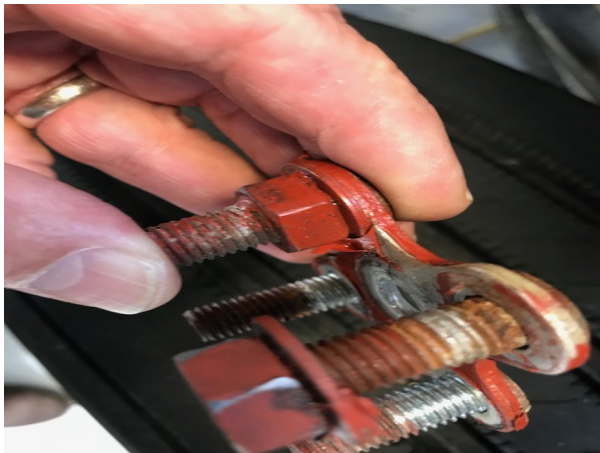
The ground star is located on the driver's side frame rail near the battery box and fuel tank. If the ground becomes loose or gets protective coating, paint, dirt, or corrosion in between the terminals, the ground star needs to be removed, cleaned, and the protective coating needs to be reapplied.
