# Volvo Chassis - SNV16-029 Barksdale - Suspension Height Level Control Valve

**Bulletin:** SNV16-029  
**Date:** August 23, 2016  
**Valid to:** Until Further Notice  
**Replaces:** N/A  
**Action Required?** **Yes**

**Subject:** Barksdale - Suspension Height Level Control Valve

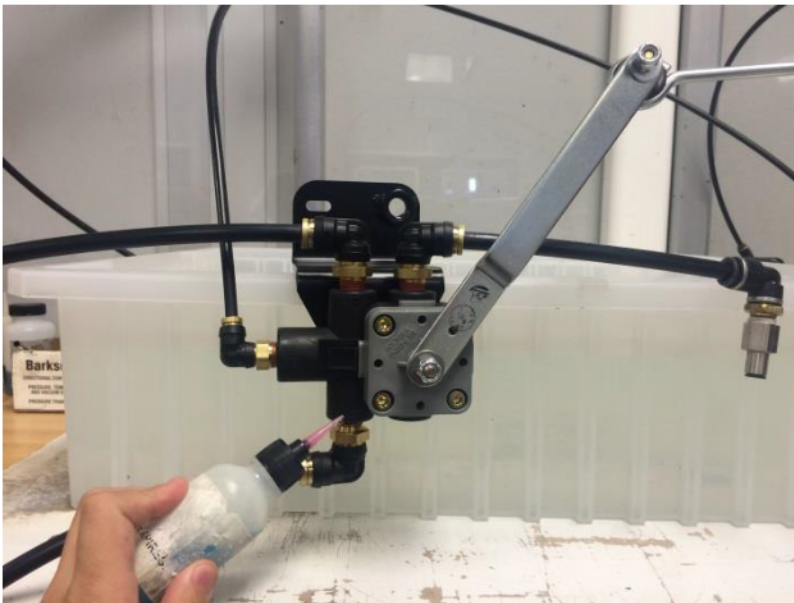
6. If there are still bubbles present after Step 5, please return through the normal warranty process for further analysis. Please note that the presence of bubbles does not definitively indicate that a valve has failed.
