SERVICE BULLETIN

Classification: AT16-001Q	Reference: NTB16-110Q	Date: December 7, 2021
------------------------------	--------------------------	---------------------------

2013-2017 ALTIMA AND 2014-2017 ROGUE; 4 CYLINDER WITH DTC P17F0, P17F1, P0776, P2813, P1715, AND/OR P0841 STORED

APPLIED VEHICLES: 2013-2017 Altima (L33)
2014-2017 Rogue (T32)
APPLIED ENGINE: QR25DE (4 cylinder only)

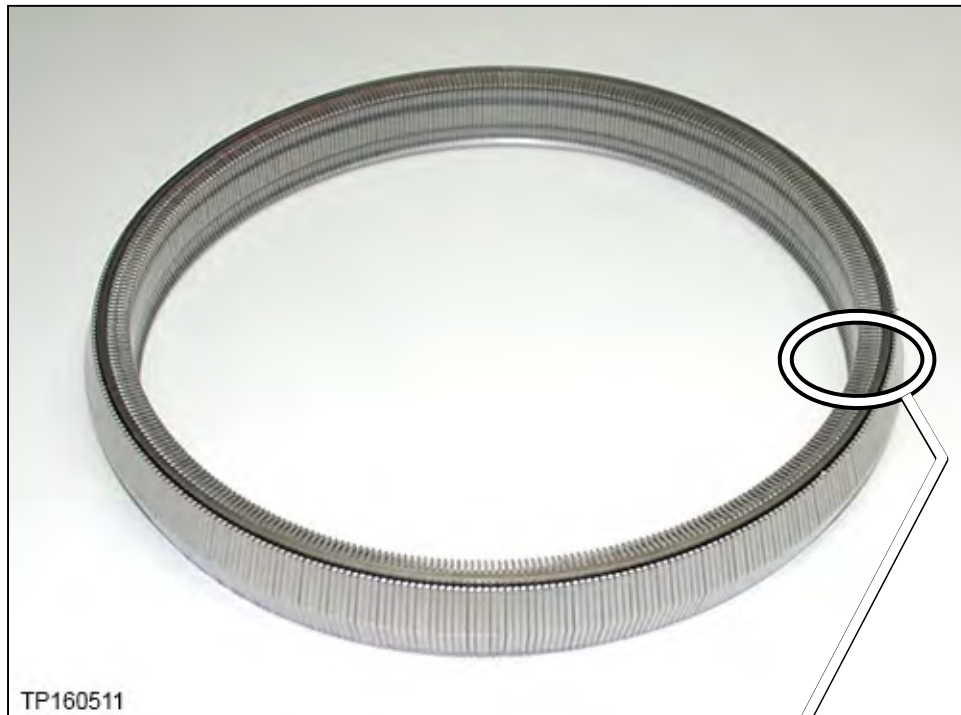
Figure 16: New belt

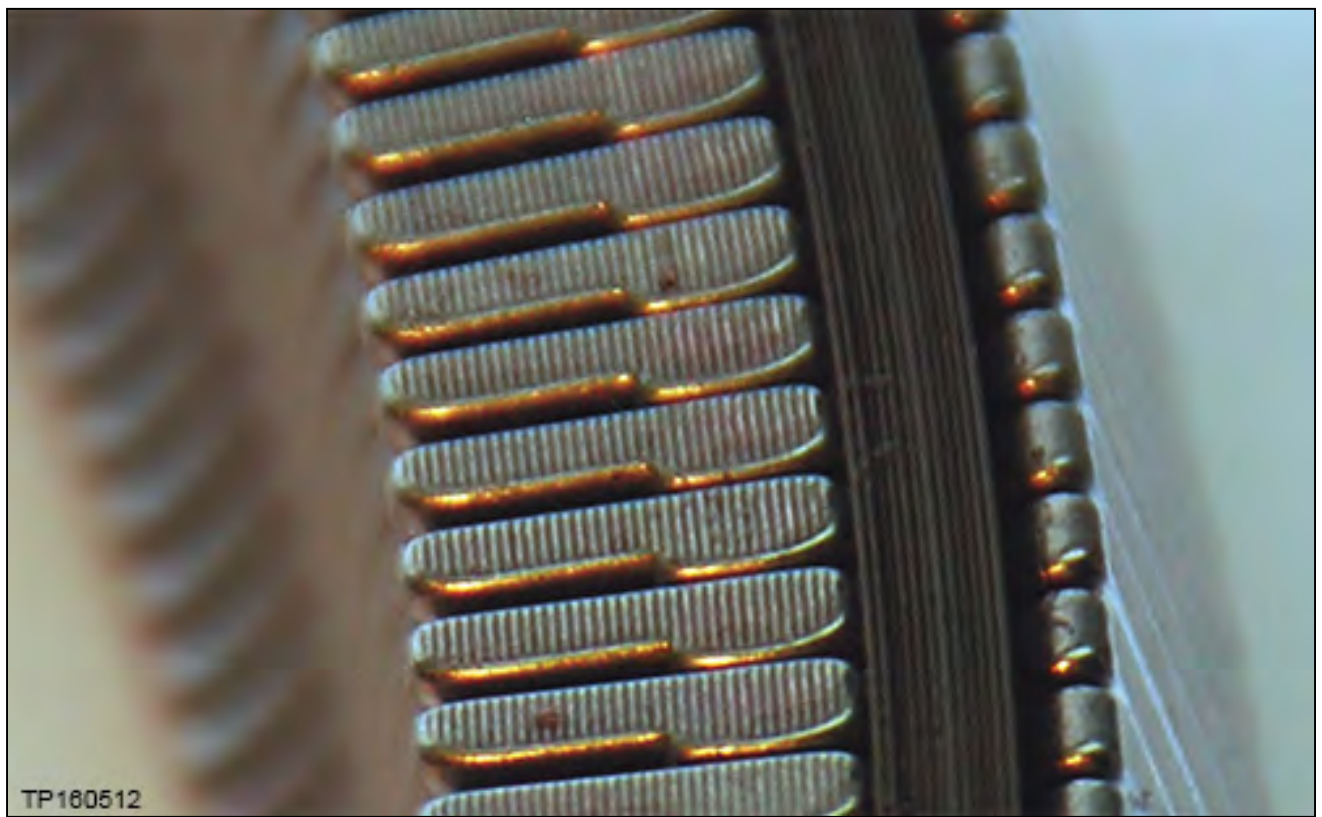
Figure 17: Close-up of section to be inspected

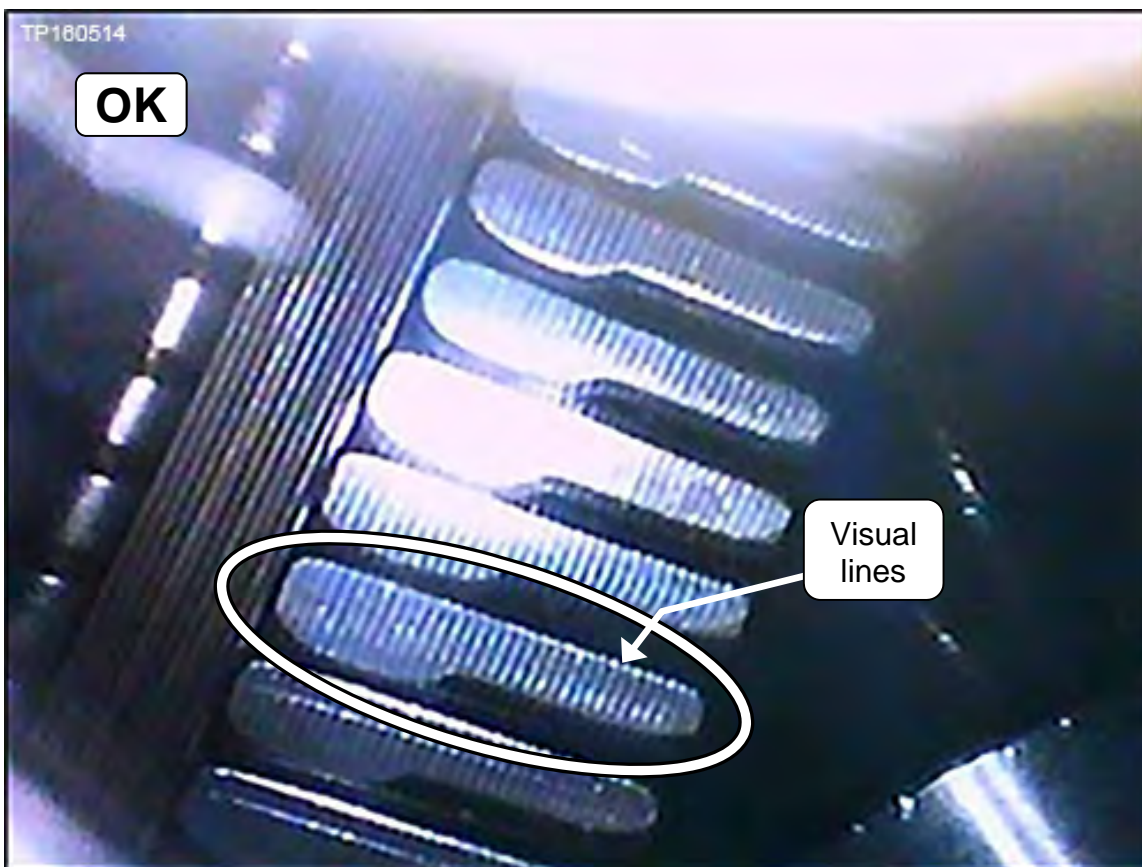
Pictures in Figure 18 and Figure 19 were taken with borescope J-51951.

Figure 19: Belt is OK

7. If the belt inspection result is **OK**, replace only the valve body, and then reprogram the TCM if applicable.

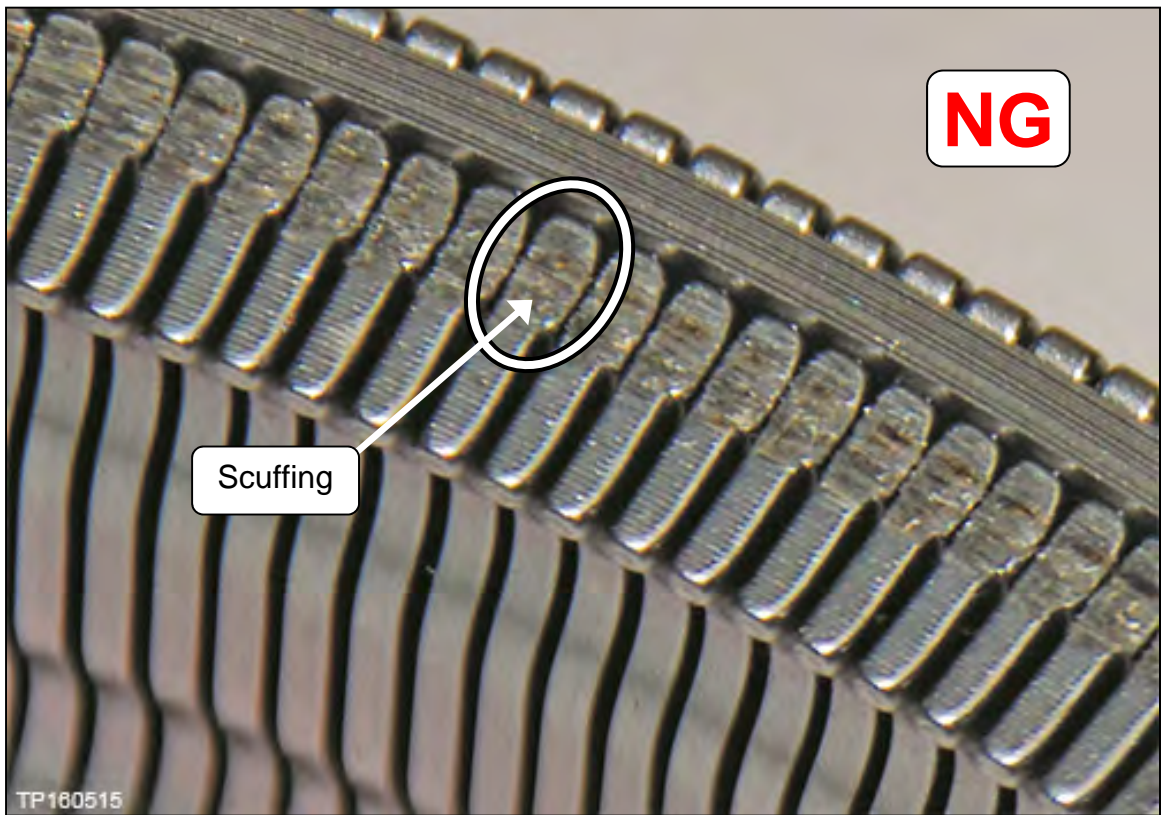
Figure 20: Example of NG belt

8. If the belt inspection result is **NG**, replace the CVT sub-assembly and valve body, and then check step 139 on page 80 to confirm if a TCM reprogram is available.

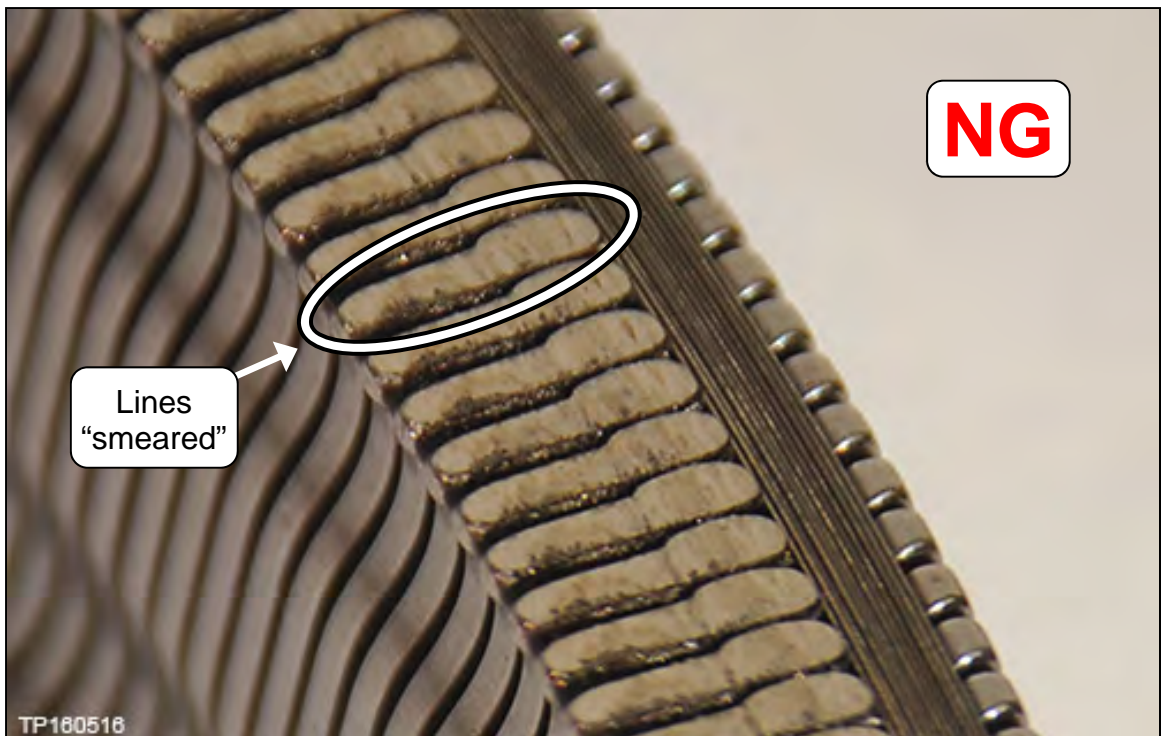
Figure 21: Example of NG belt

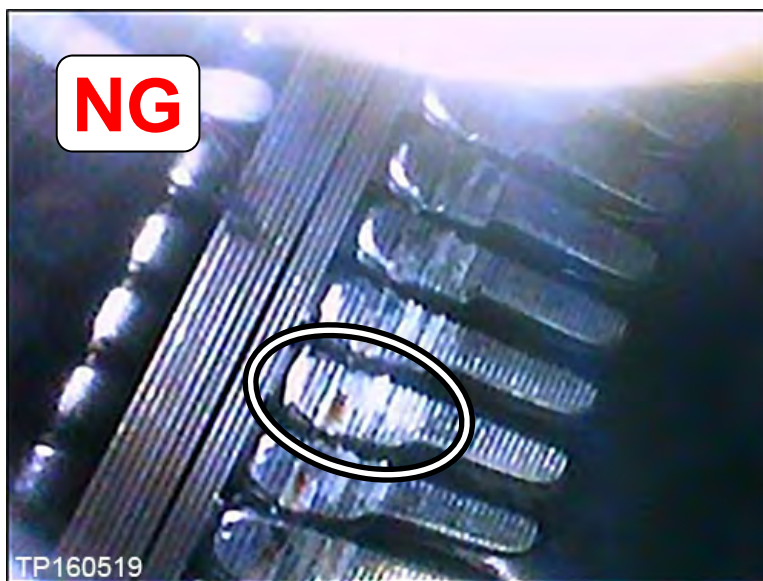
Pictures in Figure 22-Figure 24 were taken with borescope J-51951.

Figure 24: Example of NG belt

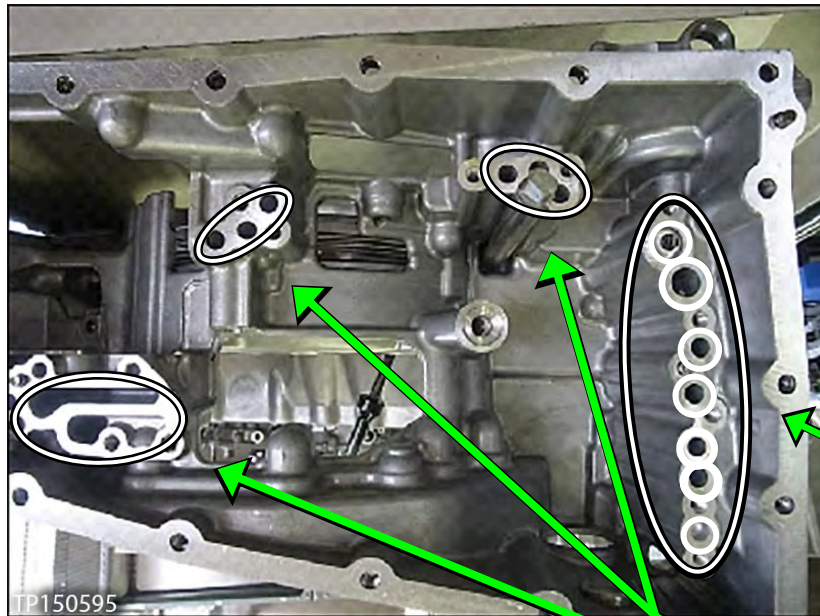
Figure 57

Apply cleaner, and then 75 PSI maximum air pressure in these passages.

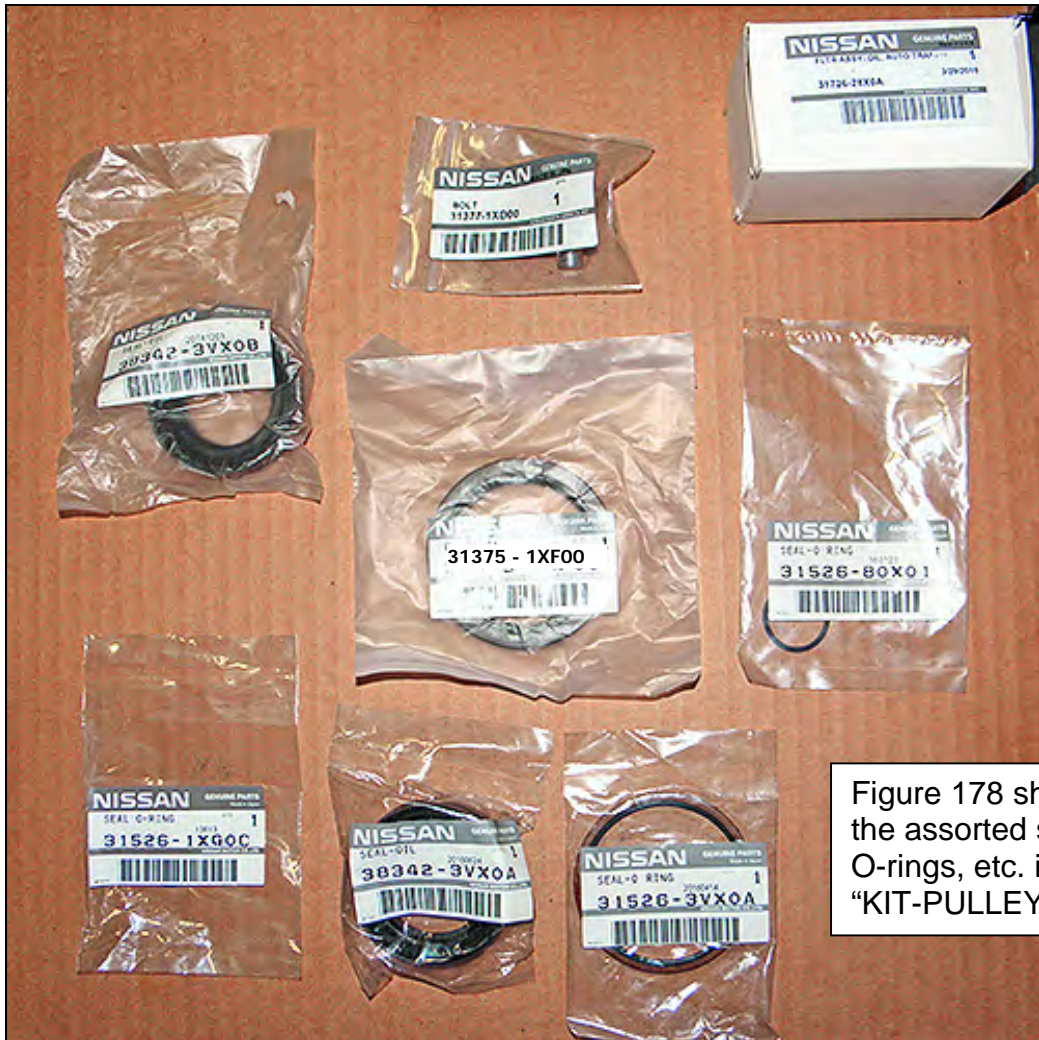
Figure 178 shows the assorted seals, O-rings, etc. in "KIT-PULLEY"
