Service Bulletin

Bulletin No.: 18-NA-033

Subject: Diagnostic Tip for Low Oil Pressure Light on at Idle

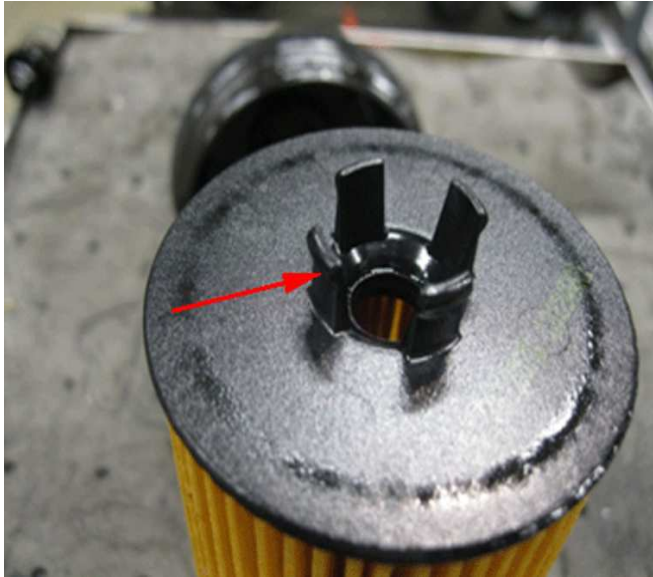
3283232

During an oil change, it is possible for the tabs on the oil filter, as shown in the illustration above, to break off and fall into the oil filter housing.

Involved Region or Country	North America
Condition	Some customers may comment on the low oil pressure light coming on or flashes on and off at idle.
Cause	This condition may be caused by oil pressure being bled off due to debris in the oil drain check valve and/or a damaged oil filter.
Correction	<p>Use a manual pressure gauge to check oil pressure:</p> <ul style="list-style-type: none"> • If the pressure is low, perform a visual inspection of the condition of the oil filter. • If the condition of the oil filter is good, remove the filter and confirm proper operation of the oil filter drain check valve. • If the valve does not seal or it is held open, repair as necessary and recheck oil pressure.

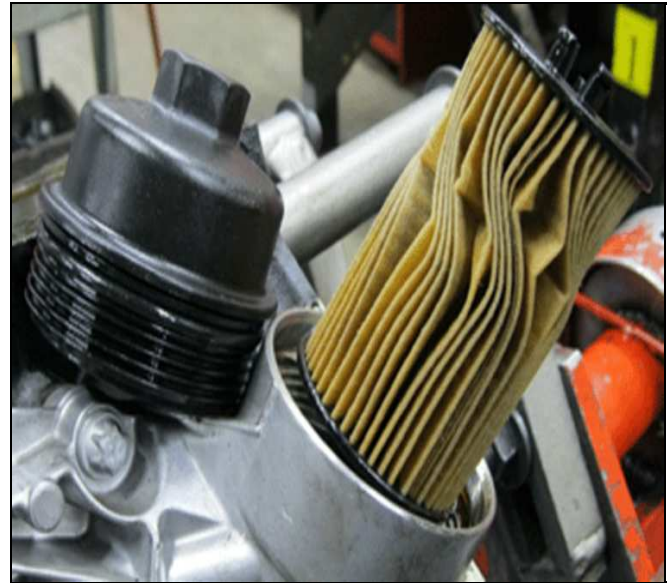
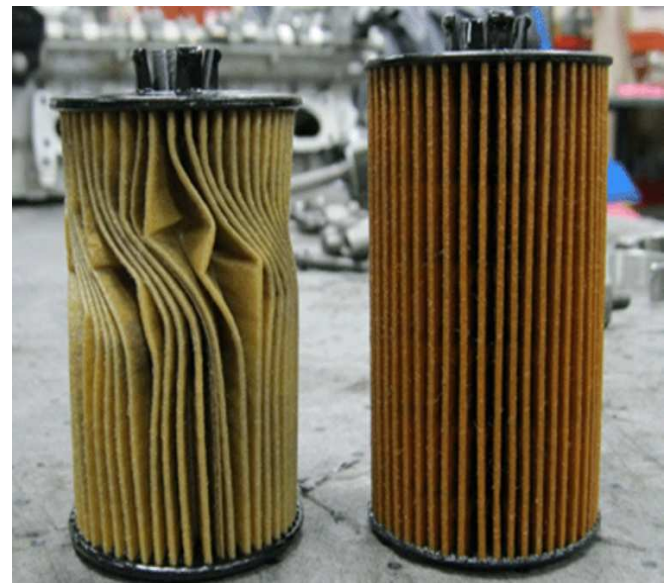
Shown in the illustrations above is an oil filter that was installed improperly, which caused the oil filter to be smashed and cannot close the oil filter drain check valve.

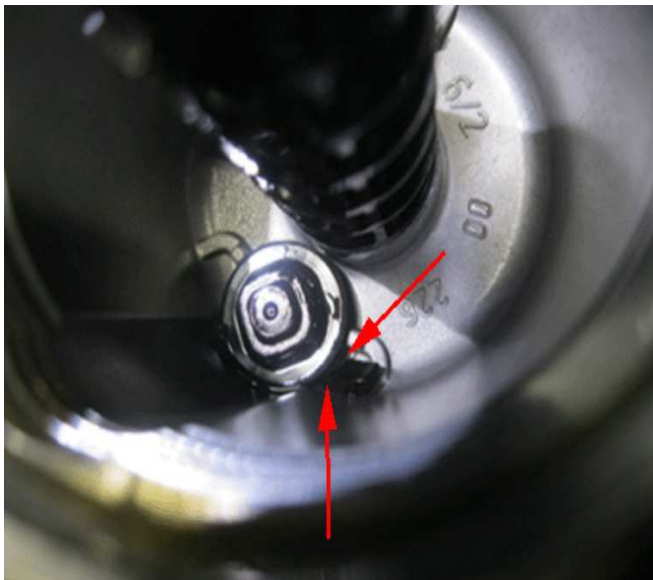
3283221

illustration above. This will allow oil to drain back into the oil pan and reduce the pressure allowed to the engine.

This piece may become lodged under the oil filter housing drain check valve, causing it to remain open when the new filter is installed as shown in the
