## **MULTI-MODEL** **EXTERIOR TRIM HEAT DAMAGE**

Some vehicles may experience exterior trim heat damage when parked near a glass building. This may be caused by the sun's reflection.

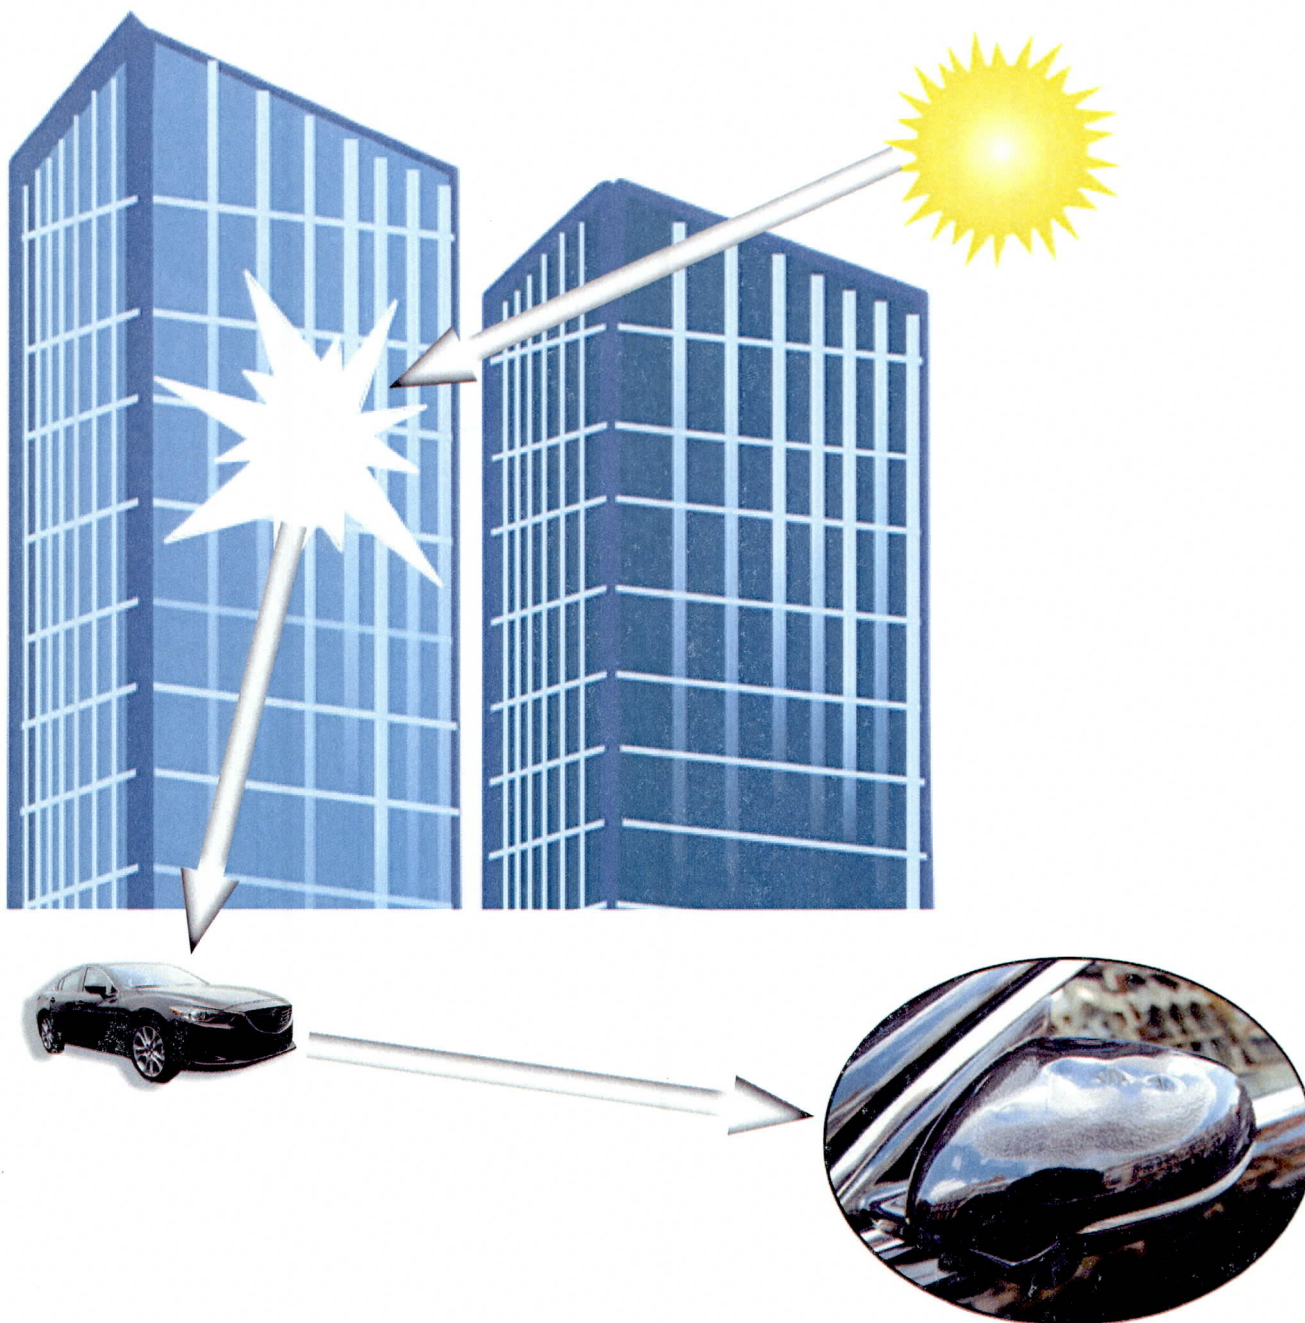
If a building creates enough of a curve with a series of flat windows, which act like mirrors, the reflections all converge at one point, focusing and concentrating the light onto the street below.

Vehicle repairs for this concern are not covered under Mazda's warranty policy.
