NUMBER: 05-004-21

GROUP: 05 - Brakes

Front Click Noise at Low Speed Turns

This bulletin involves installing a friction disc kit on both front hub bearings and rotors.

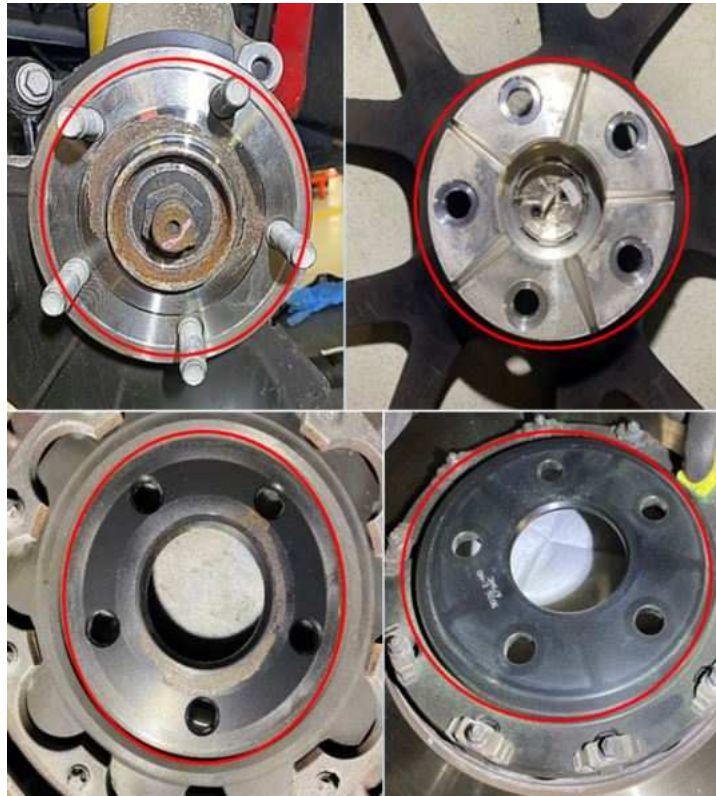
**Fig. 1****Areas That Needs To Be Cleaned**

1. Remove both front brake rotors. Refer to the detailed service procedures available in DealerCONNECT/Service Library under: 05 - Brakes / 05 - Brakes, Base / Hydraulic/Mechanical / Rotor, Brake / Removal, Front - SRT.
2. Clean hub face where the rotor surface contacts the hub face to remove any dirt or corrosion, using scotch brite pad or similar style scouring pad that will not scratch the surface. Clean all mounting surfaces as seen in (Fig. 1) .

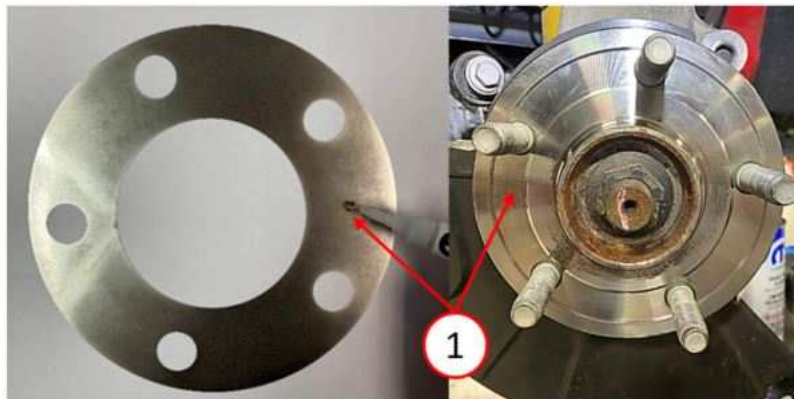
**Fig. 2****Cleaned Hub and Friction Disc**

1 - Put Adhesive in This Location

3. Use small amount of adhesive between friction disc and hub to hold disc centered on hub (Fig. 2) .

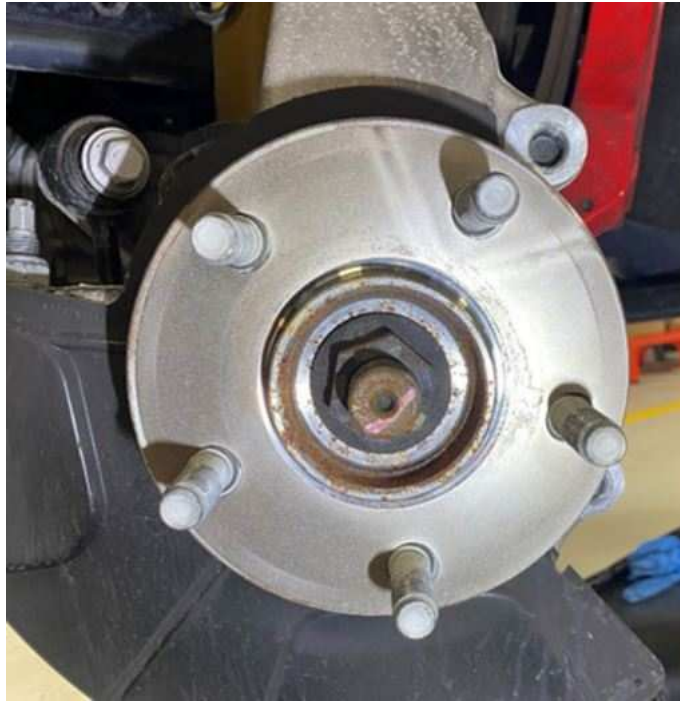
Fig. 3
Friction Disc Installed On Hub

4. Install the friction disc on to both front hub flanges (Fig. 3) .

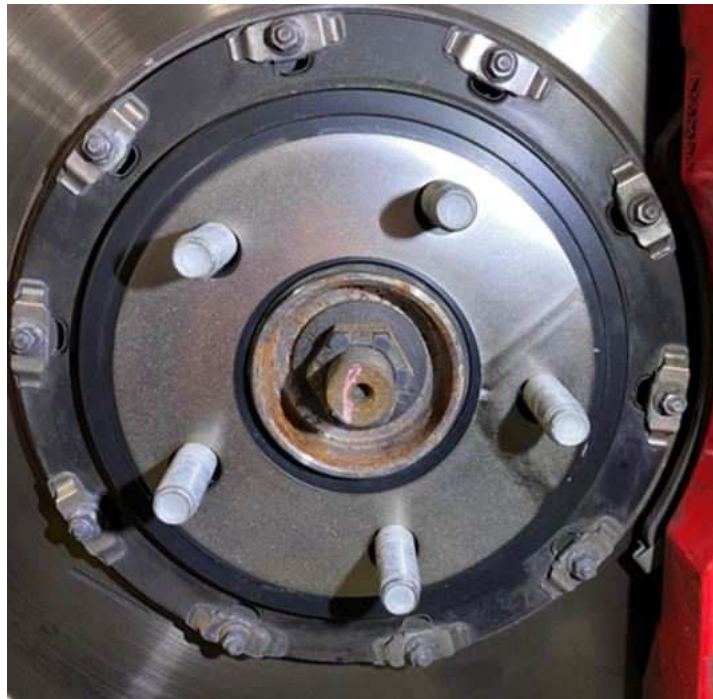
Fig. 4
Friction Disc Installed On The Rotor

5. Put both rotors back onto the hubs and apply a small amount of adhesive in the center of the friction disc. Put both friction discs on the outside of the rotors (Fig. 4) .
