STAR ONLINE PUBLICATION

Case Number: S2123000062

Symptom/Vehicle Issue: Door Will Not Open Using Inside Door Handle

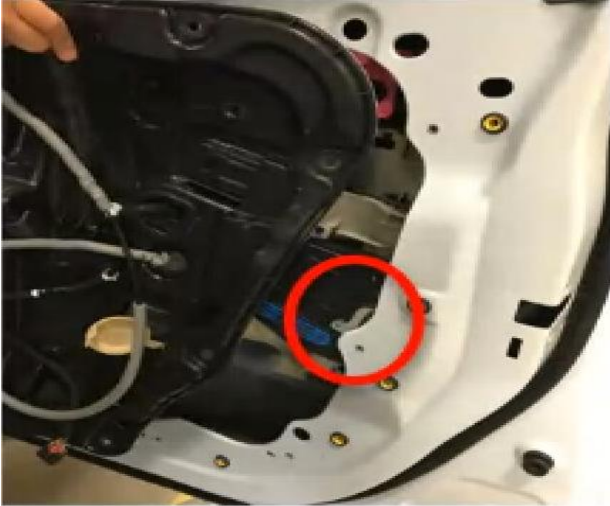
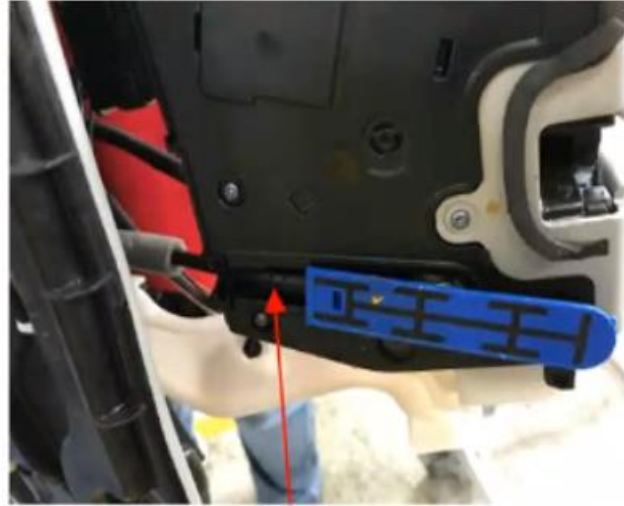
Fig 1
location of interior door handle cable dust cover (left image). Unseated cover (right image)

Discussion: Open the door using the outside handle. Remove the trim panel. Refer to Service Information 23 - Body / Doors - Front / PANEL, Door Trim / Removal and Installation. With the panel removed inspect the lower rear door cavity shown in Fig 1 for the blue cable dust cover position. If the blue dust cover is found un seated from the door carrier, seat the cover and place a piece of tape 68065586aa over the dust cover as shown in Fig 2. Once the cover is secured and taped in place reassemble the door panel.

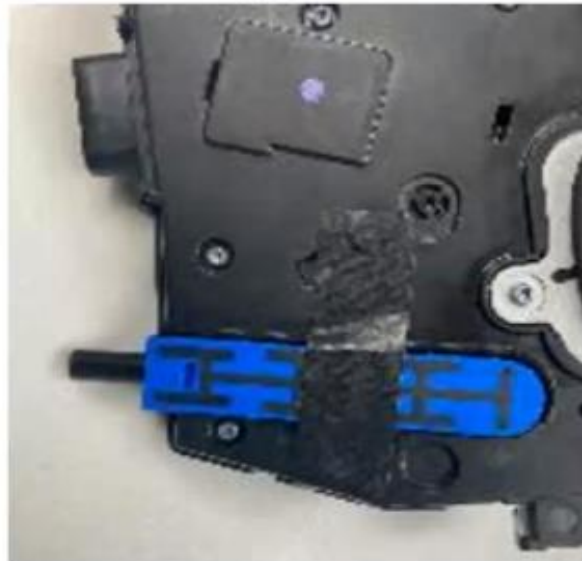
Fig 2
Dust cover seated properly and tape applied over top.
